Campaign No. 2023120010, December 2023

SUBJECT: **Model GLE (167 platform)**
Model Year 2021-2022

Check the 12V Ground Connection Bolt Torque

Order No. P-RC-2023120010

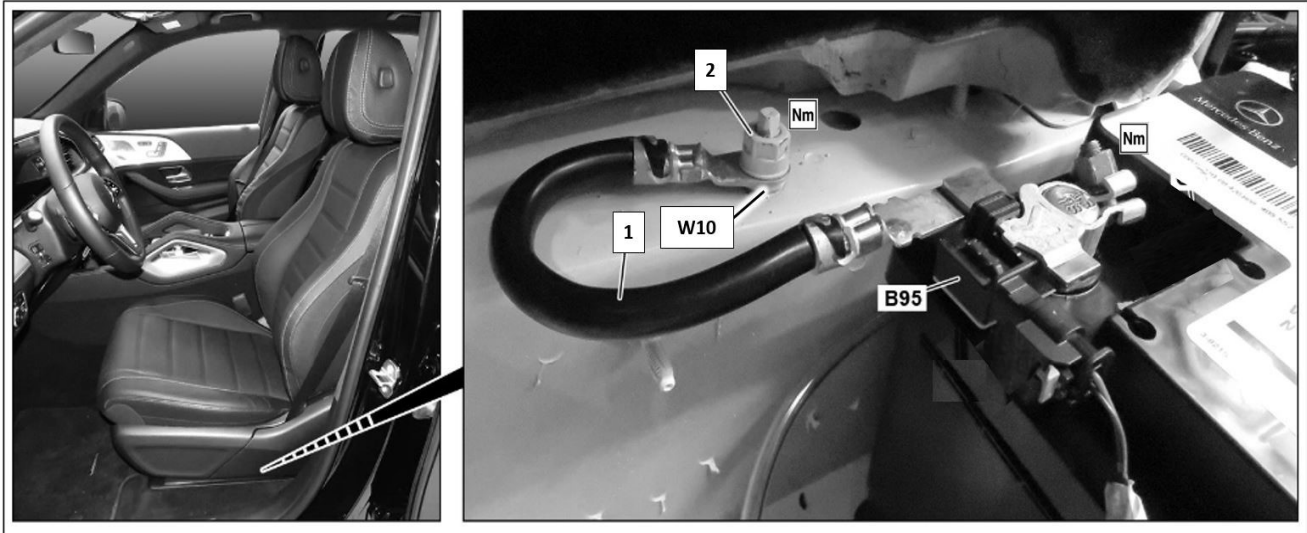
Figure 1

1. Visually check ground point (W10, Figure 1) and ground line (1, Figure 1) under the driver's seat for damage.
 - i** For basic information, see AR54.10-P-0002ME.

- a. If **no damage** is present:
Carry out Check/test Procedure 2.
- b. If **there is damage** to the ground line (1, Figure 1) or ground point (W10, Figure 1):
Carry out Work Procedure 2.

2. Check nut (2, Figure 1) for correct tightening torque.
 - i** For basic information, see AR54.10-P-0002ME.
 - a. If tightening torque of nut (2, Figure 1) is correct and no damage present:
End measure.
 - b. If tightening torque of nut (2, Figure 1) **is not correct**:
Carry out Check/test Procedure 3.

5. Install existing ground line (1, Figure 1) including battery sensor (B95, Figure 1) with **new** nut (2, Figure 1) and tighten with prescribed tightening torque.
i For basic information, see AR54.10-P-0002ME.

6. **Clean** area around ground point (W10, Figure 1) and threaded pin.
i If necessary, recut threaded pin using a thread cutter.
7. **Replace** ground line (1, Figure 1) including battery sensor (B95, Figure 1) and nut (2, Figure 1).
i For basic information, see AR54.10-P-0002ME.
8. Perform commissioning of battery sensor (B95).
i For basic information, see AD00.00-P-2000-06ME.

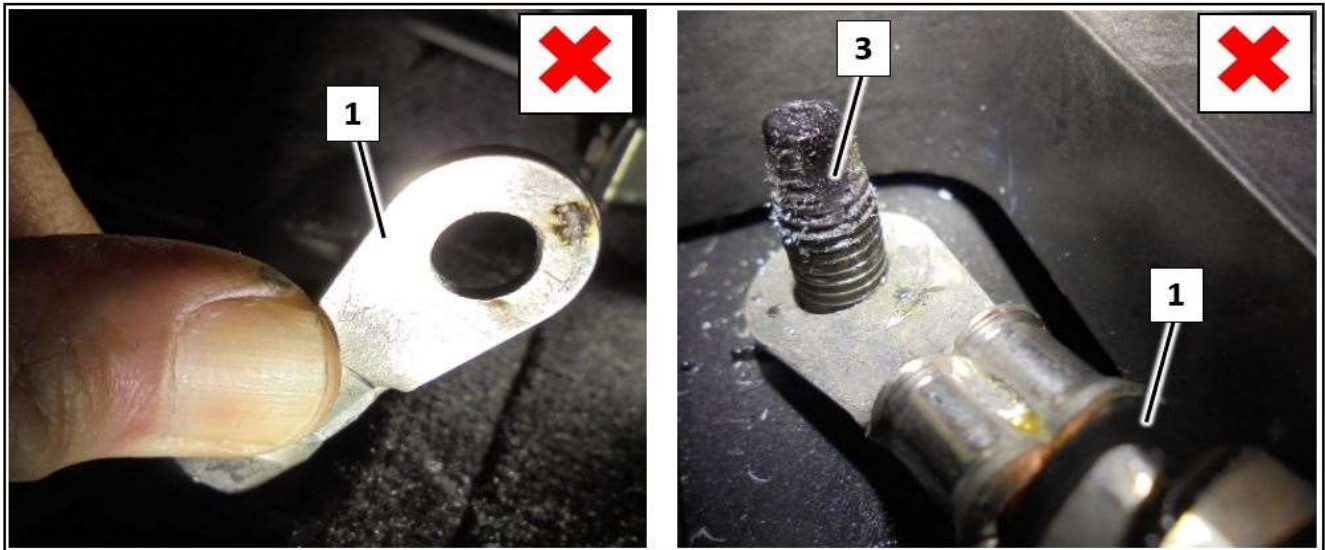
**Figure 2**

3. Remove nut (2, Figure 1) and ground point (W10, Figure 1) from body.
i For basic information, see AR54.10-P-0002ME.
4. Check threaded pin (3, Figure 2) and cable lug or ground line (1, Figure 2) for damage.

- a. If there is **no damage** at threaded pin (3, Figure 2) and cable lug or ground line (1, Figure 2):
Carry out Work Procedure 1.
- b. If **damage** is present at threaded pin (3, Figure 2) and cable lug or ground line (1, Figure 2):
Carry out Work Procedure 2.
