Safety Recall

N232421970 Seatbelt Pretensioner Recall 22V930 (N222383790)

Release Date: December 2023

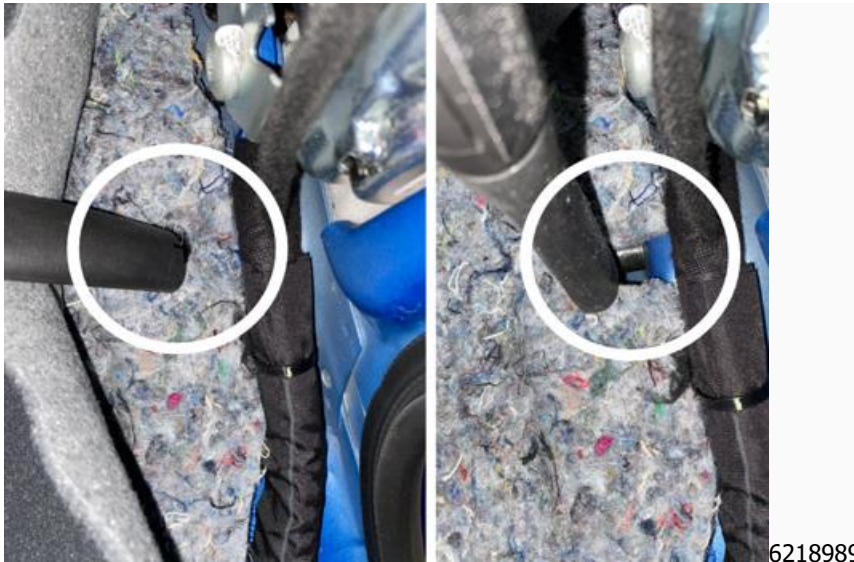
6218989

18. Pull the carpet back around the seat belt pretensioner to expose the insulation on the passenger's side of the vehicle.

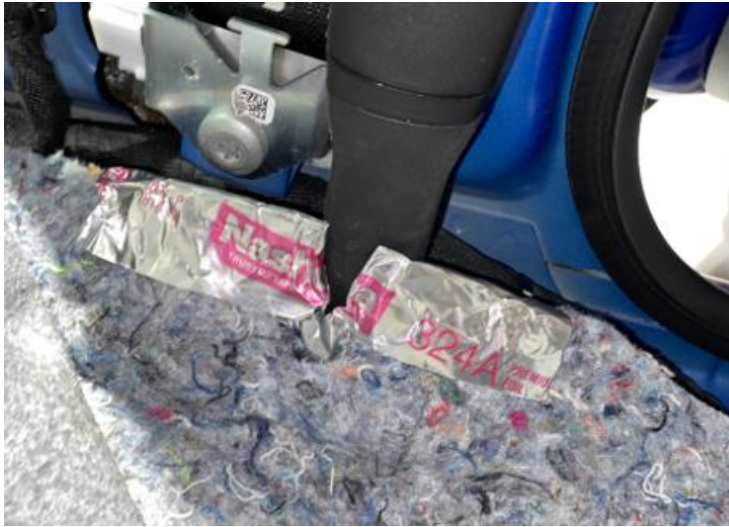
6219024

19. Inspect the carpet to see if foil tape is installed as described in this procedure, see above.

- If the foil tape is installed, proceed to step 26.
- If the foil tape is NOT installed, complete the following and proceed to step 20.

20. Cut insulation to be the same dimension as the existing hole for the cable (25 mm, 1 inch) as shown above.
