Safety Recall

N232421971 Seatbelt Pretensioner Recall 22V930 (N222383791) Not Completed

Release Date: December 2023

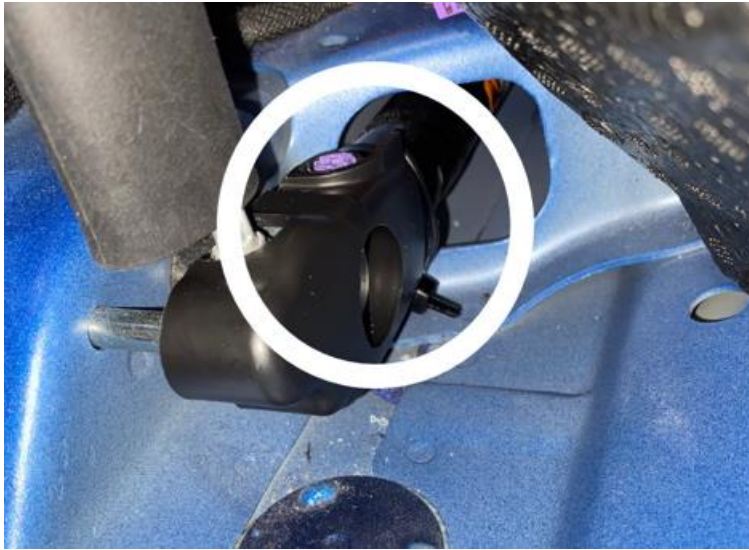
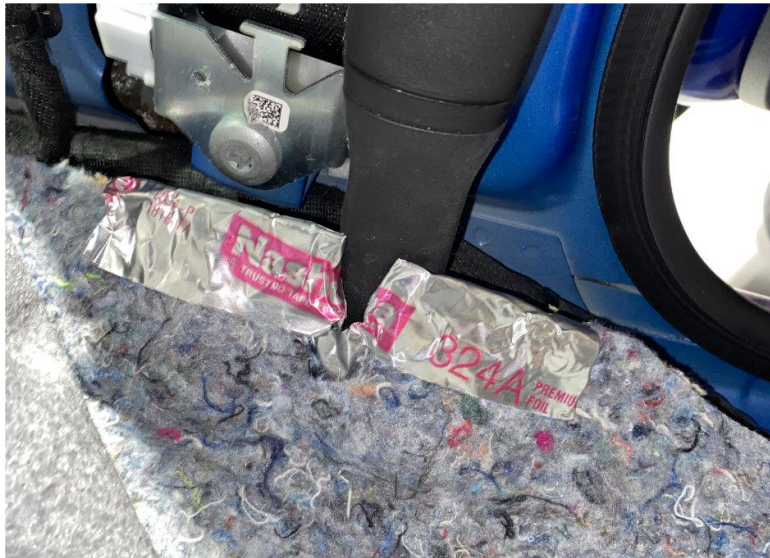
19. Inspect the carpet to see if foil tape AND the cover is installed as described in this procedure, see above.

- If the foil tape AND cover are installed, proceed to step 26.
- If the foil tape AND/OR cover is NOT installed, complete the following and proceed to step 20.

Note: If the foil tape and/or cover is NOT installed, submit a Field Product Report (FPR) in addition to completing this field action.

For US and CA Dealers - Submit a Field Product Report (FPR) and Pictures using the Field Product Reporter App found in the Certified Service Mobile Tools (reference TSB 02-00-89-002). Be sure to include the following information:
