RECALL 23V850 / 2023-667 REMEDY INSTRUCTIONS

Make(s): CONCORD
Model(s): CNC321DSF
Model Year(s): 2023 - 2024

Concern:
The air suspension air line and wiring is installed too close to the vehicle exhaust on the inside of the driver side frame rail.

2023 - 2024 CONCORD AIR LINE RELOCATION

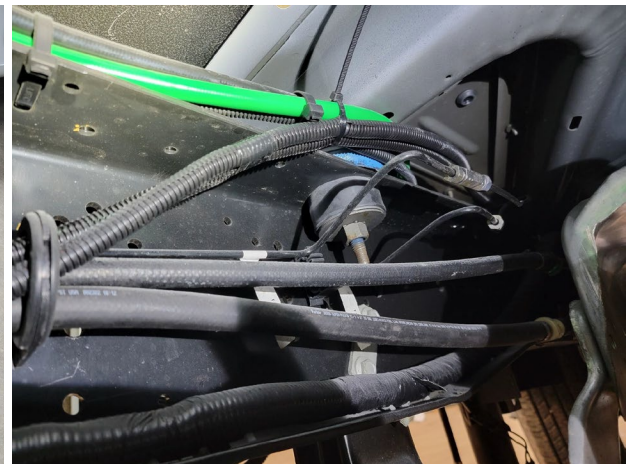
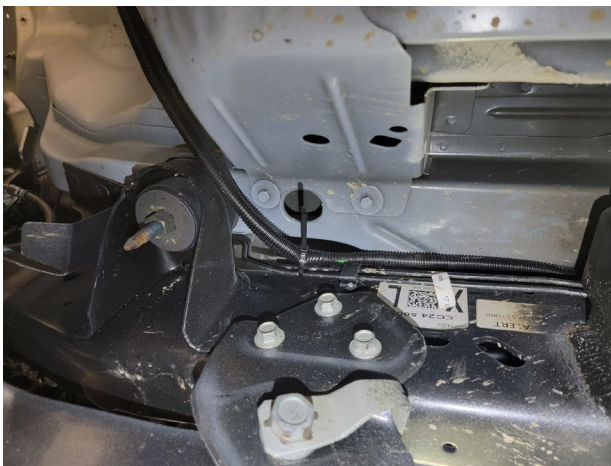
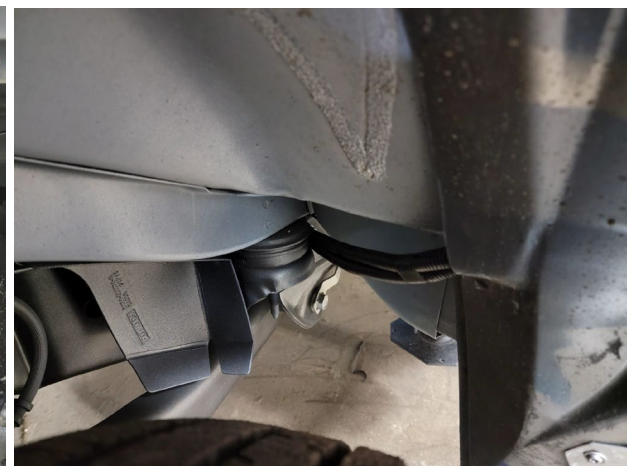
The air suspension air line and wiring is installed too close to the exhaust on the inside of the driver side frame rail. This can soften the air line and cause it to leak under pressure. This procedure shows the steps needed to re-route this section to prevent an issue.

- Cut electrical tape back, add wire loom to the airline and re-tape air line and wiring back together. (Figure 6)
- Re-route the air line to the outside of the frame rail away from exhaust. (Figure 7,8,9)
