Subject:	Publication No.: N837	
Structural Adhesive Concern	Model: Range Rover (LK)	
	Model Year: 2024	
	Model: Range Rover Sport (L1)	
	Model Year: 2024	
	Date of Issue: 08 January 2024

SERVICE INSTRUCTION - N837

Certain 2024 Model Year Range and Range Rover Sport Misapplied Structural Adhesive

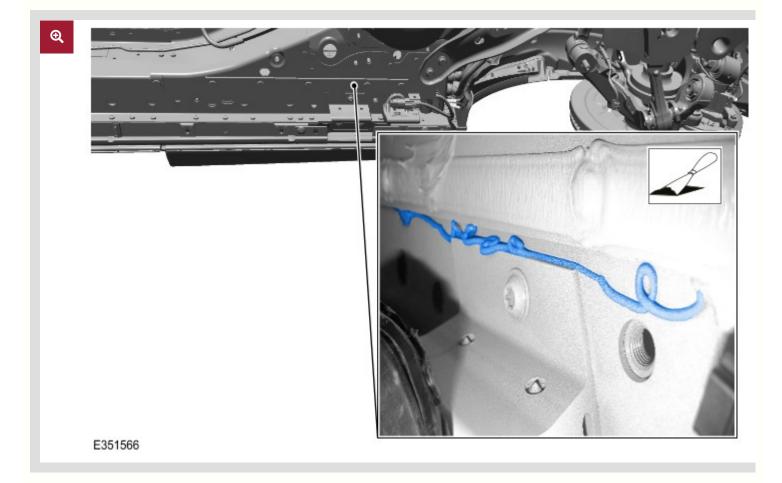
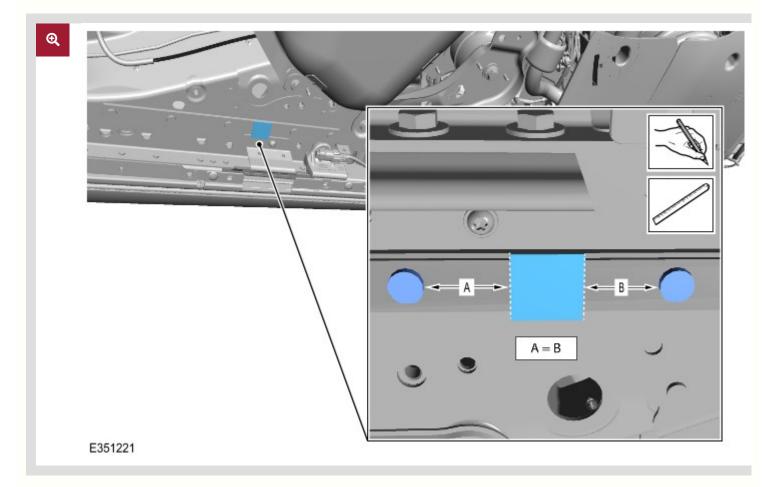
Using a suitable tool, remove the incorrectly applied sealant.

Make sure the sealant is fully removed.
