# Technical Service Bulletin

GROUP <b>RECALL</b>	NUMBER <b>23-01-095H</b>
DATE <b>DECEMBER 2023</b>	MODEL(S) <b>KONA (SX2)</b>

**SUBJECT:** ENGINE ROOM JUNCTION BLOCK WIRING – CRUSH SHIELD INSTALLATION (RECALL 252)

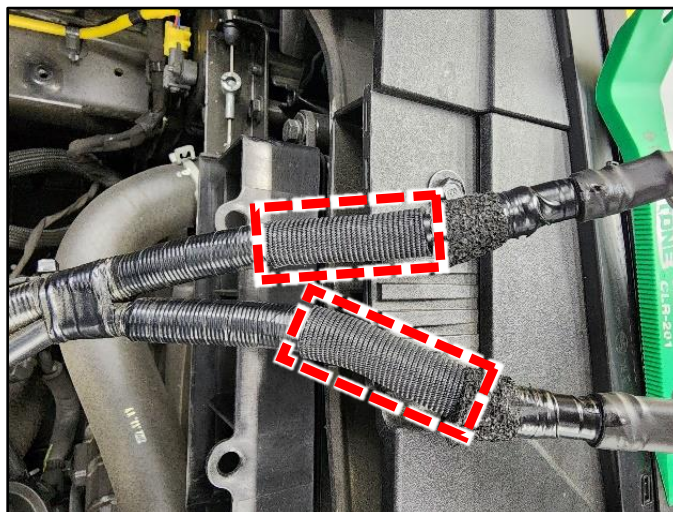
**Description:** Certain 2024MY Kona (SX2) vehicles equipped with a 1.6T engine contain a 12-volt positive battery cable that could become damaged during a frontal crash by contacting the vehicle’s engine control module bracket. An electrical short from the damaged 12-volt positive battery cable to bracket contact increases the risk of a post-crash, engine compartment fire. Follow the procedure in this TSB to install crush shields on the 12-volt battery wiring in the engine room junction block to reduce the risk of an electrical short or fire.
