Safety Recall – 2024 CX-90 - Steering Gear Safety Recall

A. VEHICLE INSPECTION PROCEDURE – AND PREPERATION FOR REPAIR

B. REPAIR PROCEDURE

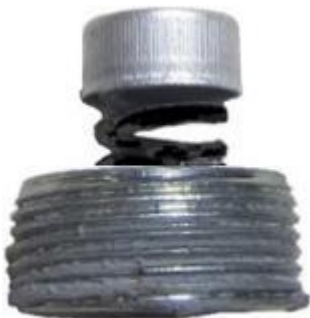
Good	No Good

--	The spring seat is placed upside down.	The spring and the spring seat are reversed.
