## **NHTSA Recall 24V-037**

Brinkley RV REC-2401

### MODEL Z RECALL LIPPERT AXLE SPINDLE WELD

# AXLE SPINDLE WELD INSPECTION

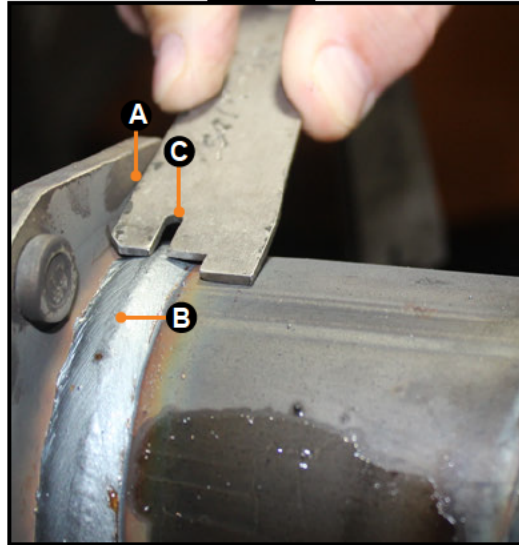
Fig. 2

1. Visually inspect the spindle weld location around the full circumference of the weld at 12, 3, 6 and 9 o'clock positions using a weld gauge (Fig. 2).

**NOTE:** Ensure the back edge of the weld gauge is flush against the back of the spindle flange (Fig. 2A).

2. Determine if the crown of the weld (Fig. 2B) is within the weld gauge specifications (Fig. 2C).
3. If the location is outside of the gauge parameters (at any point around the full circumference of the weld), the axle will need replaced.

### For axle replacement:

1. For axle replacement instructions, see Spring Axle Installation and Owner's Manual:  
<https://lci-support-doc.s3.amazonaws.com/manuals/axles-and-suspension/ccd-0007318.pdf>
2. Brakes **MUST** be burnished after axles are replaced. See Proper Way to Burnish Your Trailer Brakes video:  
<https://youtu.be/d9HDloz9fq8?si=xJDiwkgDrF6JMxm1>
