SAFETY RECALL CAMPAIGN 3A01 **2024 Hayabusa ABS Hydraulic Unit Flare Nut Tightening**

- Affected Models:** Certain 2024 Hayabusa (GSX1300RR/RRZM4) motorcycles
- Affected Departments:** Management, Service, Warranty, Sales, Parts, Accessories
- Attachments:** Sales Bulletin 24-012 (Hayabusa Stop Sales) & Customer Notification Letter
- Reference:** Hayabusa GSX1300R Service Manual (99500-10L00-03E)

This notice is sent to you in accordance with the requirements of the National Traffic and Motor Vehicle Safety Act. Suzuki Motor Corporation has decided that a defect which relates to motor vehicle safety exists in certain 2024 model-year Hayabusa (GSX1300RRM4) and Hayabusa 25th Anniversary Edition (GSX1300RRZM4) motorcycles.

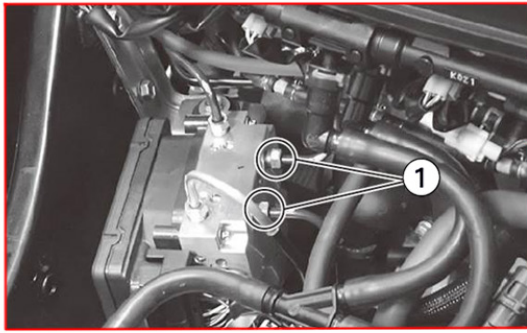
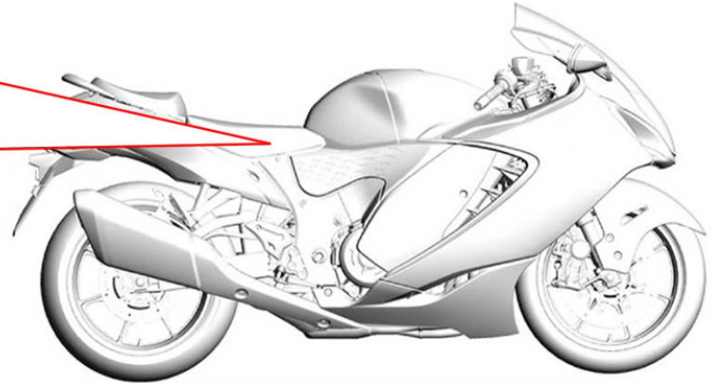
The brake fluid pipe flare nut installation torque for the brake fluid supply lines attached at the ABS unit that supply the front and rear brake calipers may have been tightened to less than the correct specification. If the motorcycle continues to be used in this condition, in the worst case, loosening of a flare nut may cause brake fluid leakage and increase braking distance, increasing the risk of a crash.

- Follow the repair procedure listed on the following pages to tighten the brake fluid pipe flare nuts ① on the ABS hydraulic unit to the proper torque.

- If brake fluid leakage is found, check the brake fluid level. And if the brake fluid level is below the lower limit line, replenish the brake fluid up to the specified amount. Clean any area contaminated by leaked or spilled brake fluid.

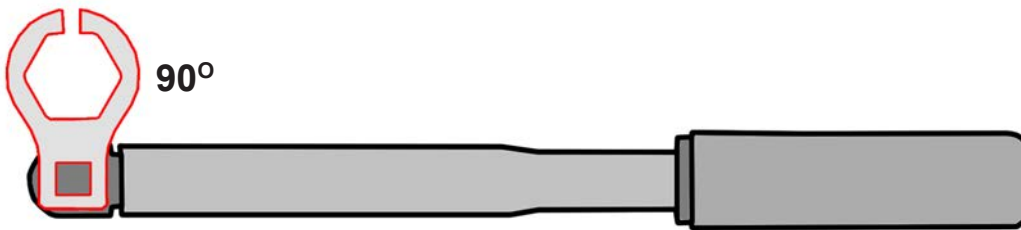
The flare nut socket wrench (example ①) is not the same as a crow's foot wrench. The crow's foot wrench has a driving head like an open wrench. A flare nut socket wrench has a closed-hex driving head with a small groove that allows it to pass over the pipe that is secured by a flare nut. This helps ensure that no slippage occurs between the tool and nut so the proper torque is applied to the flare nut during tightening.

If you install the flare nut socket wrench onto the drive head of the torque wrench at exactly 90-degrees (see image above) the torque value of the torque wrench will be accurate (in this case, 12.0 lb-ft (16 N·m, 1.6 kgf-m)).

If the flare nut socket wrench is not set exactly at 90-degrees on the torque wrench drive, a difference occurs between the set value of the torque wrench and the actual torque being applied. This occurs because of the distance (length) between the drive head of the torque wrench and wrench head of the flare nut wrench. Because this length affects the force of the torque applied to the flare nut you will need to calculate the torque setting for the torque wrench based upon the effective length of the flare nut socket and the torque wrench to be used.
