A. INTERIM VEHICLE INSPECTION PROCEDURE UNTIL PARTS ARE AVAILABLE

2009 Mazda6 (HP) and 2010 Mazda6 (HZ) vehicles, which were originally sold in, or currently or previously registered in Salt Belt States listed below.

B. CROSS MEMBER INSPECTION PROCEDURE 2009-2010 MAZDA6

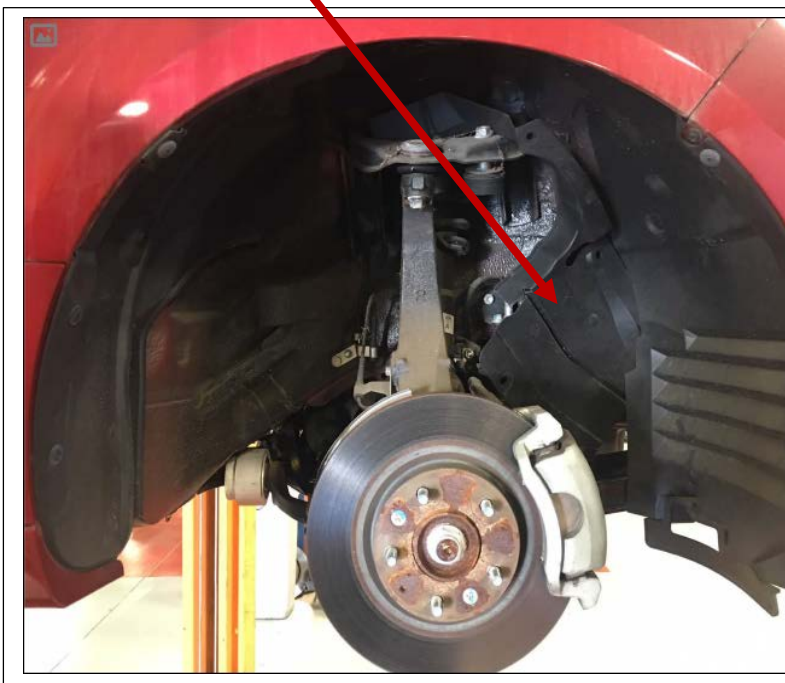
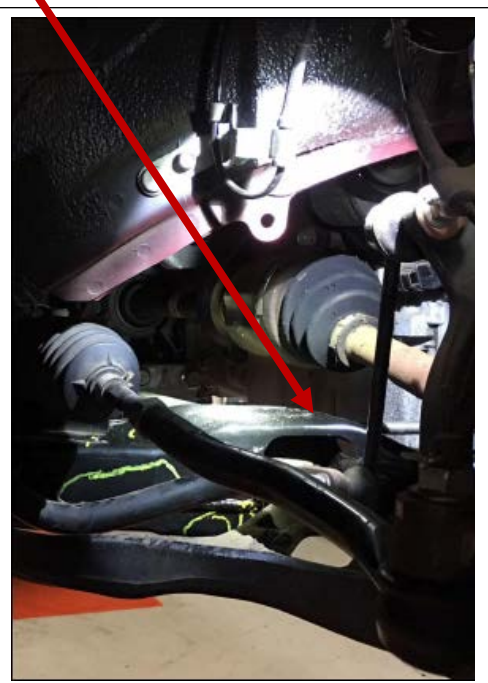
1. Remove the right front tire.
2. Remove **visible** clips of side cover of right front tire house.
Then bend the side cover so that Inspection point Zone No.1: Upper surface of the cross member can be seen

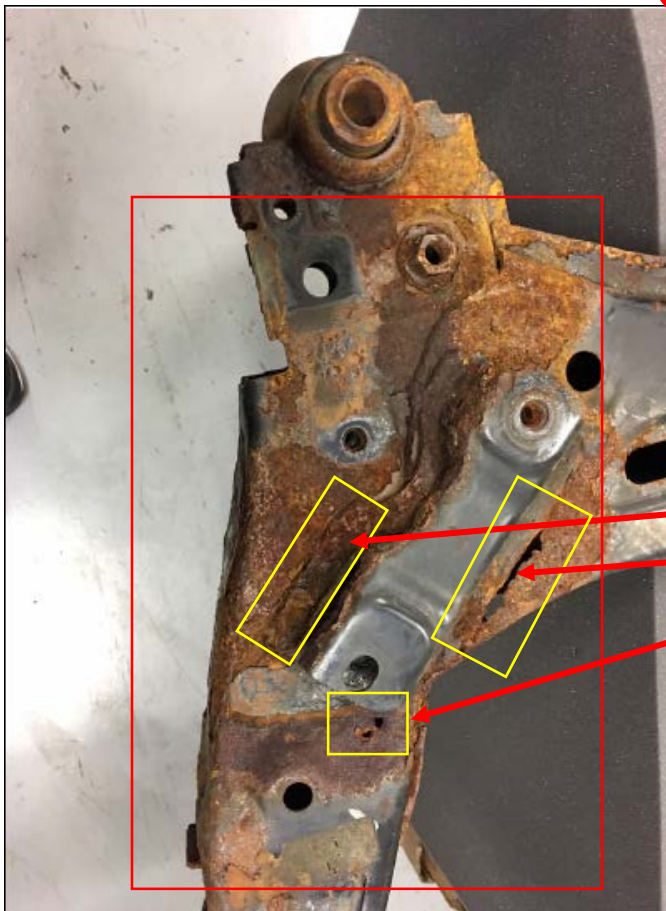
Top View: Used Cross member

Look for holes or cracks along the top surface in these areas. If a hole or crack is present, the cross member needs to be replaced. This cross member fails inspection as there is perforation

Top side Zone 1 Failure due to perforation. Replace

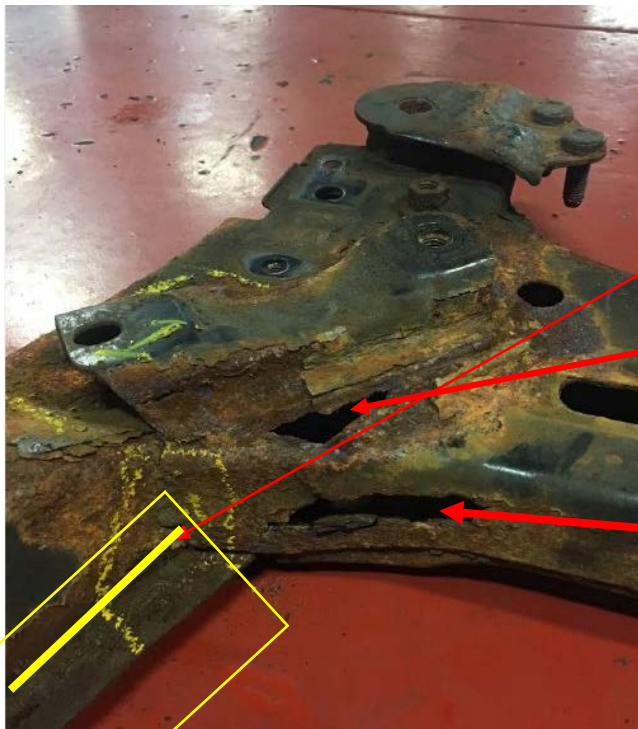
Inside Top View: Damaged Cross member

Look for perforation or crack along the flange in this area. If a crack or perforation is present, replace the cross member.

Corrosion or a hole in this area does not compromise the structural integrity of the cross member, however this cross member will fail a state safety inspection due to perforation so we need to replace the cross member

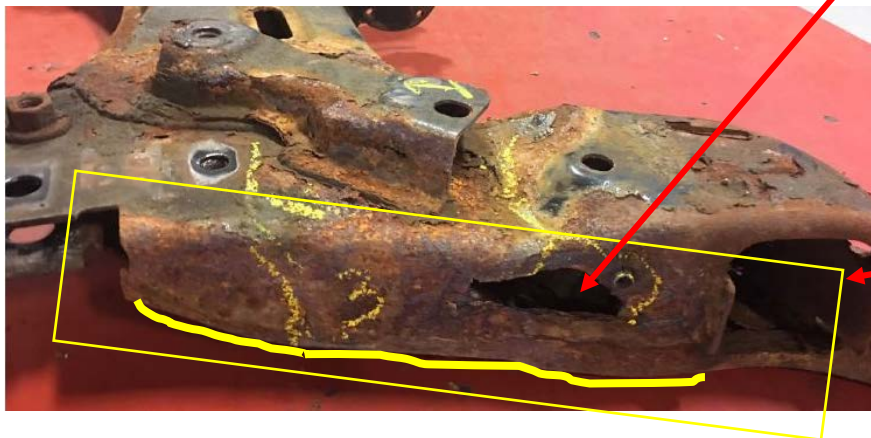
Top Side View: Damaged Cross member

Zone 3 inspection Area:
Look for perforation especially along the bottom corner ridge line (this area). If perforation or a crack is present the cross member needs to be replaced.

This cross member passes inspection even with the perforation as the bracket supports and covers the hole. If perforation is visible beyond what the bracket covers, the cross member must be replaced as it will fail a state safety inspection for perforation.

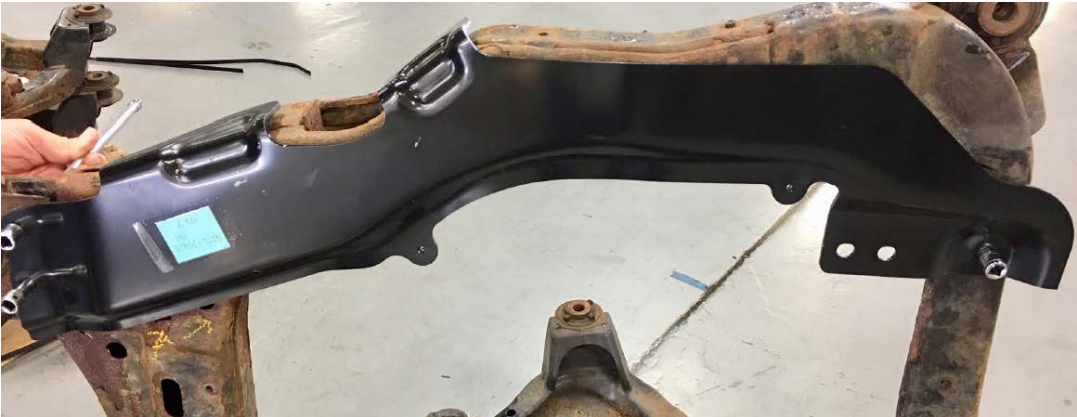
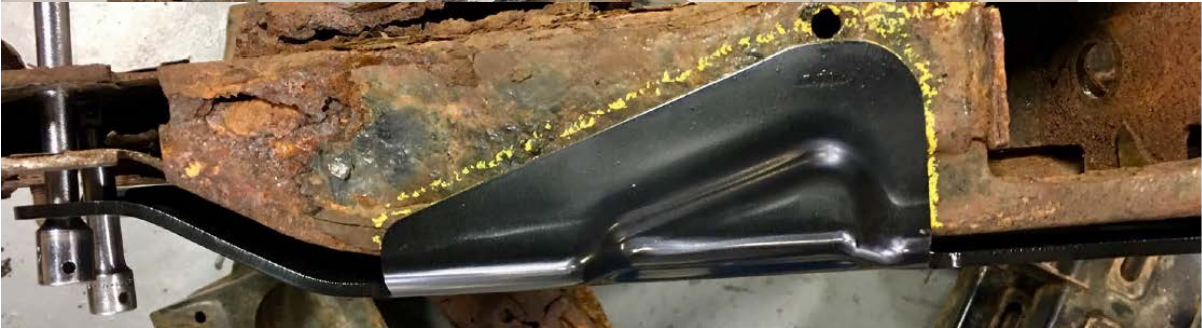
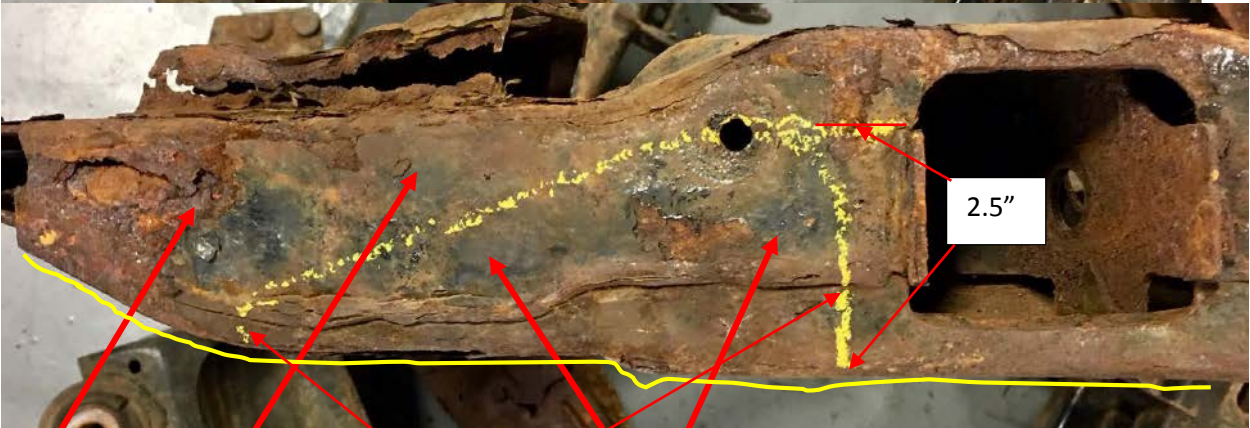
Photos of the bracket installation

Perforation in this area is not covered by the bracket and will fail State Inspection.

6.5 " Perforation in this area is covered by the bracket and is ok to use the cross member.
