ATB 52056 (1407)

Safety Recall: Wrong A-Pillar Trim Is Installed

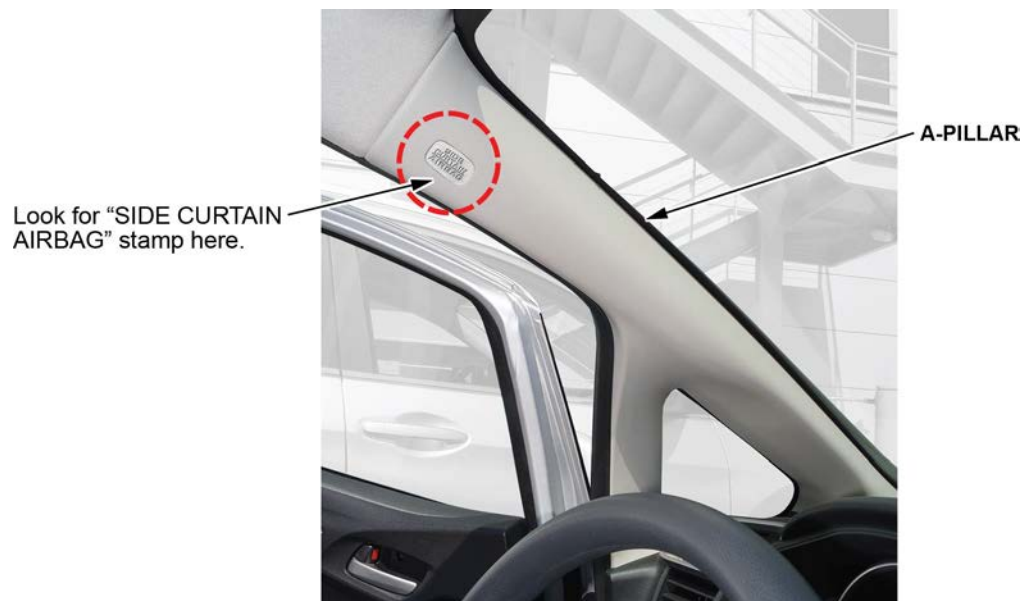
- Look for a "SIDE CURTAIN AIRBAG" stamp on the left and right A-pillar trim.
 - If the A-pillar trim has "SIDE CURTAIN AIRBAG" stamped on it, the vehicle is OK. No further action is needed.
 - If the A-pillar trim does not have "SIDE CURTAIN AIRBAG" stamped on it, go to REPAIR PROCEDURE.
