December 20, 2016

05483 Version 2

Safety Recall: Rear Wire Harness/Rear Subframe Harness

Year	Model	Trim	VIN Range
2017	Ridgeline	AWD	Check the iN VIN status for eligibility

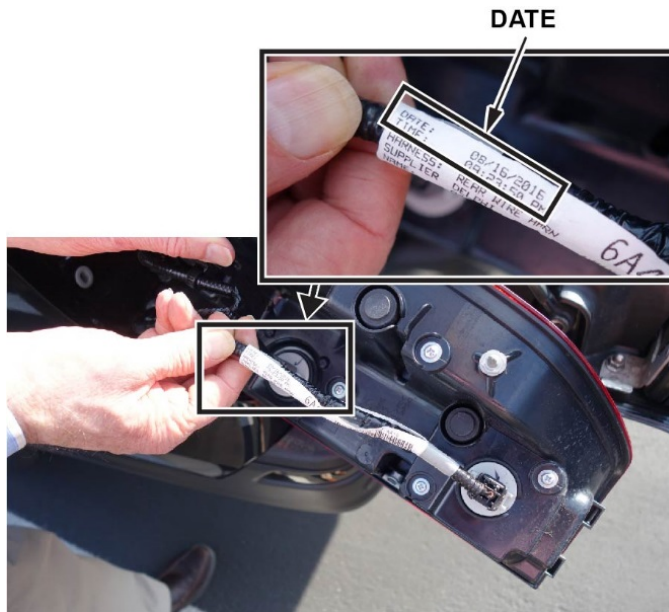
1. Remove the driver's side taillight. Refer to the service information.
2. Check the date on the label on the rear wire harness.
 - If the harness date is **before** August 9, 2016 (08/09/2016), go to step 3.
 - If the harness date is **on or after** August 9, 2016 (08/09/2016), go to REPAIR PROCEDURE C.

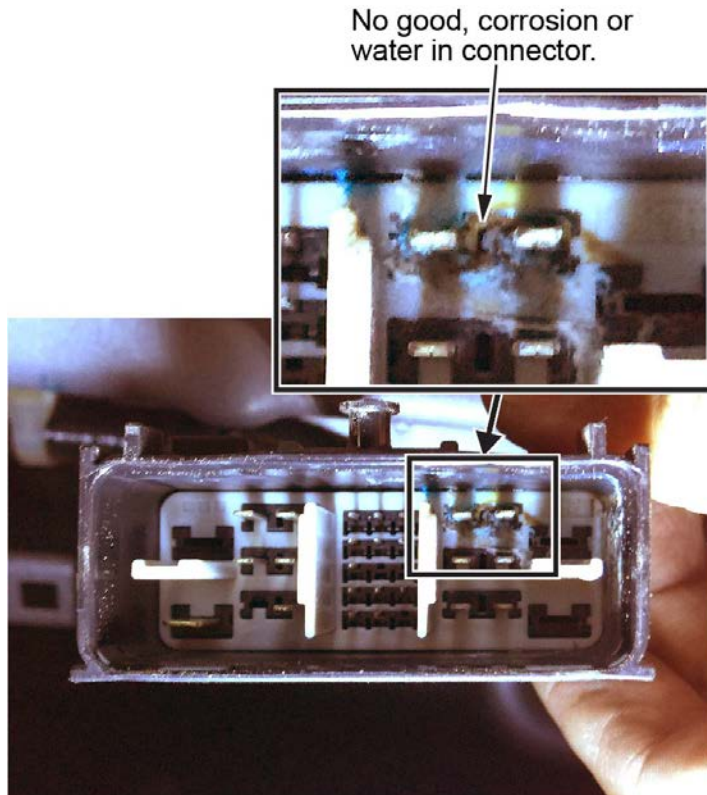
3. Disconnect connector C601 (rear wire harness/rear subframe harness), and inspect the interior of the connector and terminals on both the male and the female side for signs of water intrusion and/or corrosion.

Is there water and/or corrosion inside the connector?

Yes – Go to REPAIR PROCEDURE B.

No – Go to REPAIR PROCEDURE A.

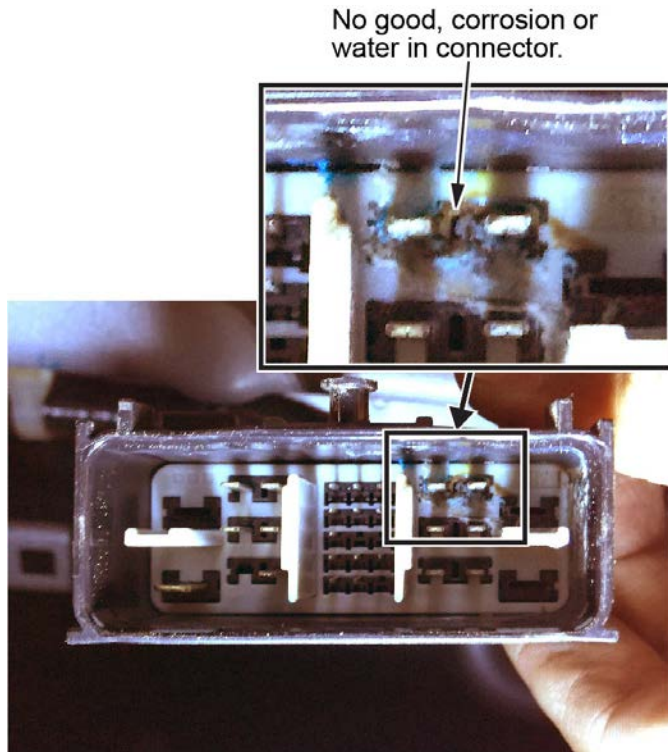
1. Disconnect connector C601 (rear wire harness/rear subframe harness), and inspect the interior of the connector and terminals on both the male and the female side for signs of water intrusion and/or corrosion.

Is there water and/or corrosion inside the connector?

Yes – Go to REPAIR PROCEDURE B.

No – Go to step 2.
