May 5, 2015

01261-01904 Version 3

## Safety Recall: Headlight LED Lens Film Delaminates

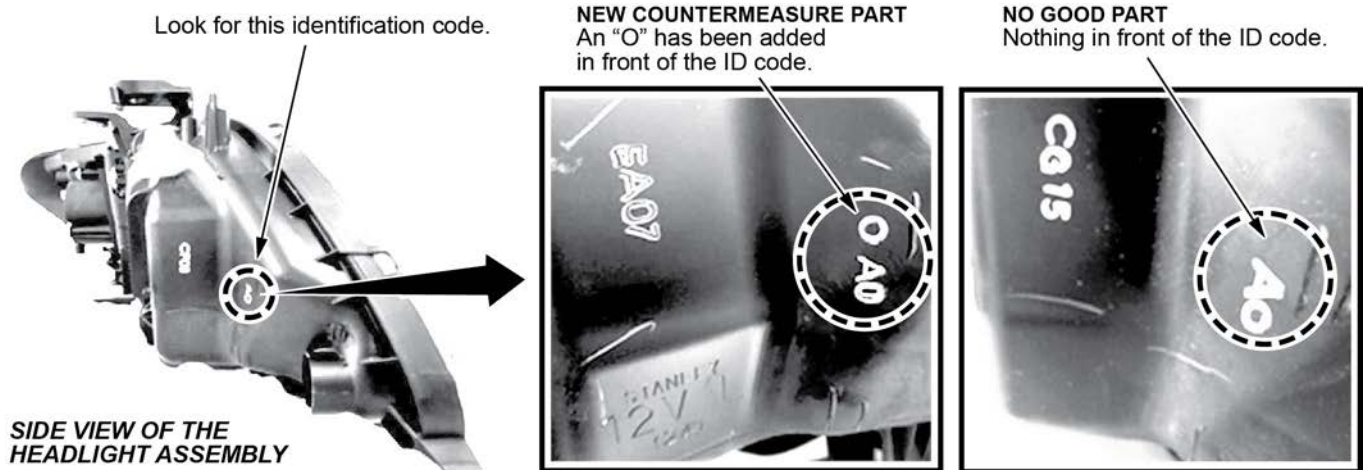
NOTE: To differentiate the original head light assemblies from the improved ones, the improved assemblies have the letter "O" in front of the ID code.

5. Install the new headlights onto the corner upper beam and tighten the bolts to **9.4 N·m (6.9 lb-ft)**.
