H039NAS1

# TECHNICAL BULLETIN

SAFETY RECALL: Incorrect Installation of High Pressure (HP) Fuel Pump

MODEL:	MODEL YEAR:	VIN:	ASSEMBLY PLANT:	APPLICABILITY:
F-PACE (X761)	2017	888024	Solihull	V6 S/C 3.0L Petrol

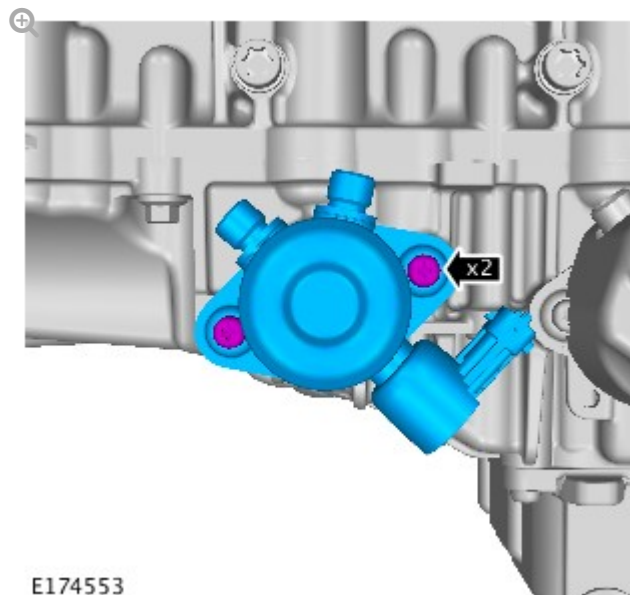
Remove the HP fuel pump 2.

**NOTES:**

- Loosen the fixings a turn each at a time.
- Discard the HP fuel pump bolts.
