# TECHNICAL INSTRUCTIONS

## SAFETY RECALL J0X

### SRS SENSOR SOFTWARE UPDATE

#### CERTAIN:

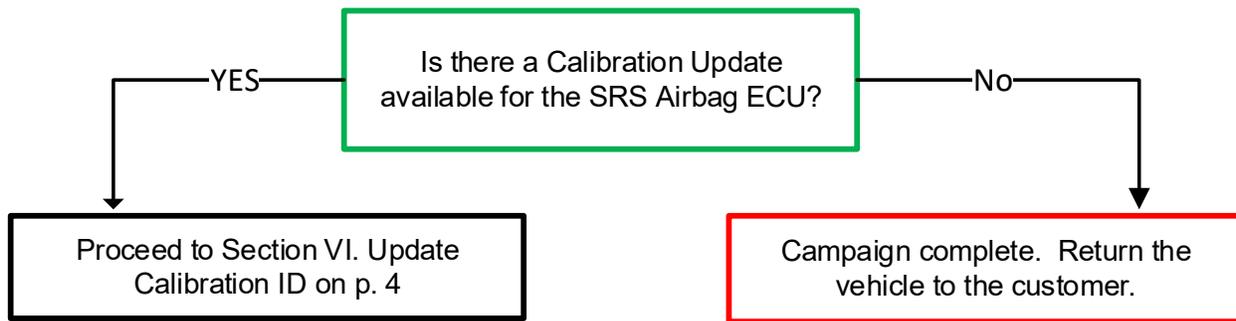
### 2. DETERMINE CALIBRATION UPDATE STATUS

- a. Locate the Update column for the **SRS Airbag** ECU in the Stored Data tab.
- b. Determine the status of an available update; indicated by a YES or NO.

System	Calibration	Update
Engine and ECT	30CM5101	No
Cruise Control	50CA5001	No
Four Wheel Drive	-	-
Tire Pressure Monitor	8953F0C01000	No
ABS/VSC/TRAC	-	-
Occupant Detection	F15260C092	No
<b>SRS Airbag</b>	8917F0C022	<b>Yes</b>
Combination Meter	838000CQ8000	No
Main Body	-	-
D-Door Motor	-	-

Note: If the SRS Airbag ECU already has the updated Calibration ID, the campaign is complete. No further action is required. Submit the warranty claim to complete this vehicle.
