Subject: Recall Campaign ref: L147.R-01.03
Upper Steering Column Shaft Coupling

Automobili
Lamborghini S.p.A.

Procedure: L147.R-01.03

Operation: Instructions for upper steering shaft coupling bolt torque verification

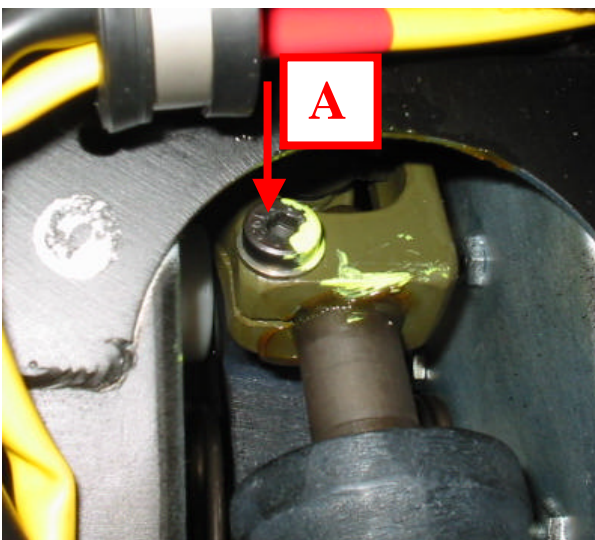
The Upper Steering Column Shaft Coupling could separate from the Steering Column Shaft because the locking bolt was not properly tightened.

- 1.3 Tighten the bolt (A) of the Upper Steering Shaft Coupler show in Fig. 3 between the steering shaft and the steering column using a torque wrench to 27 Nm or 20 ft.lbs. (with a tolerance of $\pm 5\%$).

- 1.4 After tightening the bolt, mark with yellow paint. See Fig. 3.
- 1.5 Install Recall Completion Sticker on lower side of driver's door above VIN Conformity label.
