Subject Headlight Adjuster Accessibility Enhancement.

Group 9.81.00 Date 14/12/2012

Lamborghini Aventador US version LP-700 My 2012 from Vin CLA00091 to CLA00793

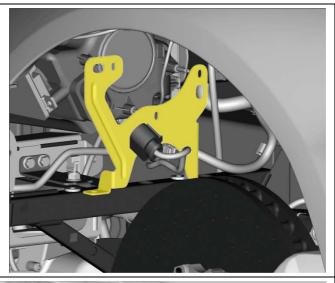
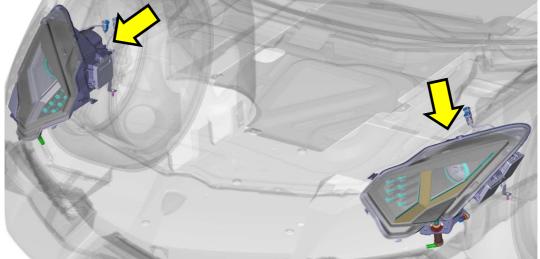
Locate the working area.

5 Disassenble on both side headlight brackects (094103).

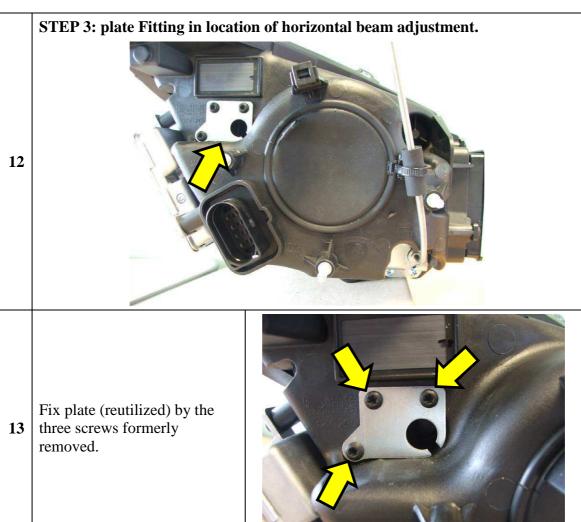
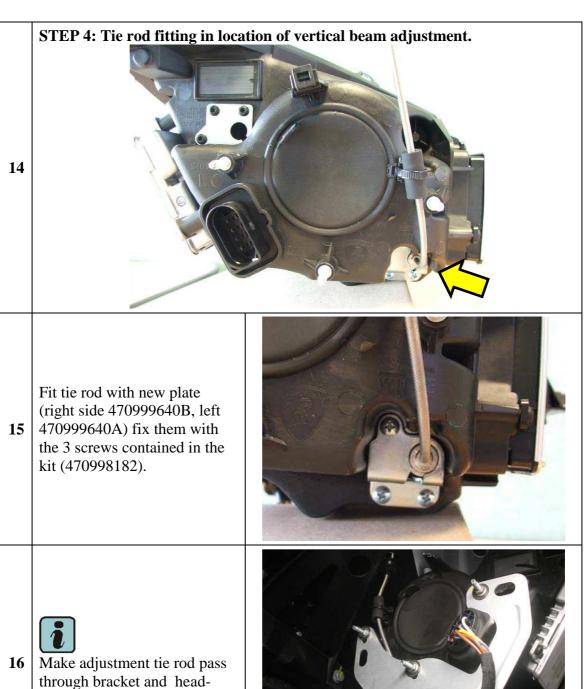
Holed inhibitor has to be fitted in the inner side of headlight lower part (vertical adjustment).

17	Fit cable tie (470998225).		
18	Fasten tie rod with cable tie.		
19	Check that adjuster screws are alligned with adjustment hole in trunk.		
20	Perform operation on both vehic	ele sides.	
21	Fit headlight brackets (094105)		
22	Fit wheel house panels (081005).
