# Special Coverage Adjustment

## 14519 PRNDL Display

Reference Number: N140519  
GWM Number: 2014519

Release Date: September 2016  
Revision: 00

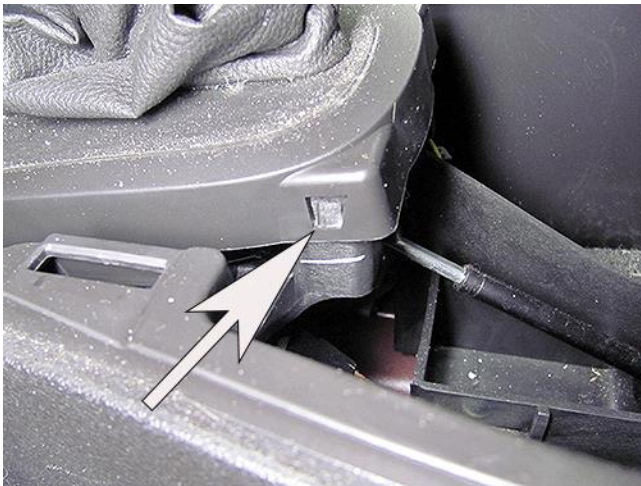
4540049

3. Using a small flat blade screwdriver, release the four trim bezel tabs.

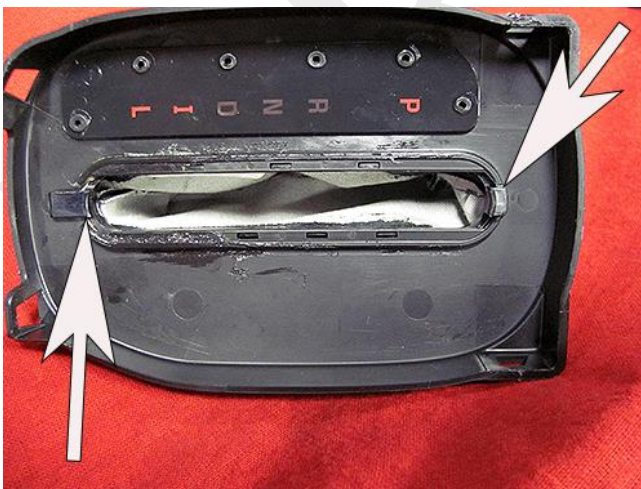
4540051

4. Remove the shifter boot (fabric) from the trim bezel. Discard the old bezel.

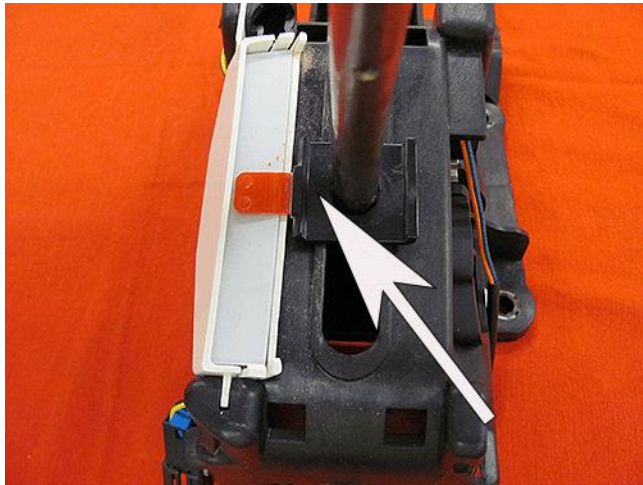
4540053

5. Remove the indicator tab from the shift lever, discard the indicator tab.

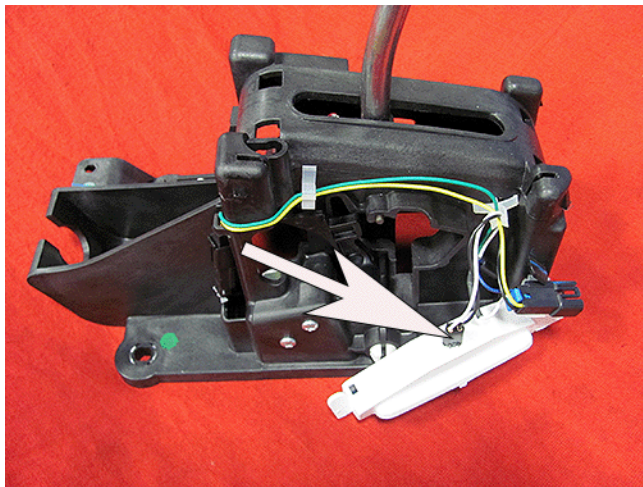
4540056

6. Remove the indicator bulb and socket from the indicator lamp housing. Discard the lamp housing.

**NOTE:** Inspect the indicator lamp (bulb) and replace if necessary.

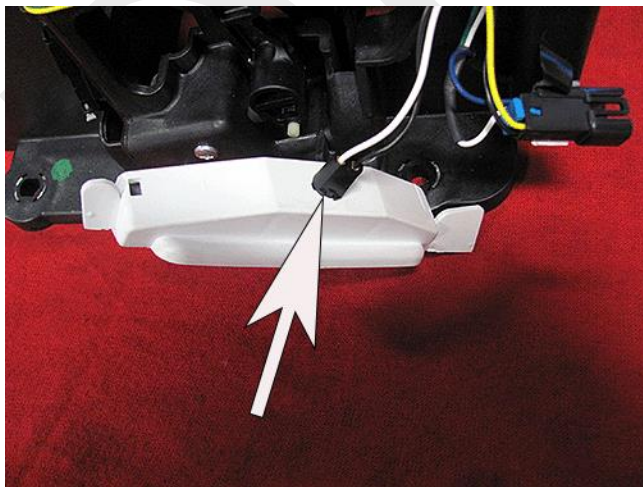
4540060

7. Install the indicator lamp and socket into the new indicator lamp housing.

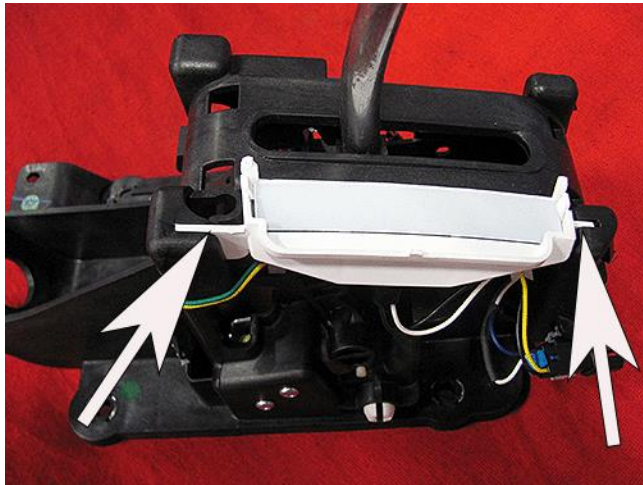
4540062

8. Install the new lamp housing onto the shifter assembly.

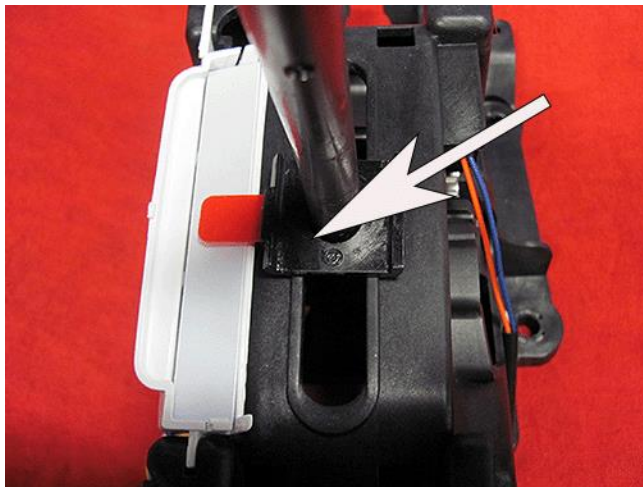
4540068

9. Install the new indicator tab onto the shifter with the guide legs up, insure it is aligned with the lens of the indicator lamp housing.

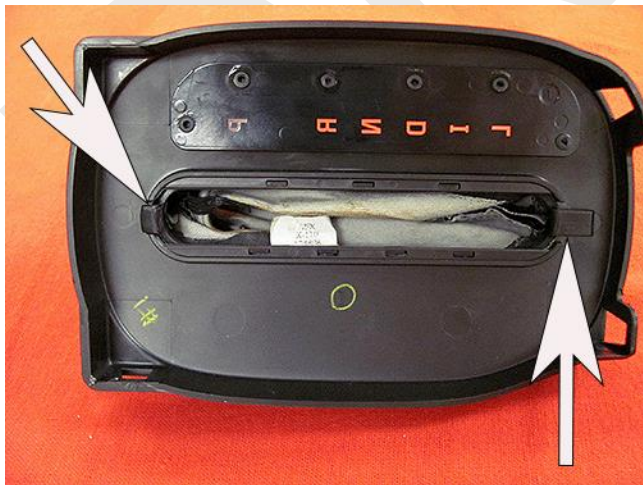
4540071

10. Install the shifter boot onto the new shifter bezel.

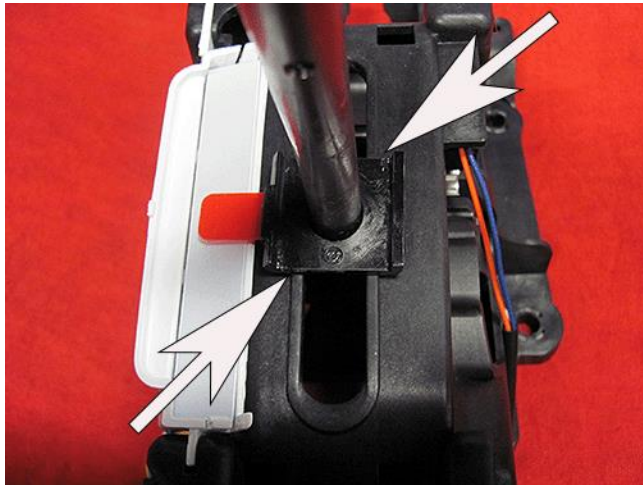
4540073

11. Insure the indicator tab is square to the shifter assembly.
12. Install the shifter bezel onto the shifter assembly. Insure all four tabs are engaged.
13. Temporarily install the transmission control knob and verify the shifter indicator lamp operation and shifter function.
14. Reinstall the console front trim plate. Refer to *Console Front Trim Plate Replacement* in SI.
15. Reinstall the transmission control lever knob. Refer to *Transmission Control Lever Knob Replacement* in SI.
