Michael A. Berardi  
 Director  
 Service Engineering Operations  
 Ford Customer Service Division

September 13, 2017

**SUBJECT:** **NEW VEHICLE DEMONSTRATION / DELIVERY HOLD –  
 Customer Satisfaction Program 17B25**  
 Certain 2013-2017 Model Year Police Interceptor Utility Vehicles  
 Exhaust Odor and Carbon Monoxide Complaints

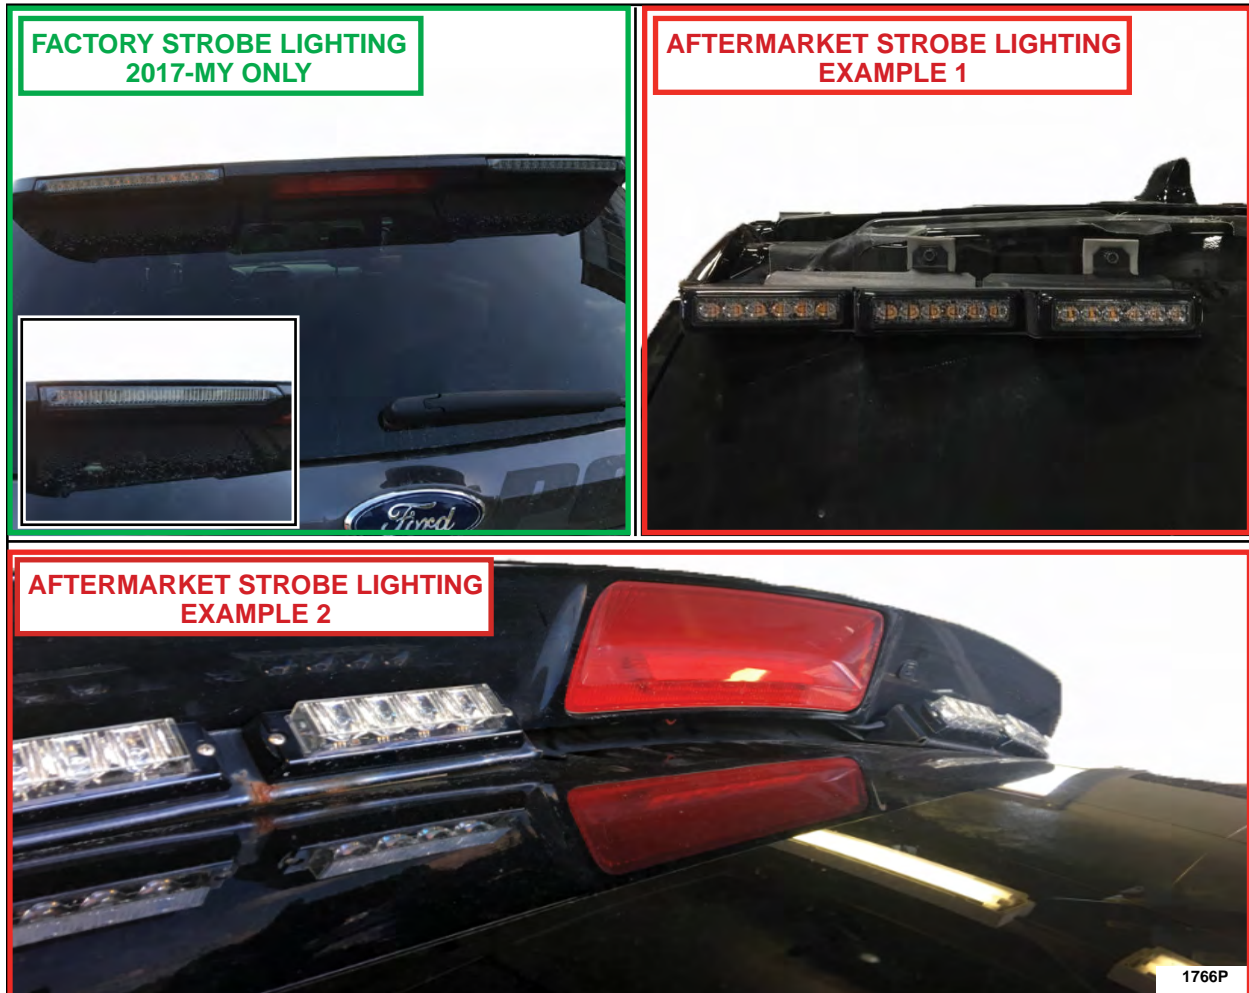
FIGURE 9

- a. Is there aftermarket lighting or other equipment mounted to the spoiler? See Figure 9.
- b. Has the spoiler or vehicle been painted?  
**NOTE:** All Police Interceptor Utility Spoilers are painted black from the factory.
- c. Is the spoiler damaged or have any holes drilled through it?
- d. Is any aftermarket wiring routed to the spoiler?

**NOTE:** Aftermarket lighting and/or equipment mounted to the liftgate spoiler can compromise vehicle sealing and create a leak path for exhaust to enter the vehicle. Ford recommends removal of any aftermarket lighting and/or equipment mounted to the spoiler to prevent a potential path for exhaust to enter the vehicle. Any removed equipment must be returned to the customer.

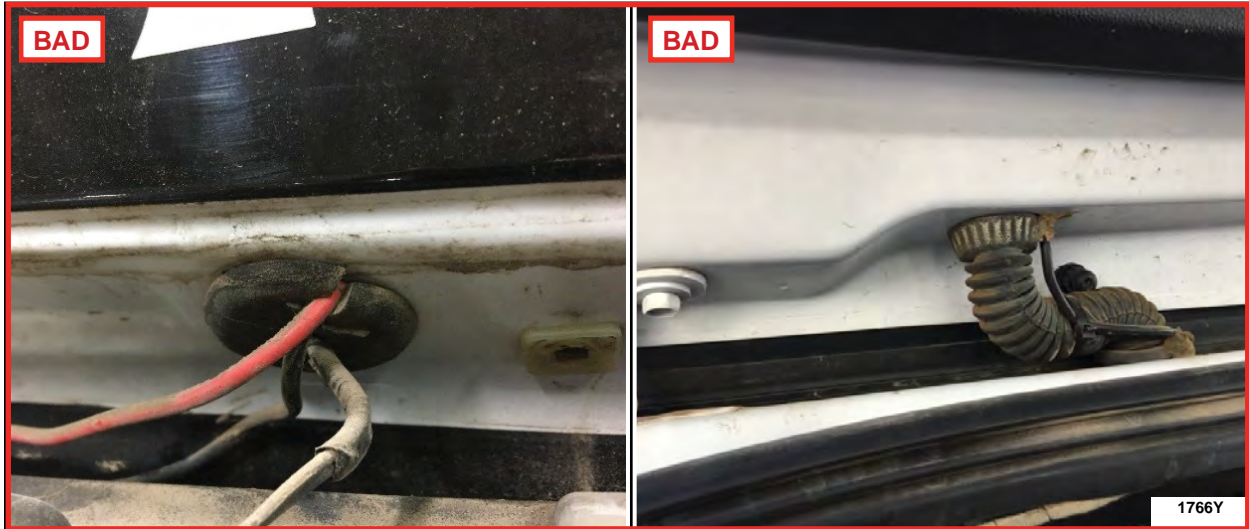
FIGURE 11a

2. Inspect for any aftermarket wiring pass throughs/holes that could affect the sealing ability of the spoiler. See Figures 11a and 11b.

3. Seal any leak paths created by the aftermarket wiring pass throughs/holes in the spoiler area with Motorcraft® TA-2 seam sealer or equivalent.
