**NEW VEHICLE DEMONSTRATION / DELIVERY HOLD –
Customer Satisfaction Program 17B25 – Supplement #3**
Certain 2013-2017 Model Year Police Interceptor Utility Vehicles
Exhaust Odor and Carbon Monoxide Complaints

17B25 – Customer Information Form

Liftgate Spoiler – Aftermarket Lighting and/or Equipment

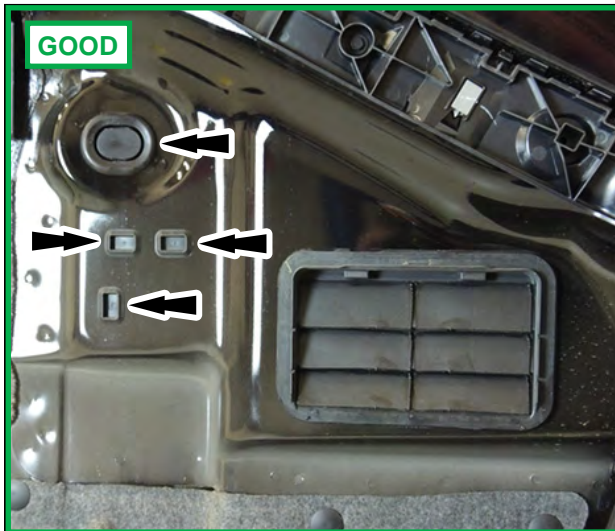
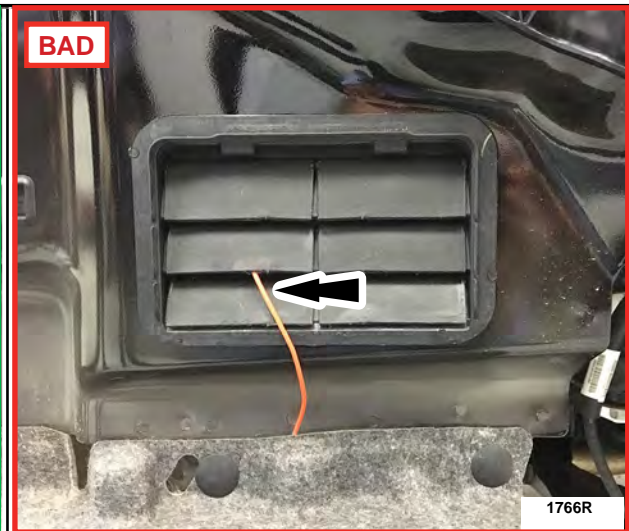
- Using a telescoping mirror and flashlight, inspect the 4 body plugs and air extractor through the wheelhouse openings on each side of the vehicle to determine if aftermarket wiring has been routed through these components. Reroute aftermarket wiring as needed. See Figures 4a and 4b.
 - Replace body plugs or air extractors if any damage is present. Rear bumper cover removal is required to replace the air extractor. Please follow the WSM procedures in Section 501-19.

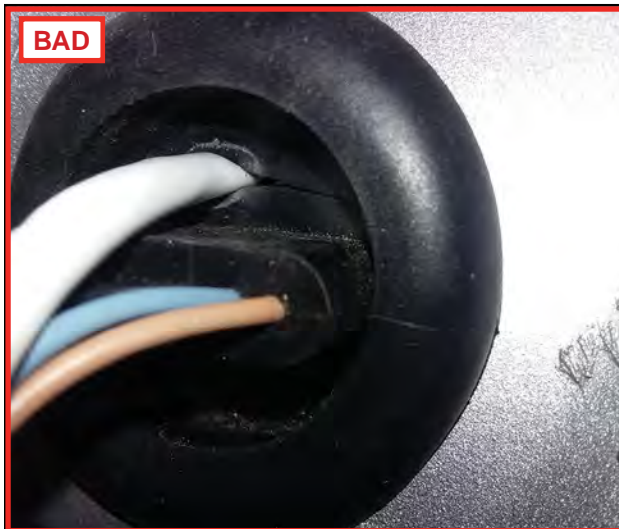
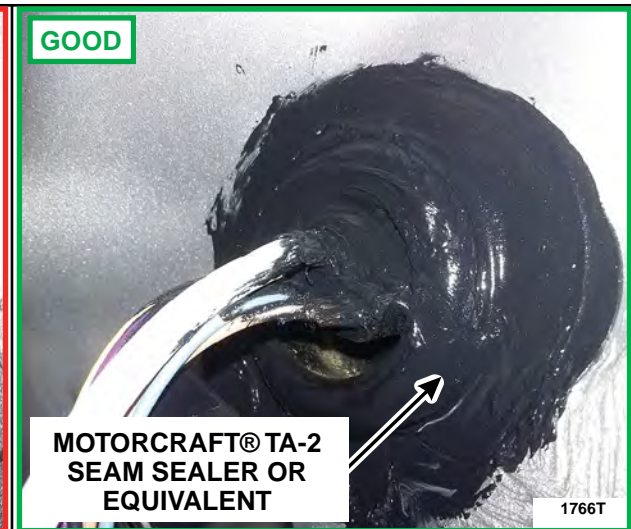
6. Remove the LH and RH rear tail lamp assemblies. Please follow the WSM procedures in Section 417-01.
7. Inspect the sheet metal, wiring harness grommets and factory equipped pass throughs for damage or holes created when installing aftermarket wiring and equipment. See Figure 6a. Seal all holes in the sheet metal and wiring harness grommets with Motorcraft® TA-2 seam sealer or equivalent. See Figure 6b.

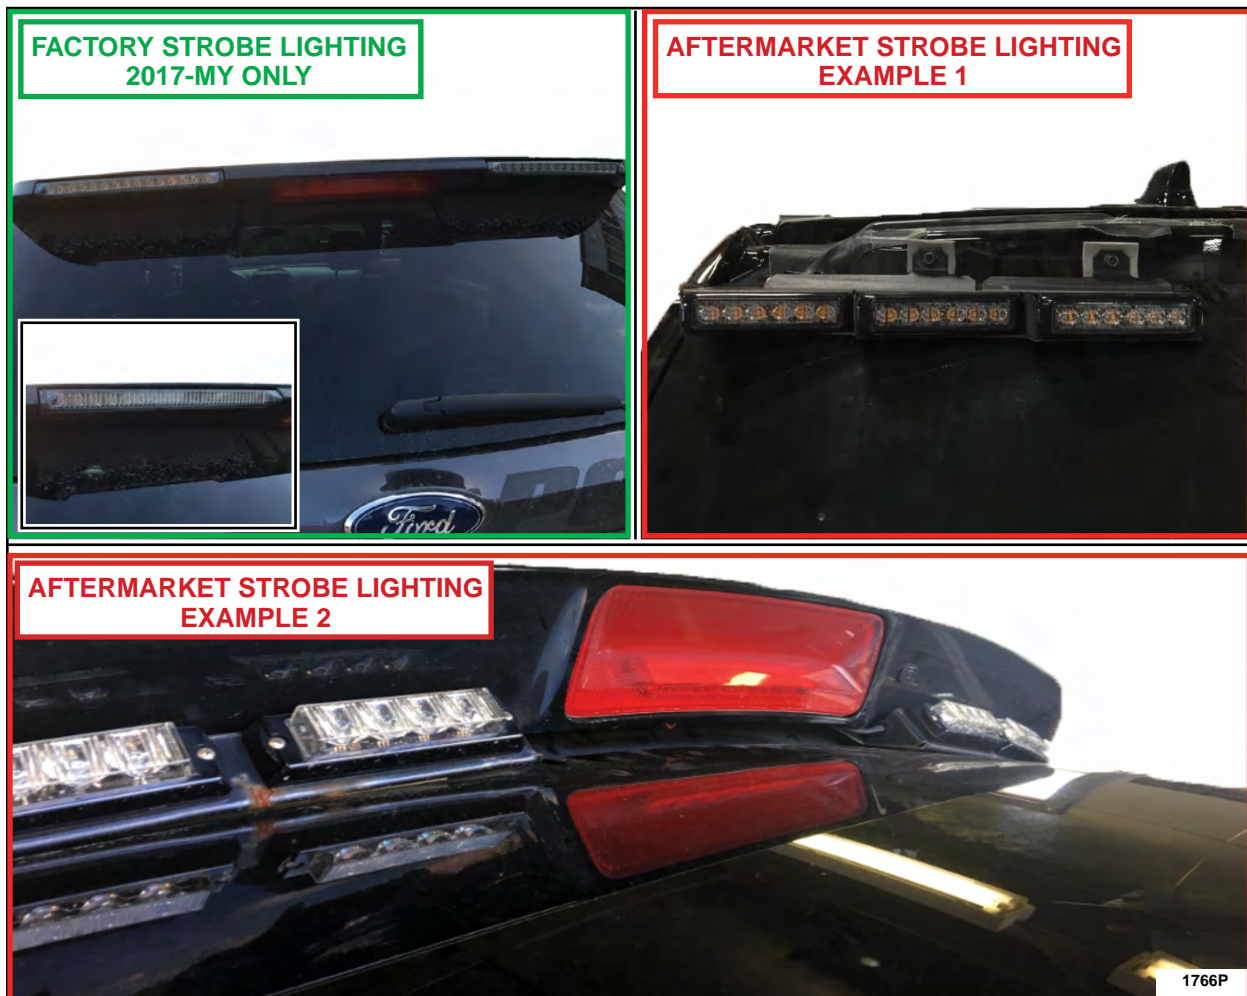
FIGURE 9

- a. Is there aftermarket lighting or other equipment mounted to the spoiler? See Figure 9.
- b. Has the spoiler or vehicle been painted?
NOTE: All Police Interceptor Utility Spoilers are painted black from the factory.
- c. Is the spoiler damaged or have any holes drilled through it?
- d. Is any aftermarket wiring routed to the spoiler?

NOTE: Aftermarket lighting and/or equipment mounted to the liftgate spoiler can compromise vehicle sealing and create a leak path for exhaust to enter the vehicle. Ford recommends removal of any aftermarket lighting and/or equipment mounted to the spoiler to prevent a potential path for exhaust to enter the vehicle. Any removed equipment must be returned to the customer.

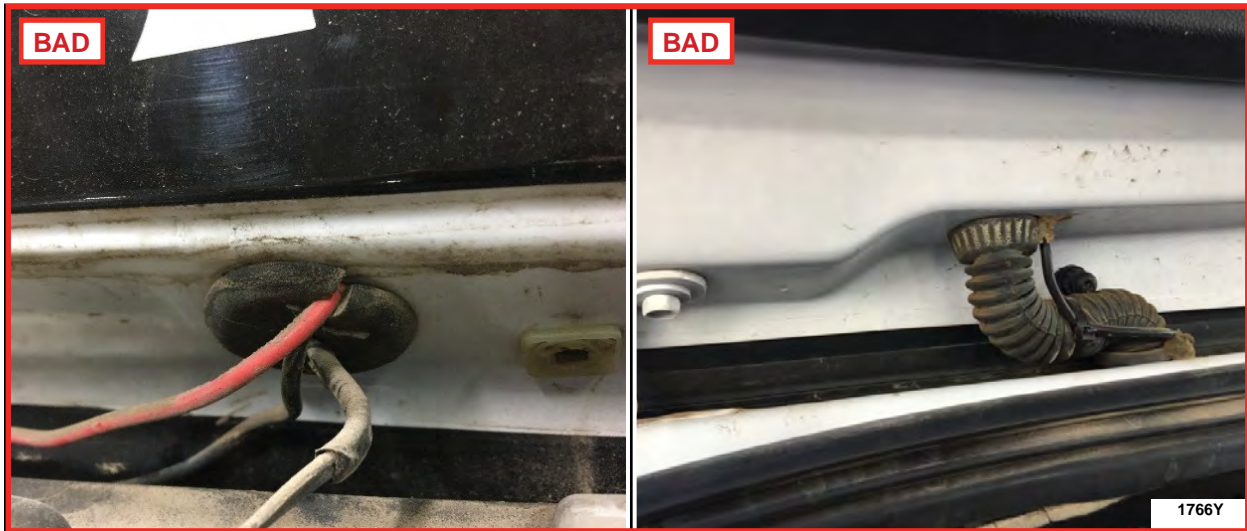
2. Inspect for any aftermarket wiring pass throughs/holes that could affect the sealing ability of the spoiler. See Figures 11a and 11b.

3. Seal any leak paths created by the aftermarket wiring pass throughs/holes in the spoiler area with Motorcraft® TA-2 seam sealer or equivalent.
