Customer Satisfaction Program

17200 Loss of Electric Power Steering (EPS)

Reference Number: N15201720
GWM Number: 2017200

Release Date: August 2016
Revision: 00

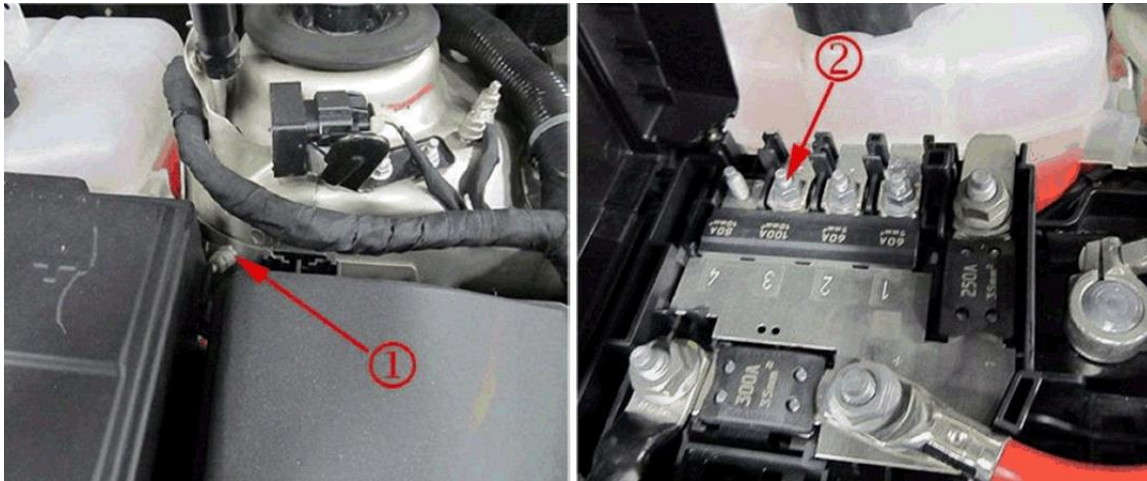
Condition	Certain 2014 model year Chevrolet Impala vehicles, equipped with Belt Driven Electric Power Steering (EPS) (RPO NJ2), may have a condition in which an intermittent or lasting loss or reduction of power steering assist may occur at startup or while driving. Updating the Power Steering Control Module (PSCM) software improves system performance. If power steering assist is lost or reduced, a message is displayed on the Driver Information Center and a chime sounds to inform the driver. Steering control can be maintained because the vehicle will revert to manual steering mode, but would require greater driver effort particularly at low vehicle speeds.
Correction	Dealers are to inspect the PSCM ground and fuse for proper connection and update the PSCM software.

1. Inspect the G111 ground (1) and the 100A F3UB fuse (2) for proper connection. Ensure the ground is free of paint and both connections are tight.
 - Tighten the G111 ground to 9Nm (80 lb in).
 - Tighten the F3UB fuse to 4.7Nm (42 lb in).
2. Fully charge the battery using the GR-8 Tool (EL-50313).
3. Reprogram the power steering control module using the Service Programming System (SPS) with the latest calibrations available on TIS2WEB. Refer to the *Power Steering Control Module Programming and Setup (NJ2)* procedure in SI.
