Service Bulletin

SUBJECT: Special Coverage Adjustment – Unable to Remove Ignition Key

MODELS: 2005-2010 Chevrolet Cobalt
2006-2011 Chevrolet HHR
2006-2010 Pontiac Solstice
2007-2010 Pontiac G5
2005-2006 Pontiac G4/Pursuit
2007-2010 Saturn Sky
2003-2007 Saturn Ion
Equipped with Automatic Transmission

Subject: 14632C – Special Coverage Adjustment
Unable to Remove Ignition Key
Part Information Section Revised

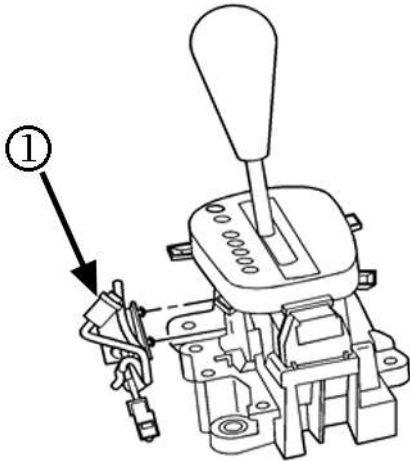
4043711

Important: For Ion models only, refer to *Diagnostic Starting Point - Automatic Transmission Shift Lock Control* and as necessary, *Shift Lock Control Solenoid (1) Replacement* in SI.
