Michael A. Berardi
Director
Service Engineering Operations
Ford Customer Service Division

SUBJECT: **NEW VEHICLE DEMONSTRATION / DELIVERY HOLD – Customer Satisfaction Program 17B25 – *Supplement #4***
Certain 2013-2017 Model Year Police Interceptor Utility Vehicles
Exhaust Odor and Carbon Monoxide Complaints

REF : **Customer Satisfaction Program 17B25 – Supplement #3**
Dated: October 25, 2017
Customer Satisfaction Program 17N03
Dated: October 25, 2017

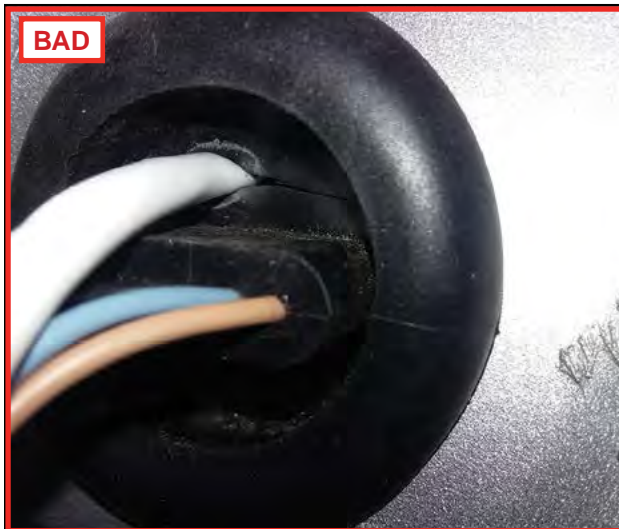
FIGURE 6a

6. Remove the LH and RH rear tail lamp assemblies. Please follow the WSM procedures in Section 417-01.
7. Inspect the sheet metal, wiring harness grommets and factory equipped pass throughs for damage or holes created when installing aftermarket wiring and equipment. See Figure 6a. Seal all holes in the sheet metal and wiring harness grommets with Motorcraft® TA-2 seam sealer or equivalent. See Figure 6b.

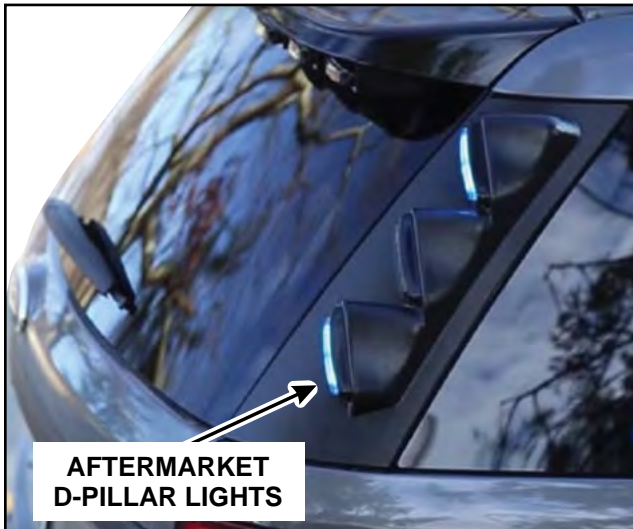
FIGURE 7a

8. For vehicles equipped with aftermarket lights on the D-pillars, seal all holes in the sheet metal and wiring harness grommets used as wiring pass throughs with Motorcraft® TA-2 seam sealer or equivalent. See Figures 7a and 7b.

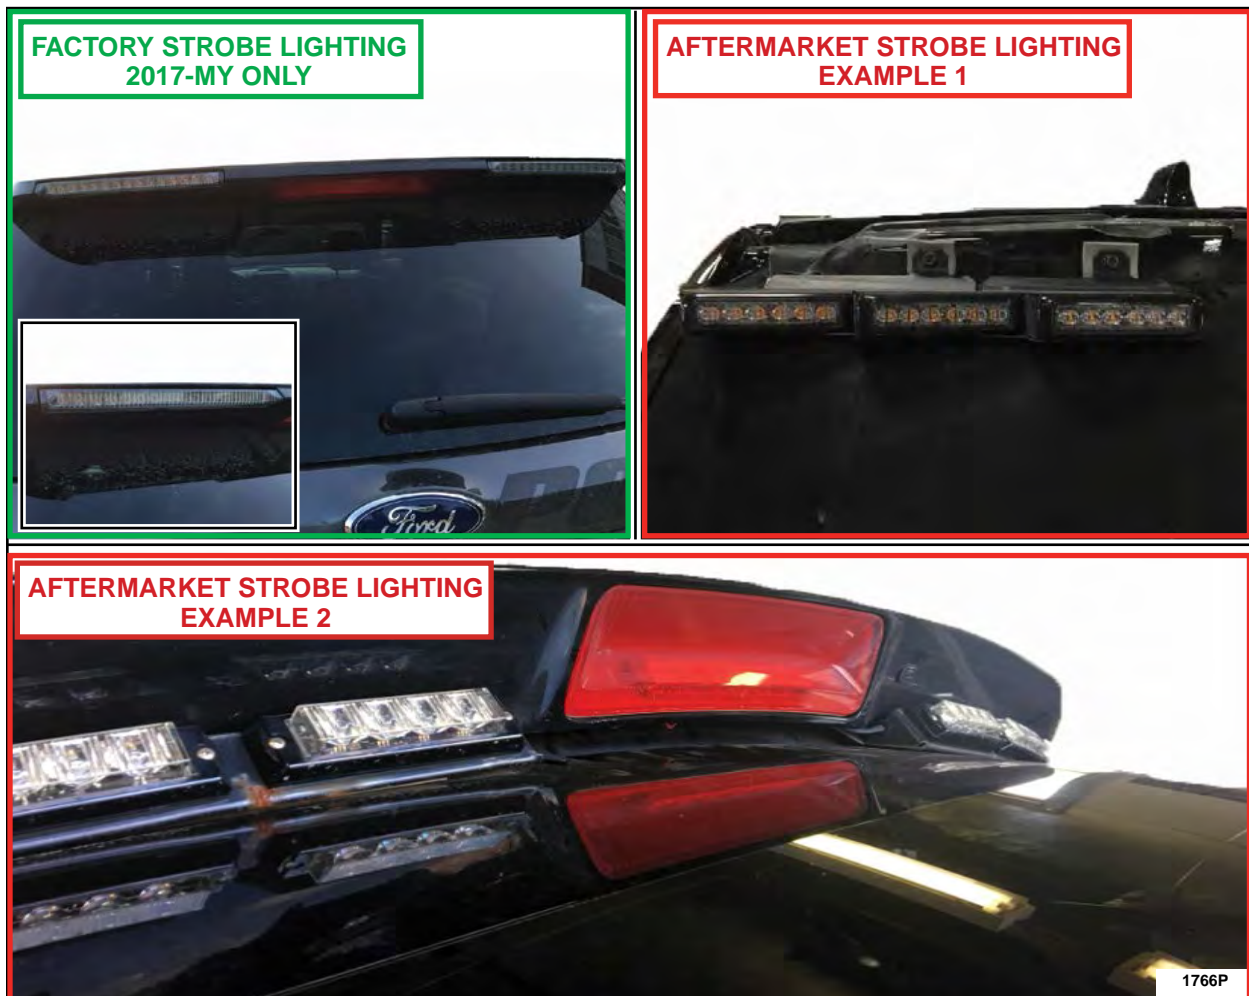
FIGURE 9

- a. Is there aftermarket lighting or other equipment mounted to the spoiler? See Figure 9.
- b. Has the spoiler or vehicle been painted?
NOTE: All Police Interceptor Utility Spoilers are painted black from the factory.
- c. Is the spoiler damaged or have any holes drilled through it?
- d. Is any aftermarket wiring routed to the spoiler?

NOTE: Aftermarket lighting and/or equipment mounted to the liftgate spoiler can compromise vehicle sealing and create a leak path for exhaust to enter the vehicle. Ford recommends removal of any aftermarket lighting and/or equipment mounted to the spoiler to prevent a potential path for exhaust to enter the vehicle. Any removed equipment must be returned to the customer.
