# Service Update

## 18038 Reduced Engine Power

Reference Number: N172144100

Models: 2018-2019 Chevrolet Corvette

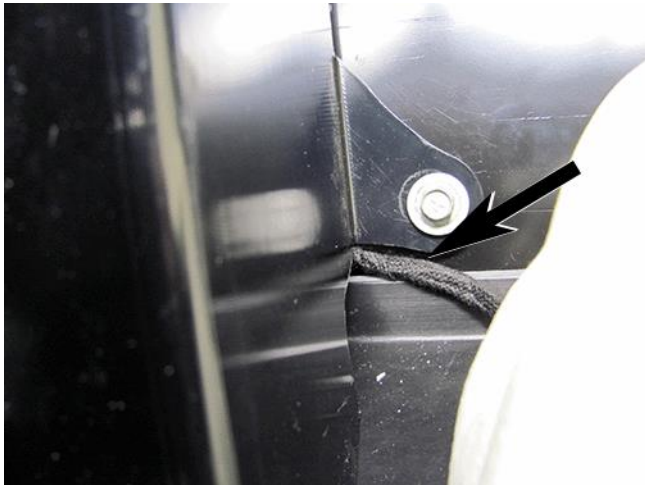
4961438

3. Lift the front floor carpet to access the footrest mounting bracket area.
4. Inspect the harness branch from main body wiring harness to accelerator pedal. Verify the branch is not pinched underneath footrest mounting bracket.

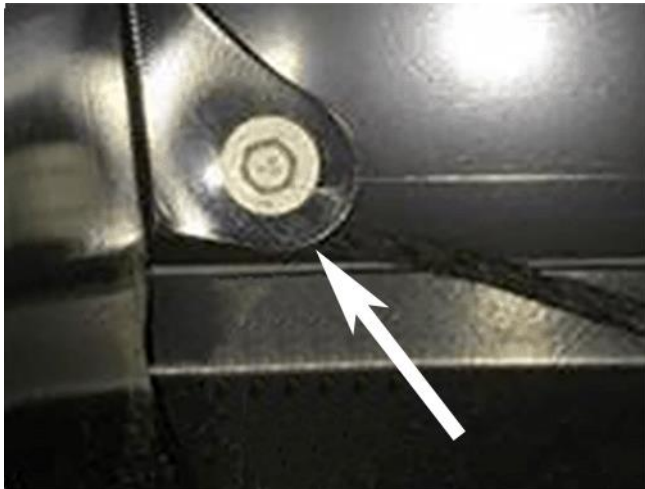
4961445

- If the branch is not pinched under the footrest mounting bracket, no further action is required. Reinstall the components in the reverse order of removal.

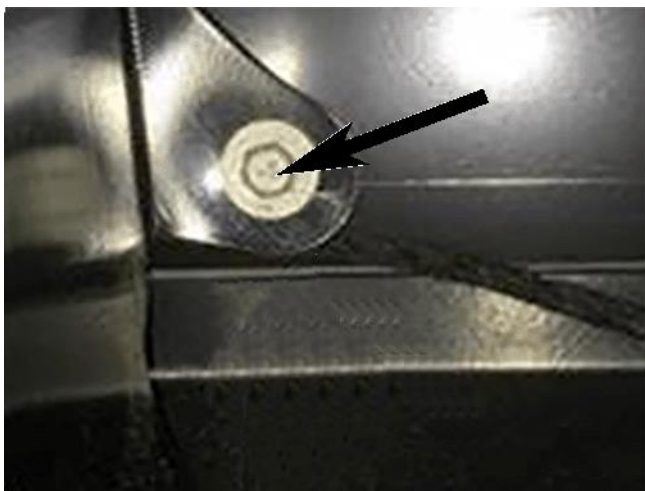
4961452

- If the branch is pinched under the footrest mounting bracket, proceed to step five.

5. Remove the foot rest mounting bracket fastener.
6. Inspect the harness for damaged wires. If damage is found, repair the harness as required. Refer to *Wire to Wire Repair* in SI. This harness repair will be covered as a warranty claim.
