April 9, 2018

SUBJECT: NEW VEHICLE DELIVERY HOLD
Update Prior to Sale 18U12
Certain 2018 Model Year Escape and MKC Vehicles
Transmission Bell Housing Bolt Torque

CERTAIN 2018 ESCAPE AND MKC VEHICLES – TRANSMISSION BELL HOUSING BOLT TORQUE

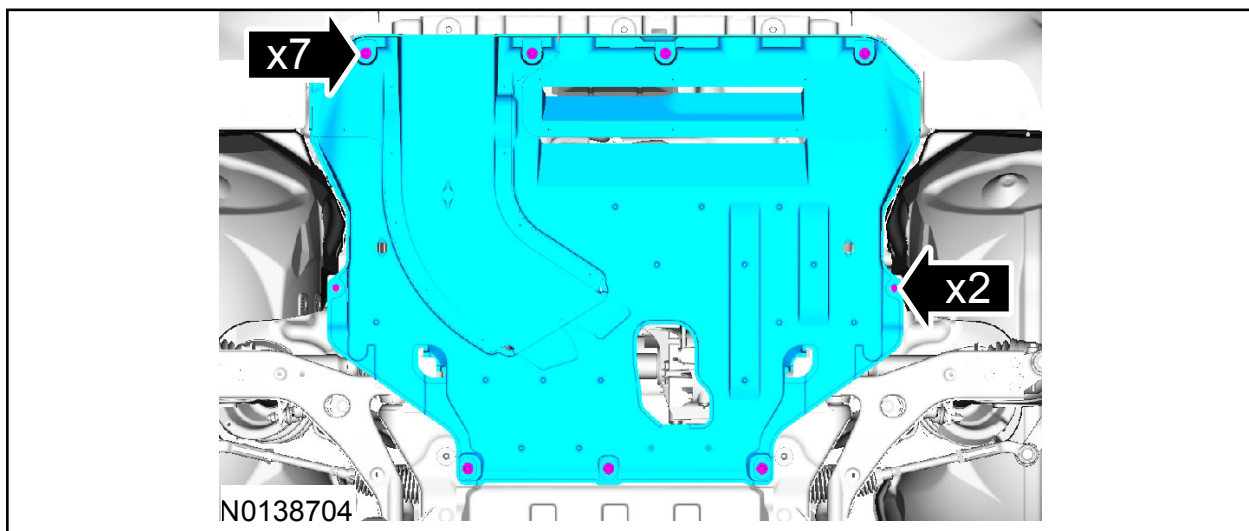
FIGURE 1

1. Remove the retainers and the engine front underbody shield. See Figure 1.

1. Install the engine front underbody shield and retainers. See Figure 1.

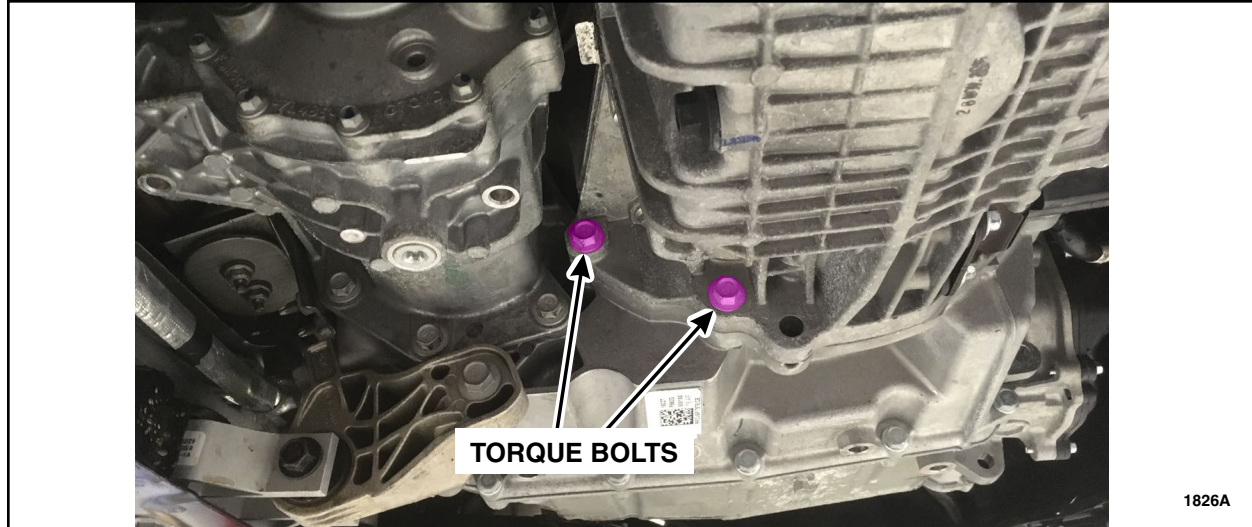
FIGURE 2

In some of the affected vehicles, depending on engine configuration, one or two transmission bell housing bolts may have been torqued below specification. If any transmission bell housing bolts are torqued below specification, other bolts may loosen over time and the customer may experience an under-hood clunk noise, a vibration while driving, fluid leaks from bottom of bell housing and/or flex plate may crack. Before delivering any new in-stock vehicles involved in this program, dealers are to torque the specified bolt(s).

Vehicles Equipped with a 1.5L Ecoboost Engine

2. Torque the transmission housing bolt(s) shown in the following illustrations to 35 lb.ft (48 Nm).
See Figures 2 and 3.

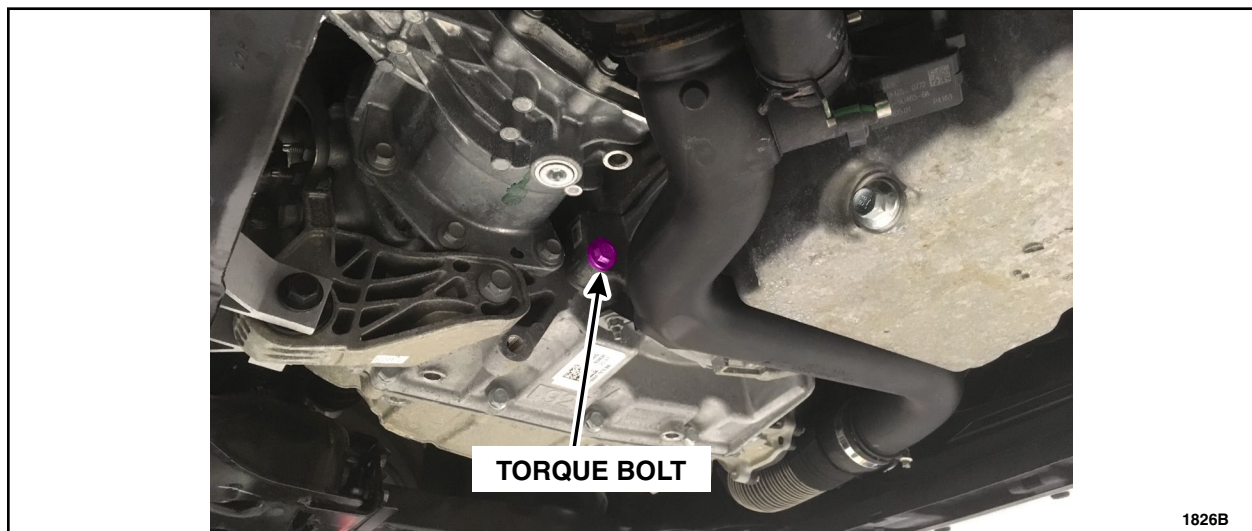
FIGURE 3

Vehicles Equipped with a 2.0L EcoBoost Or 2.5L Duratec Engine
