Service Update

18209 Diesel Turbo Exhaust Leak

Reference Number: N182153520

Release Date: June 2018
Revision: 00

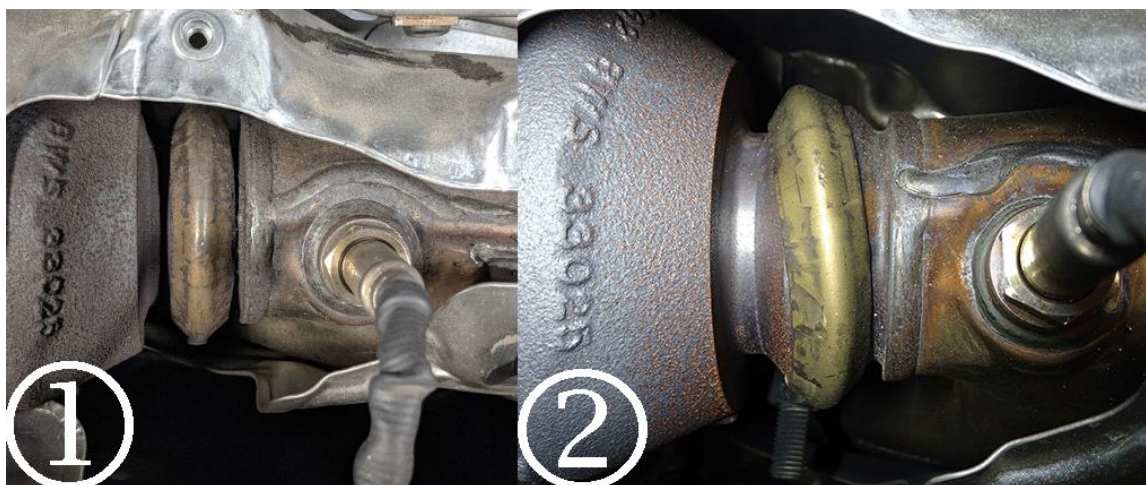
5109525

Condition	Certain 2018 model year Chevrolet Equinox and GMC Terrain vehicles equipped with a 1.6L diesel engine (RPO LH7), may have been built with an improper alignment of the clamp/gasket assembly connecting the turbocharger to the catalytic converter. This condition may cause a diesel exhaust leak and/or smoke from the underhood area of the vehicle. In addition, a check engine indicator may set with diagnostic trouble code P0421.
Correction	Dealers are to inspect and replace the turbocharger to catalytic converter clamp/gasket as necessary.

2. Inspect the clamp between the turbocharger and the catalytic converter with the vehicle running.
 - If the clamp is properly aligned (1) and there is **NO** smell of diesel exhaust, no further action is required. Reinstall the turbocharger heat shield.

NOTE: It may be necessary to remove the catalytic converter to reposition the clamp if the clamp has seized due to heat or corrosion.
 - If the clamp is misaligned (2) **OR** you can smell diesel exhaust, reposition the clamp if it is undamaged. If the clamp is damaged, replace the clamp. Refer to *Catalytic Converter Removal* in SI.
