David J. Johnson
 Director
 Service Engineering Operations
 Ford Customer Service Division

Ford Motor Company
 P. O. Box 1904
 Dearborn, Michigan 48121

SUBJECT: **NEW VEHICLE DEMONSTRATION / DELIVERY HOLD – Customer Satisfaction Program 17B25 – *Supplement #5***
 Certain 2013-2017 Model Year Police Interceptor Utility Vehicles
 Exhaust Odor and Carbon Monoxide Complaints

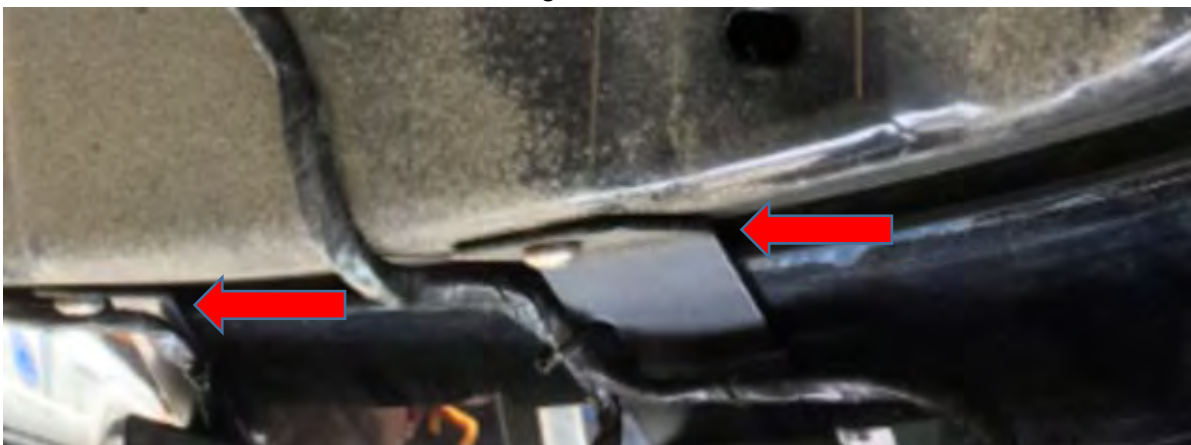
Figure 1

- Brackets positioned between the spoiler and the liftgate (See Figure 1)
- Lighting and/or equipment that forces the spoiler out of position creates a gap between the spoiler and the liftgate (See Figure 2)
- Unsealed holes drilled in the spoiler or liftgate (See Figures 3 and 4)
- Wiring for lighting and/or equipment routed from the spoiler to the vehicle in a manner that damages the seals between the spoiler and the vehicle (See Figures 5 and 6)
- When the spoiler is removed to install aftermarket lights and/or equipment, the spoiler attachment clips and seals may be damaged. If the spoiler was removed from the vehicle, the spoiler attachment clips and seals should be replaced. Use part number HB5Z-78442K03-A

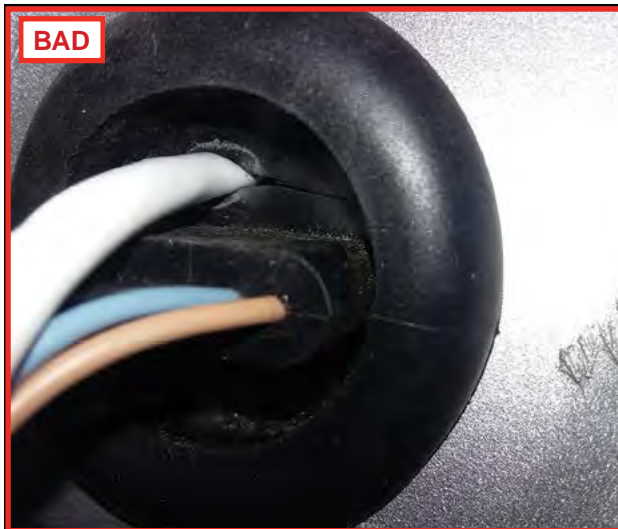
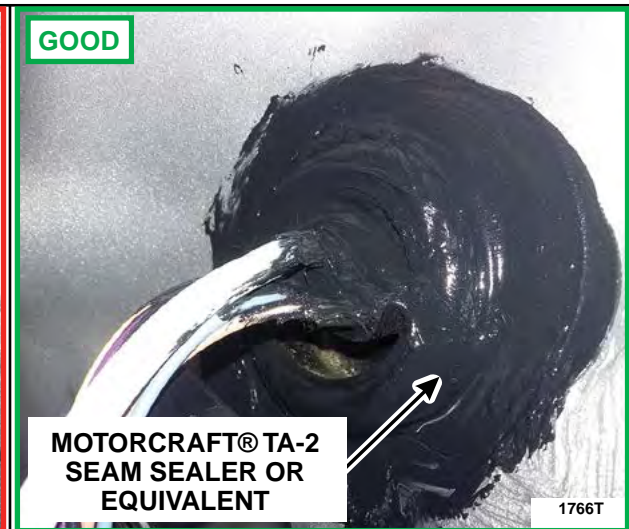
6. Remove the LH and RH rear tail lamp assemblies. Please follow the WSM procedures in Section 417-01.
7. Inspect the sheet metal, wiring harness grommets and factory equipped pass throughs for damage or holes created when installing aftermarket wiring and equipment. See Figure 6a. Seal all holes in the sheet metal and wiring harness grommets with Motorcraft® TA-2 seam sealer or equivalent. See Figure 6b.

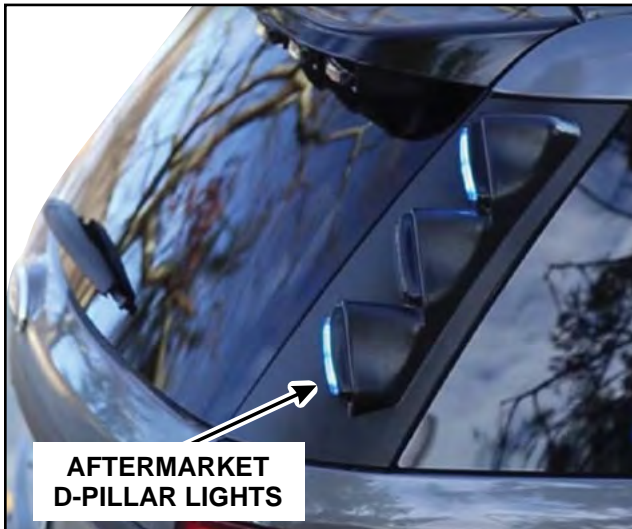
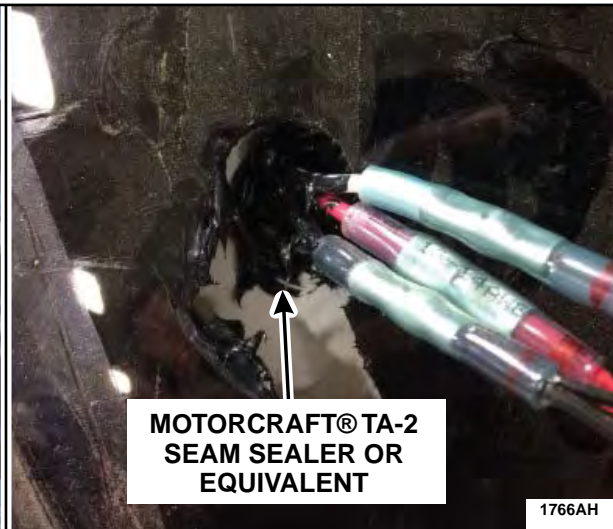
8. For vehicles equipped with aftermarket lights on the D-pillars, seal all holes in the sheet metal and wiring harness grommets used as wiring pass throughs with Motorcraft® TA-2 seam sealer or equivalent. See Figures 7a and 7b.

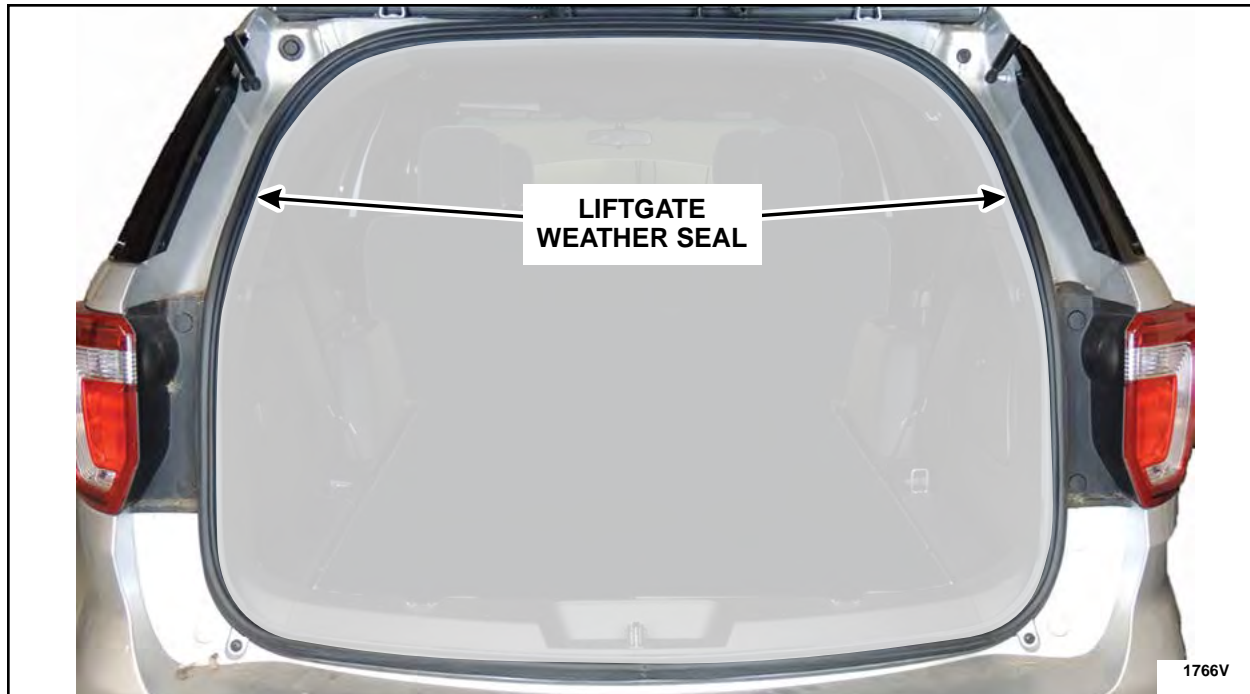
FIGURE 8

9. Inspect the liftgate weather seal for damage and proper fitment to the vehicle. Replace the liftgate weatherseal if required. See Figure 8.

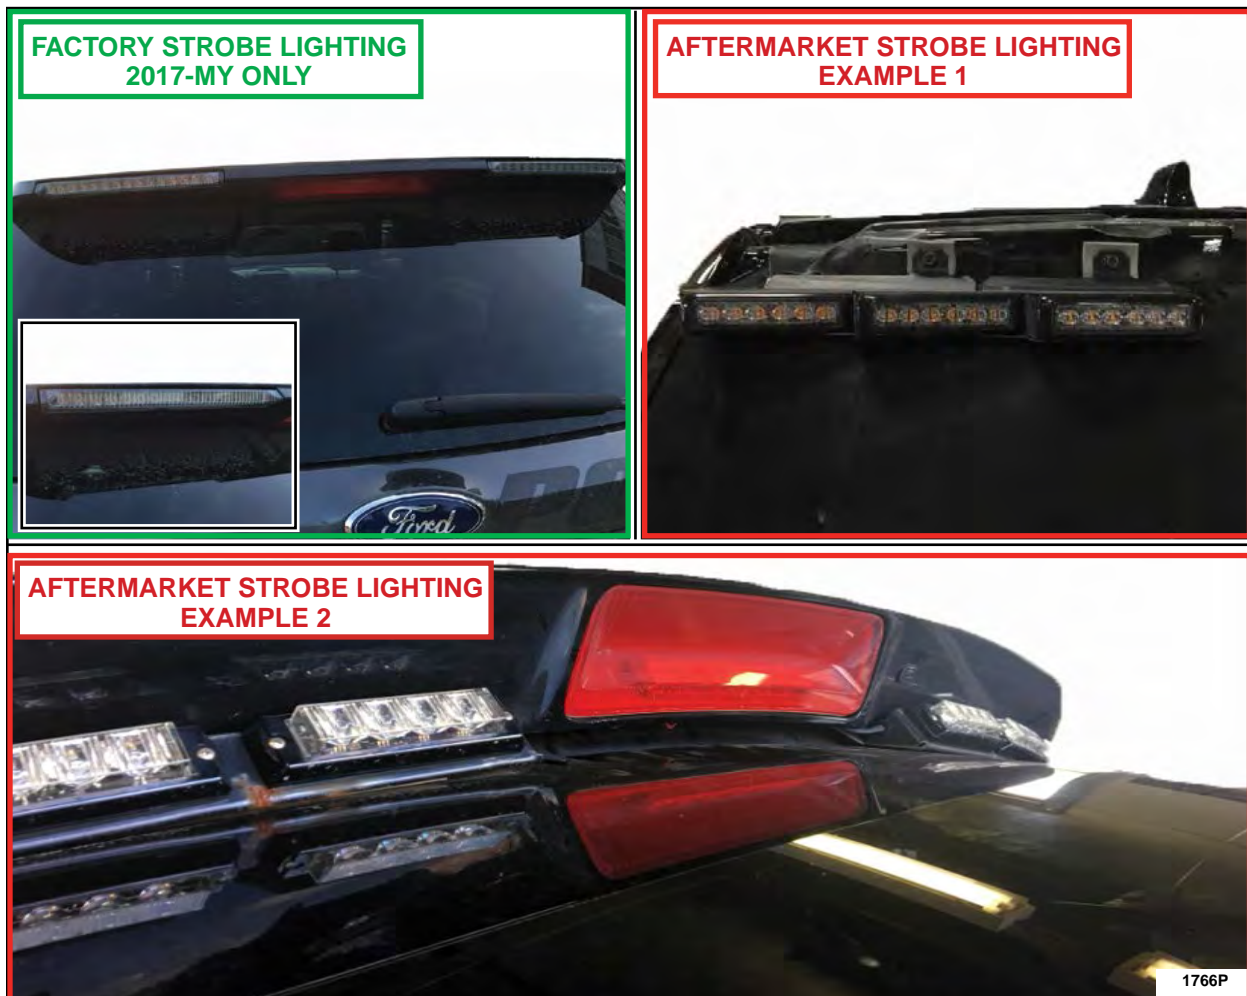
FIGURE 9

- a. Is there aftermarket lighting or other equipment mounted to the spoiler? See Figure 9.
- b. Has the spoiler or vehicle been painted?
NOTE: All Police Interceptor Utility Spoilers are painted black from the factory.
- c. Is the spoiler damaged or have any holes drilled through it?
- d. Is any aftermarket wiring routed to the spoiler?

NOTE: Aftermarket lighting and/or equipment mounted to the liftgate spoiler can compromise vehicle sealing and create a leak path for exhaust to enter the vehicle. Ford recommends removal of any aftermarket lighting and/or equipment mounted to the spoiler to prevent a potential path for exhaust to enter the vehicle. Any removed equipment must be returned to the customer.

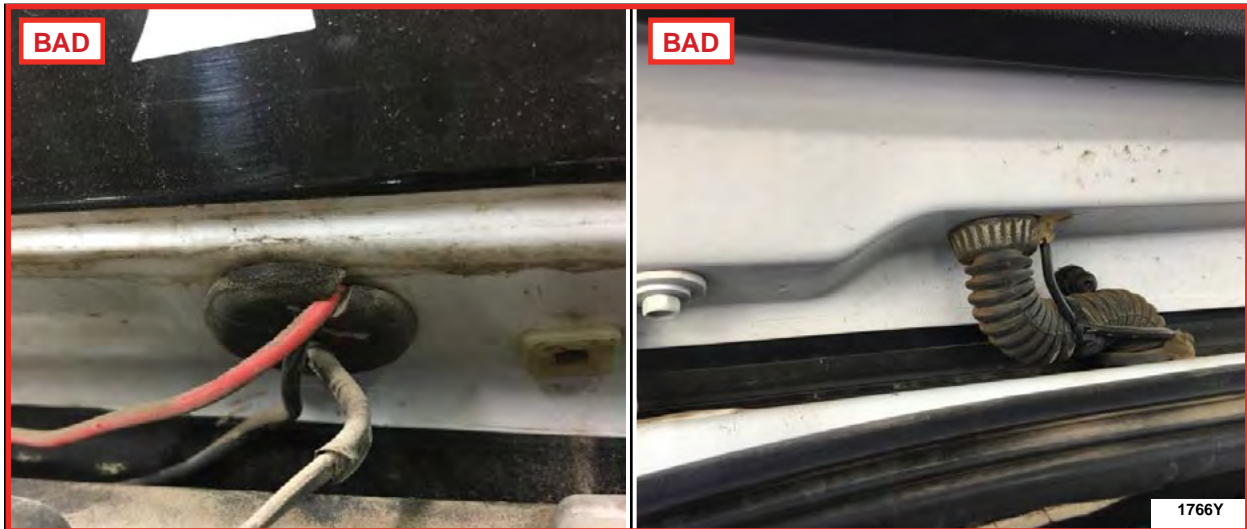
FIGURE 11a

2. Inspect for any aftermarket wiring pass throughs/holes that could affect the sealing ability of the spoiler. See Figures 11a and 11b.

3. Seal any leak paths created by the aftermarket wiring pass throughs/holes in the spoiler area with Motorcraft® TA-2 seam sealer or equivalent.

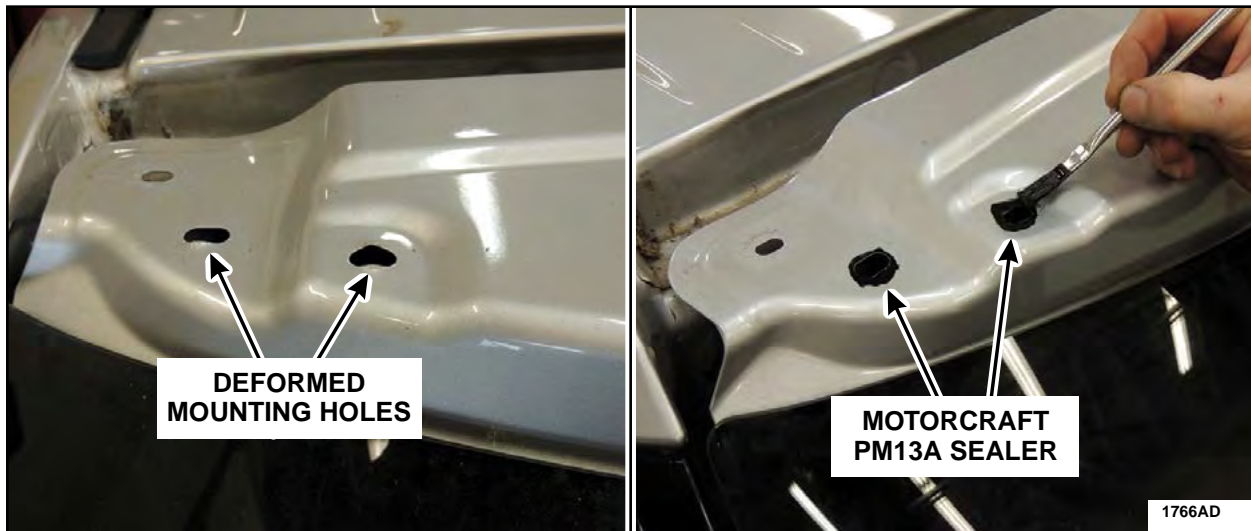
FIGURE 16

8. Using a flat faced hammer, carefully straighten any deformed spoiler retaining clip mounting holes and apply Motorcraft® PM13A sealer. See Figure 16.

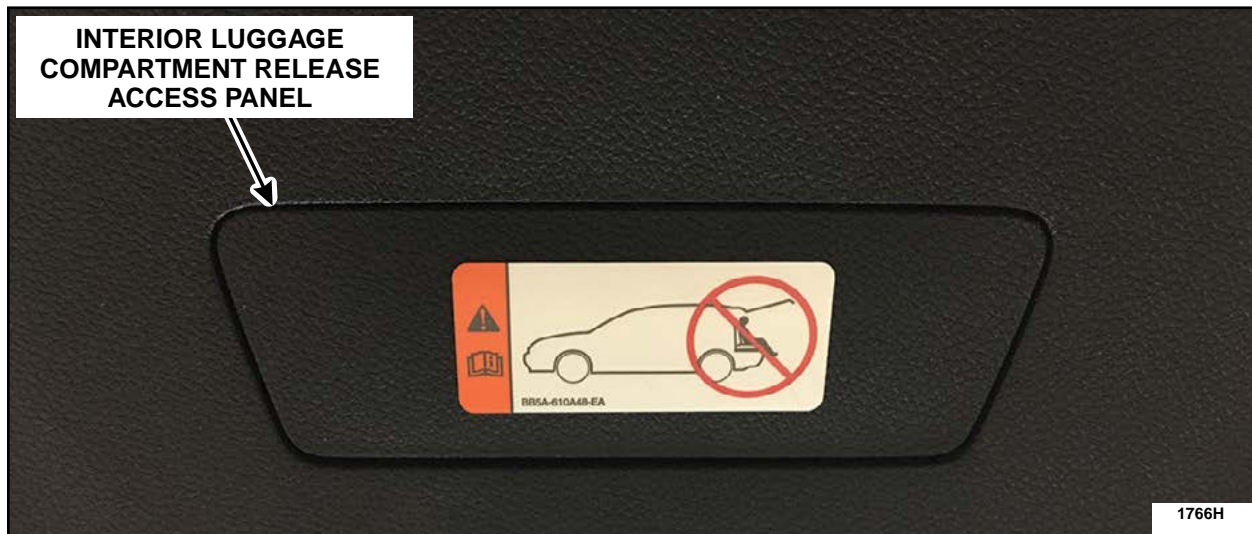
FIGURE 24

11. Inspect the liftgate trim panel for lights, pass throughs/holes and/or aftermarket equipment that could compromise the seal of the liftgate trim panel. Seal any breaches of the liftgate trim panel using mastic patch, left over foam tape, Dow Corning® 7091 Adhesive/Sealant, or other robust sealing methods.
12. Ensure the interior luggage compartment release access panel is properly installed in the lower liftgate trim panel. See Figure 24.
