**PRODUCT CAMPAIGN BULLETIN**

**APPLICABILITY:** 2017MY Impreza

**NUMBER:** WTN-74R

**SUBJECT:** Reprogramming File Availability to Optimize Rear View Camera Operation on Harman Gen 3 Audio and Navigation Head Units

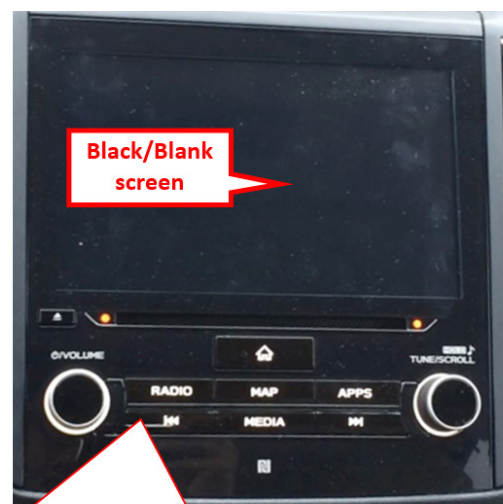
- 1) After switching the vehicle (ACC or IGN) on, the display screen goes black with no audio output and the hard key buttons are illuminated (on solid, or flashing / blinking).

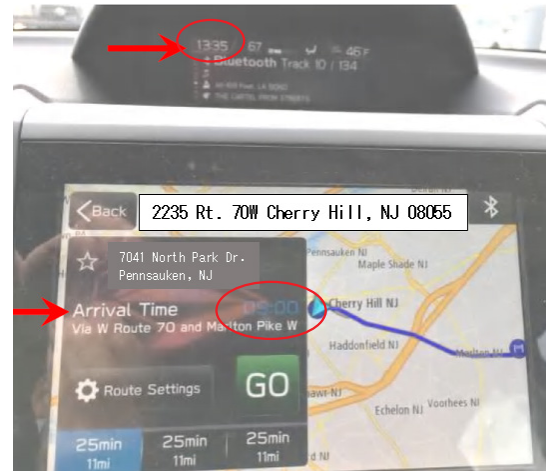
- 2) Time of day displayed in the MFD (Multi-Function Display) is incorrect and the arrival time displayed in Navigation units is also incorrect.

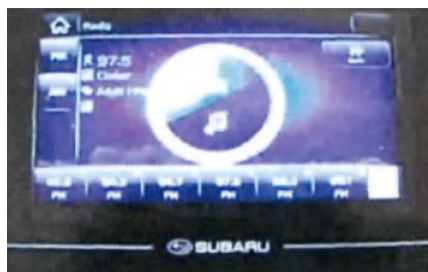
- 3) The time in the MFD automatically reverts back to a “default” setting, even after setting the time using “Manual” mode.
- 4) Audio volume goes to maximum automatically after one click of the volume up button on the steering wheel. In some cases, this condition may also occur without input from the operator. Maximum volume is also displayed on the screen.

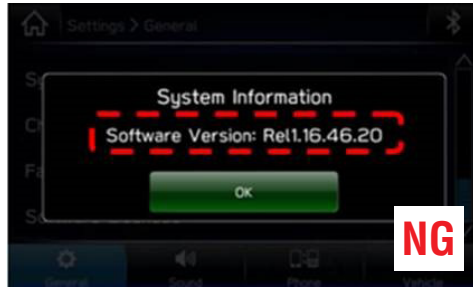
**NG-** Head Unit Must Be Updated, Proceed To Step 2.
