PRODUCT CAMPAIGN BULLETIN

APPLICABILITY: 2017-18MY Impreza

2018MY Crosstrek

SUBJECT: PCV Valve- Design Change **NUMBER:** WUP-01

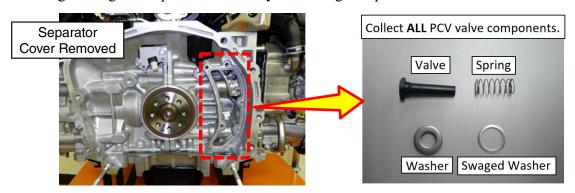
Step 3: (If necessary), following the applicable Service Manual procedures, remove the engine to collect the PCV valve component parts that may have fallen into the engine. Remove the oil separator cover and collect the PCV valve components (4 small parts) as shown in the photos below. If all the PCV valve components cannot be collected after removing the oil separator cover, proceed with removing the engine oil pan to collect any remaining components.

- If all the broken PCV valve components cannot be found and collected, replace the short block assembly along with a new PCV valve and hose (kit) following the applicable Service Manual procedures.
- If all the broken PCV valve components are found and collected, install a **new** separator cover, PCV valve and hose (kit) then reassemble the vehicle following the applicable Service Manual procedures to complete the procedure.

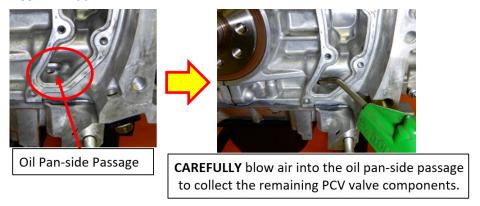
TIP: If any PCV valve components remain in the oil pan-side passage, **CAREFULLY** apply compressed air to the oil pan-side passage as shown below.

- Always wear safety glasses.
- Never reuse the oil separator cover as it is a one-time use item. Replace it with p.n. 11831AA260.
