SUBJECT: **Customer Satisfaction Program 19B37 - Supplement #1**
Certain 2017-2019 Model Year Fusion and Escape Vehicles Equipped with a 1.5L GTDI Engine - Powertrain Control Module Reprogramming

Customer Satisfaction Program 19B37 – Supplement #1

Certain 2017-2019 Model Year Fusion and Escape Vehicles Equipped with a 1.5L GTDI Engine Powertrain Control Module Reprogramming

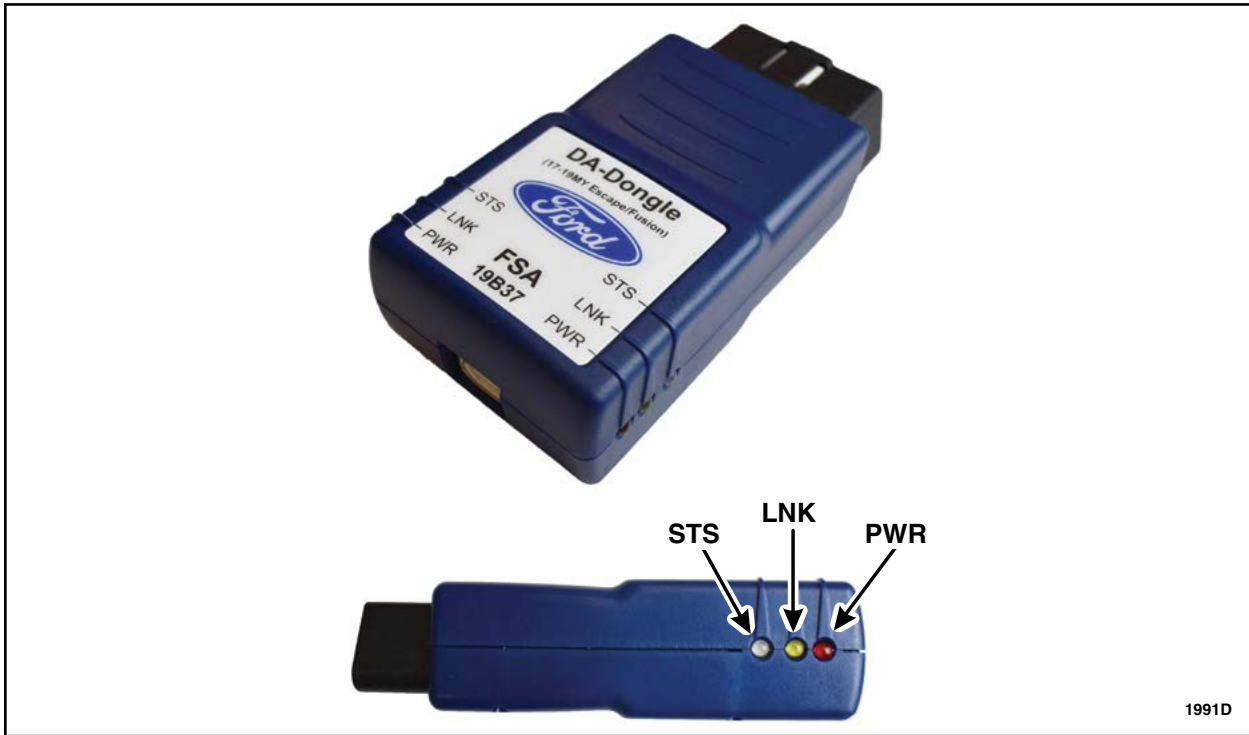
FIGURE 1

3. Connect the Dongle to the diagnostic OBDII port. See Figure 1 and Table 1.
