SERVICE PROGRAM BULLETIN

APPLICABILITY: 2014-2016 MY Forester

NUMBER: WUT-05R

SUBJECT: Forester Rear Coil Springs

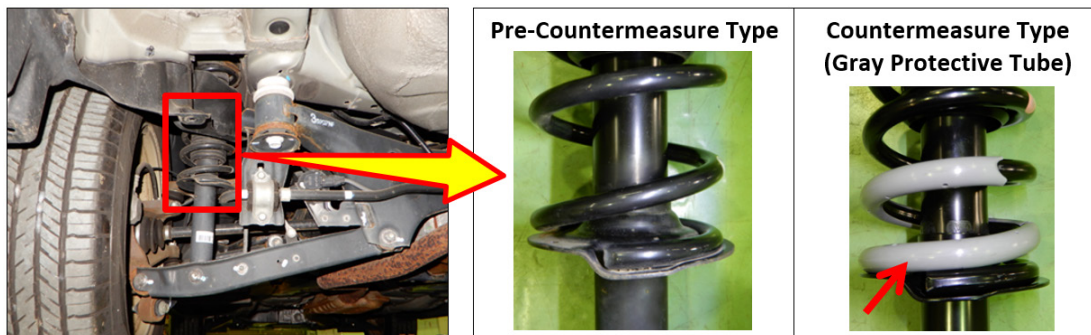
In the interest of customer satisfaction, Subaru of America, Inc. (Subaru) is initiating a service program to replace the rear coil springs on certain 2014-2016 model year Forester vehicles. Over time, if the rear coil spring outer coating is damaged by stones and other road debris, the spring material may develop pitting from corrosion and a small section of the spring could break away. When this condition is present, owners of affected vehicles may notice (i) pieces of metal (spring) on the ground near where the vehicle is parked or (ii) one corner of the vehicle sitting lower.

Step 1) INSPECTION: Inspect the coil springs on both rear shock absorber assemblies to determine if either has a gray colored protective tube installed on the bottom coils as shown below.

- If either (or both) of the coil springs are the Pre-Countermeasure Type (NO gray protective tube on the bottom coils), proceed to **Step 2** and replace ONLY the affected spring(s).
- If **BOTH** coil springs are the Countermeasure Type (gray protective tube installed on the bottom coils), the procedure is complete. Proceed to the Claim Reimbursement and Entry Procedures section and process a claim for Inspection Only.
