SERVICE PROGRAM BULLETIN

APPLICABILITY: 2014-2016 MY Forester

NUMBER: WUT-05R

SUBJECT: Forester Rear Coil Springs

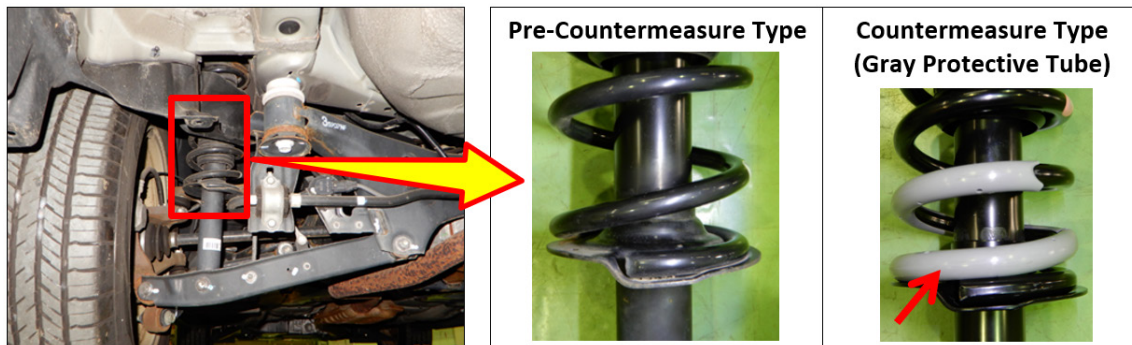
Step 1) INSPECTION: Inspect the coil springs on both rear shock absorber assemblies to determine if either has a gray colored protective tube installed on the bottom coils as shown below.

- If either (or both) of the coil springs are the Pre-Countermeasure Type (NO gray protective tube on the bottom coils), proceed to **Step 2** and replace ONLY the affected spring(s).
- If **BOTH** coil springs are the Countermeasure Type (gray protective tube installed on the bottom coils), the procedure is complete. Proceed to the Claim Reimbursement and Entry Procedures section and process a claim for Inspection Only.
