SUBJECT: **Customer Satisfaction Program 19B37 - Supplement #2**
 Certain 2017-2019 Model Year Fusion and Escape Vehicles Equipped with a 1.5L GTDI Engine - Powertrain Control Module Reprogramming

Customer Satisfaction Program 19B37 – Supplement #2

Certain 2017-2019 Model Year Fusion and Escape Vehicles Equipped with a 1.5L GTDI Engine Powertrain Control Module Reprogramming

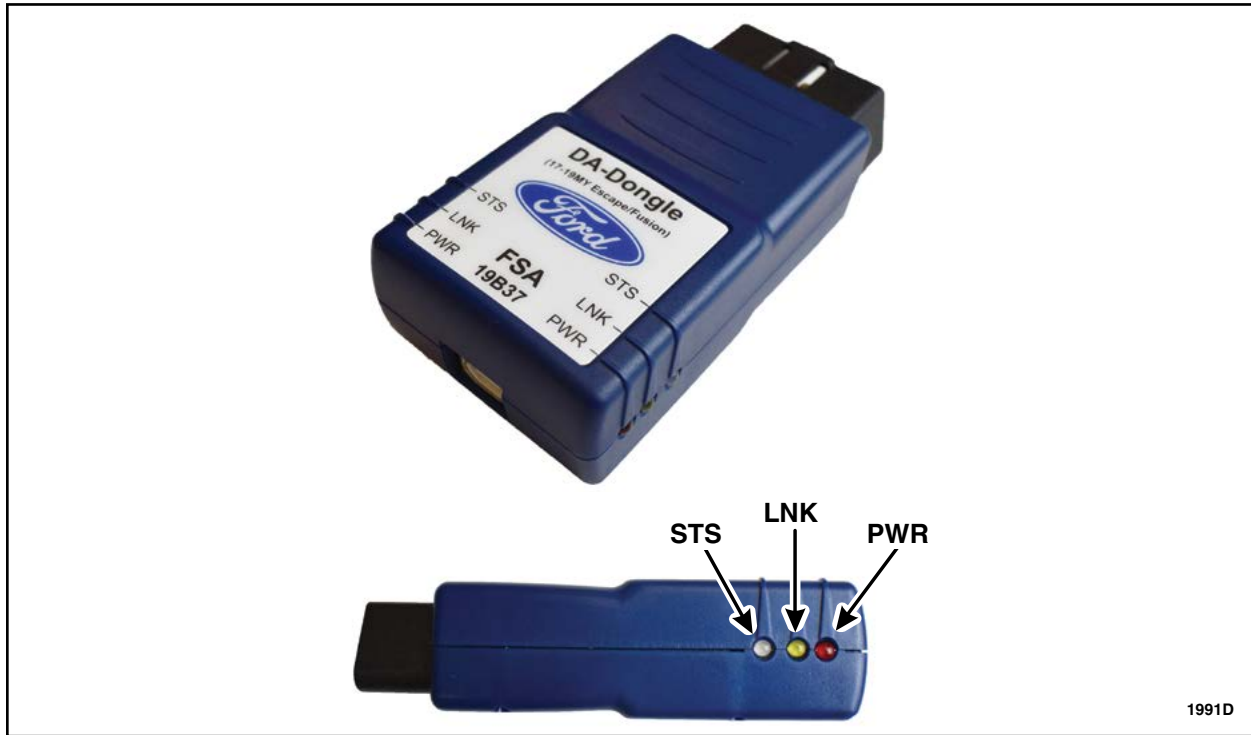
FIGURE 1

3. Connect the Dongle to the diagnostic OBDII port. See Figure 1 and Table 1.
