PRODUCT CAMPAIGN BULLETIN

APPLICABILITY: 2015-18MY Forester **NUMBER:** WUM-98R
SUBJECT: Occupant Detection Wiring Harness Inspection **NHTSA ID:** 19V-701
DATE: 10/14/19
REVISED: 03/02/20

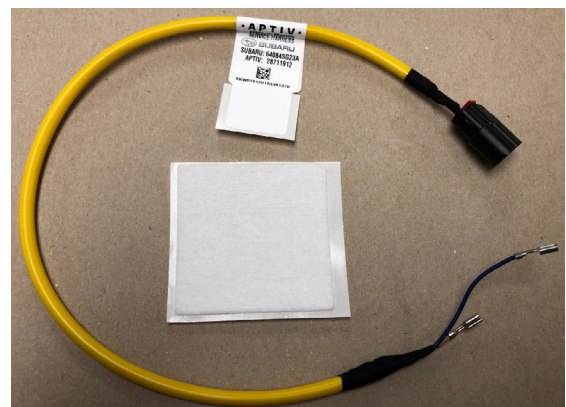
The REQUIRED first step is the Harness Label Inspection Procedure. **See the Harness Label Inspection procedure and Inspection Determination sections on pg. 3 below.** If the harness label inspection outcome dictates a repair is required, replace the pictured ODS harness (p.n. 64084SG23A) following the Harness Replacement Procedure below.

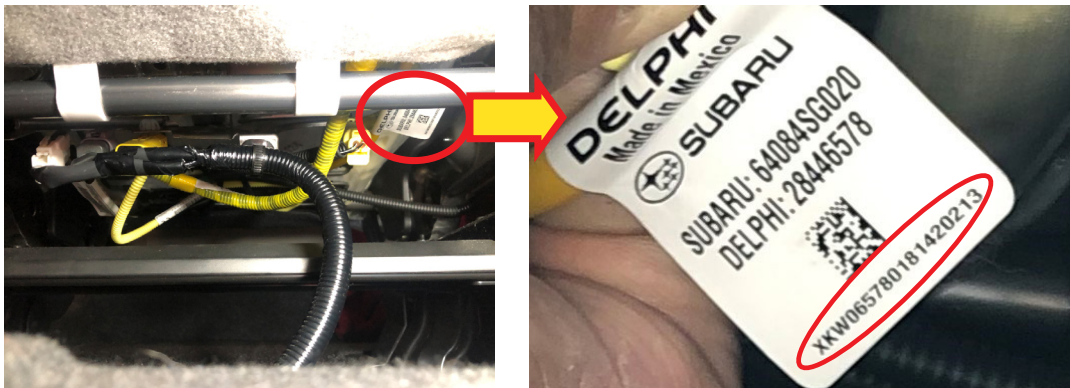
The part identification label affixed to the yellow sensor mat wiring harness is the focus of this inspection. The left photo shows an underside view of the passenger seat as seen from the front floor area and provides an approximate location of the label. On the right is a close-up of the identification label itself.

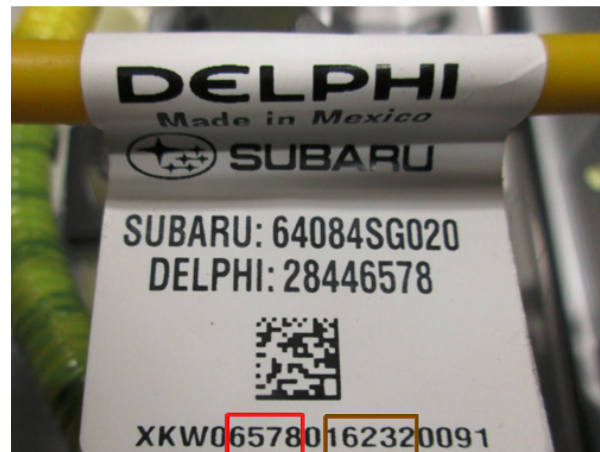
Step 1. If the date code (**BROWN** box in photo) on the label is **AFTER 18074**, the harness is **OK**. Harness replacement is **NOT** necessary. See additional ****NOTE** below.

Step 2. If the date code is **18074** or **BEFORE AND** has the supplier code **6578** (**RED** box in photo) on it, the harness is **NG** must be replaced. Proceed to Harness Replacement Procedure as outlined below.

If the supplier code is **6578**, **AND** the date code is **BEFORE 18074** the harness is **NG**.

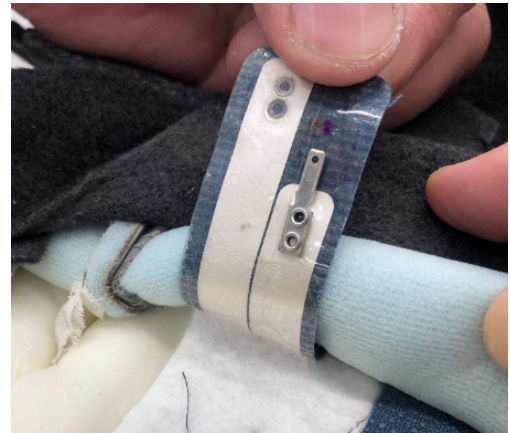
Step8- IMPORTANT: Before connecting the new harness, inspect the tail and sensor mat connectors to confirm they are tight on the 2 metal bands of the mat. Inspect closely for any breaks, cracks or other damage to the visible components of the sensor mat. If any damage is identified, the complete seat cushion assembly must be replaced as the sensor mat is not a serviceable component.

REMINDER: If a replacement is necessary, always order the most up-to-date seat cushion assembly part number for the VIN being repaired.
