SERVICE PROGRAM BULLETIN

APPLICABILITY: 2019MY Crosstrek
SUBJECT: Rear Seat Belt Webbing Locking

NUMBER: WRA-20R
DATE: 02/25/20
REVISED: 04/01/20

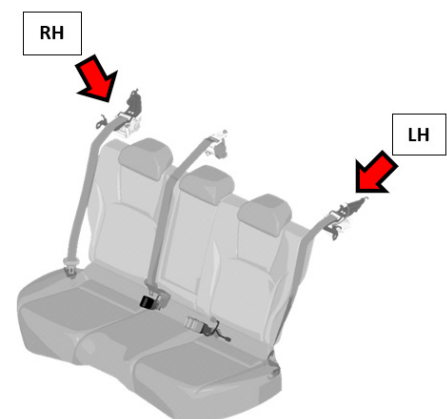
NOTE: Position Code and ID Code details are provided in the Service Procedure section below.

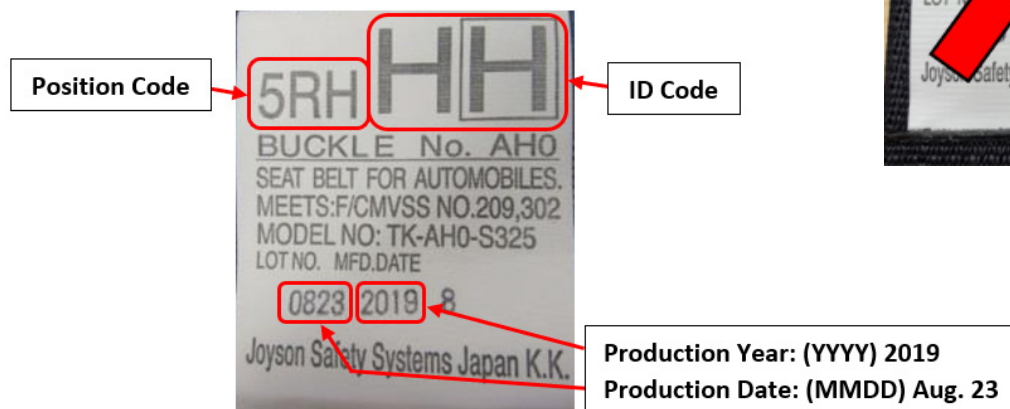
- **After seat belt removal, mark the tag with a permanent marker** as shown here to distinguish the old part from the replacement (new) part. If by chance the old parts become confused with the new parts, check the date code to identify the new seat belt assemblies using the photo below as a guide.

- Install the new outer seat belt assemblies in reverse order of removal. Confirm the new seat belt webbing is not twisted and can be pulled out and retracted smoothly.
