SERVICE PROGRAM BULLETIN

APPLICABILITY: 2014-2016 MY Forester

NUMBER: WUT-05R

SUBJECT: Forester Rear Coil Springs

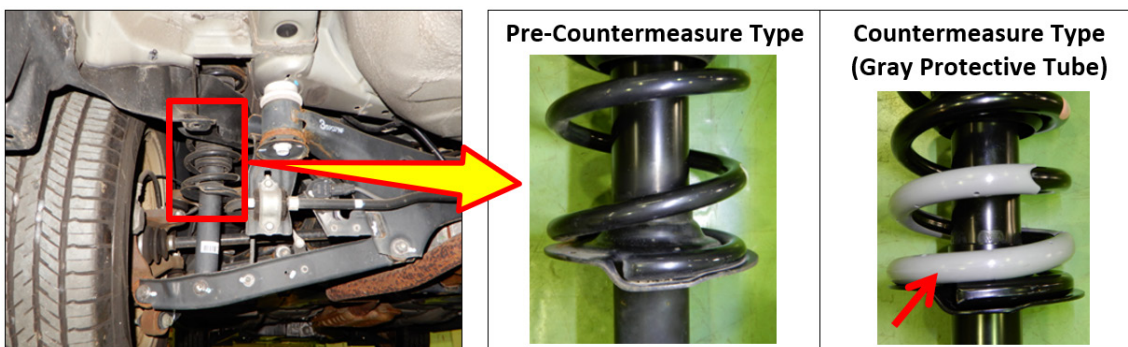
Inspect the coil springs on both rear shock absorber assemblies to determine if either spring has a gray colored protective tube installed on the bottom coils as shown below.

CHECK: Does either coil spring have the Gray Protective Tube on the coils to identify it is a Countermeasure Type spring?

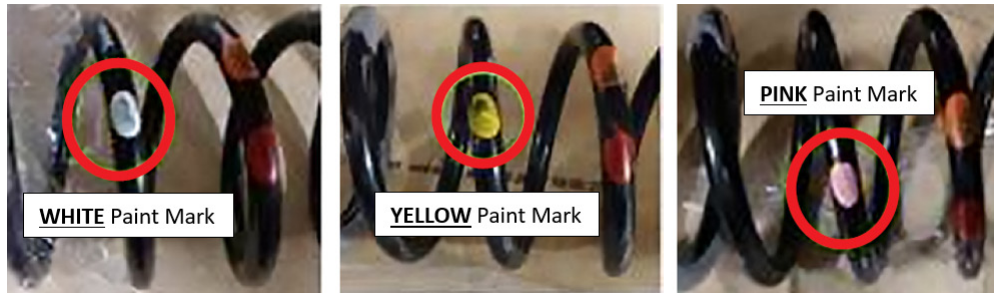
- If **YES**, inspect the Paint Mark on the spring to confirm the correct Countermeasure Type spring has been installed. Use the reference photos below as a guide.

- Springs with a **WHITE** Paint Mark are for installation on N/A (Non-Turbo) **models with MANUAL transmission ONLY.**
- Springs with a **YELLOW** Paint Mark are for installation on N/A (Non-Turbo) **models with CVT ONLY.**
- Springs with a **PINK** Paint Mark are for installation on **TURBO (XT) models ONLY.**

If both springs are the Countermeasure Type (gray protective tube installed on the bottom coils) **AND** both springs have the **CORRECT** color paint mark to indicate they are the correct springs for the vehicle, the inspection procedure is complete. Proceed to the Claim Reimbursement and Entry Procedures section and process a claim for Inspection Only.

Proceed to **Step 2** below and replace the pre-countermeasure or incorrect coil spring(s).

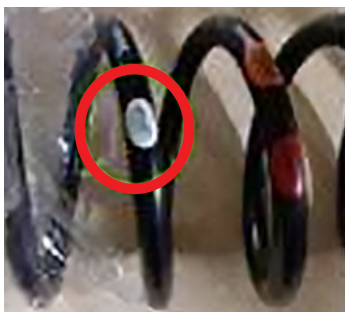
WHITE Paint Mark
Kit p.n. **X2038SG000**
Non-Turbo with MT **ONLY**

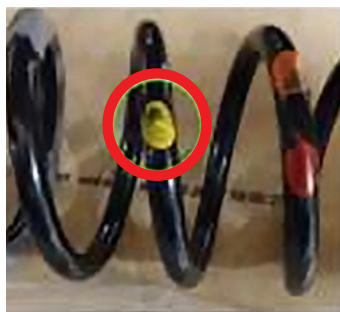
YELLOW Paint Mark
Kit p.n. **X2038SG010**
Non-Turbo with CVT **ONLY**

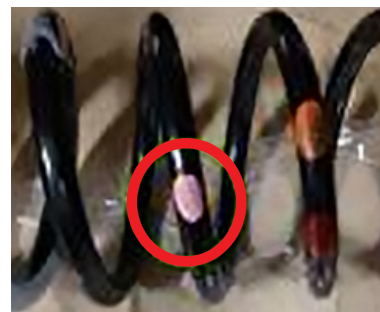
PINK Paint Mark
Kit p.n. **X2038SG020**
For Turbo Models **ONLY**
