David J. Johnson  
Director  
Service Engineering Operations  
Ford Customer Service Division

May 06, 2020

**SUBJECT:** **Customer Satisfaction Program 19B37 - Supplement #3**  
Certain 2017-2019 Model Year Fusion and Escape Vehicles Equipped with a 1.5L  
GTDI Engine - Powertrain Control Module Reprogramming

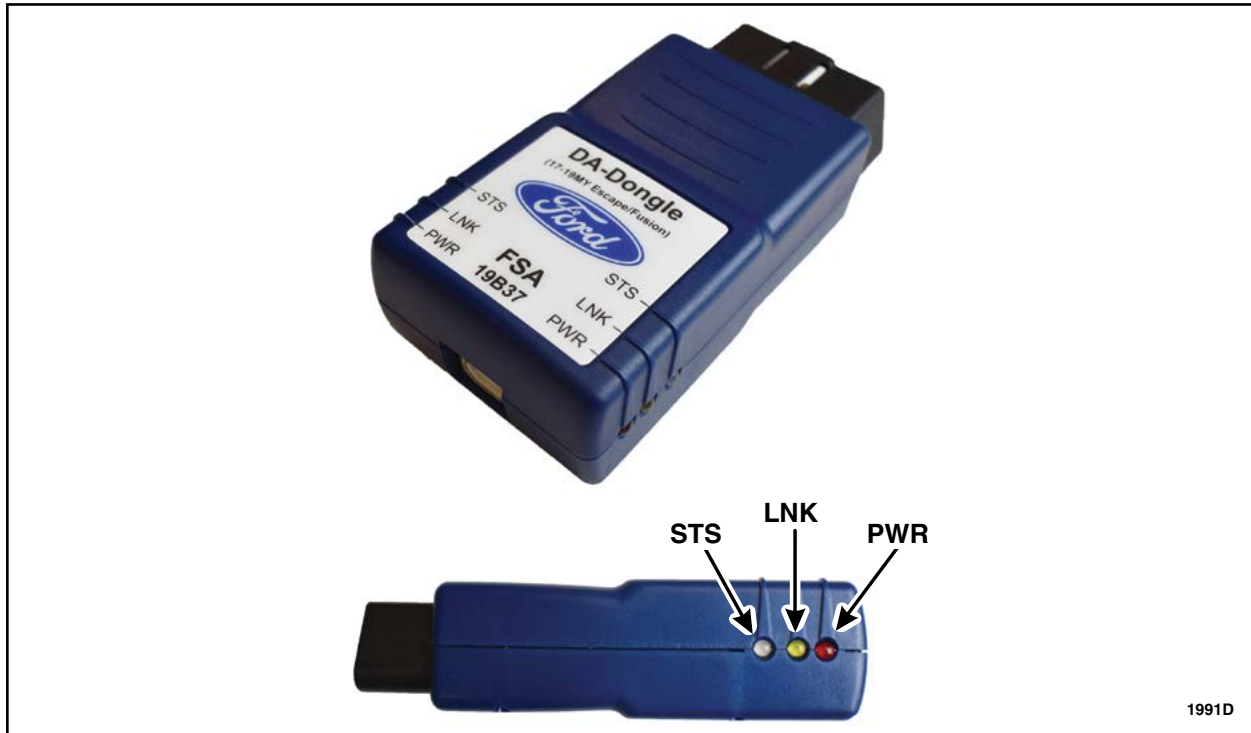
FIGURE 1

3. Connect the Dongle to the diagnostic OBDII port. See Figure 1 and Table 1.
