GLOBAL SAFETY FIELD INVESTIGATIONS  
DCS5448  
URGENT - DISTRIBUTE IMMEDIATELY

Date: July 7, 2020

Subject: N202294740-01 - Service Update  
Software Update for Multiple Modules  
Programming Error with Frontview Camera Module

Models: 2020 Cadillac CT5

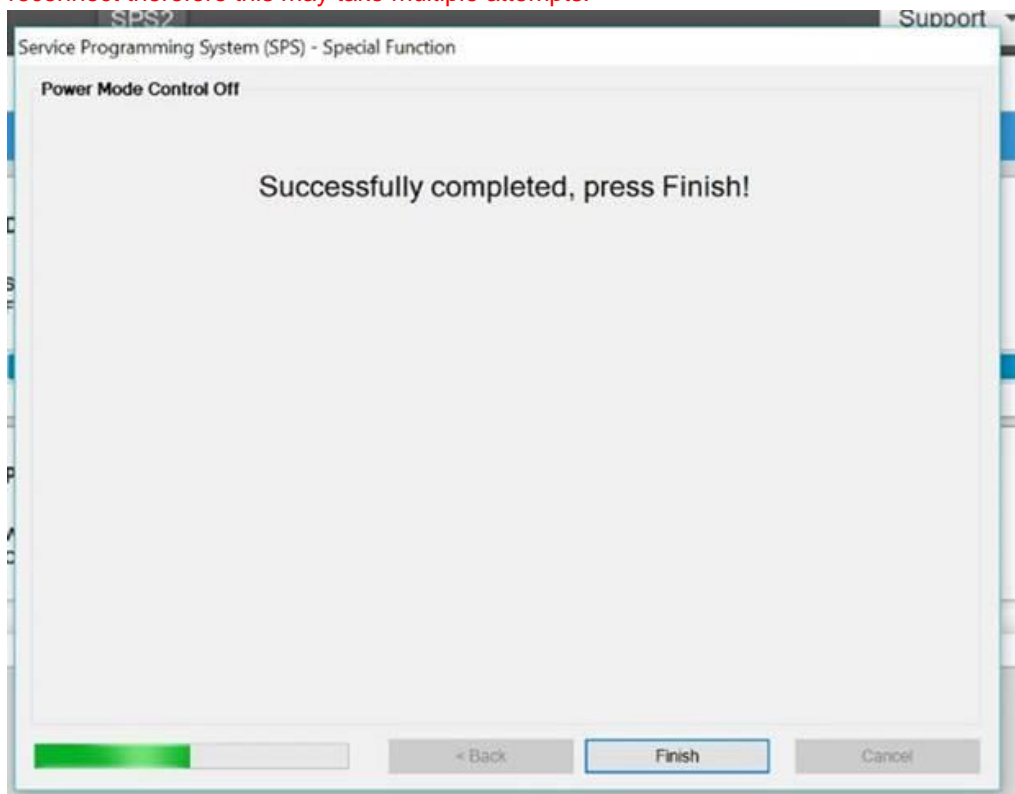
5627415

**Caution:** Before completing the procedure, there will be a "Successfully completed, press Finish!" pop up screen. Disconnect the front view camera module electrical connector for 10 seconds then reconnect the module and click "Finish" BEFORE 3 seconds have passed, or errors may occur. There is a small 3-5 second window of communication upon reconnect therefore this may take multiple attempts.

2. Reprogram the front view camera. Refer to *Front View Camera Reprogramming with SPS* in SI. Before completing the procedure, there will be a "Successfully completed, press Finish!" pop up screen. Disconnect the front view camera module electrical connector for 10 seconds then reconnect the module and click "Finish" BEFORE 3 seconds have passed, or errors may occur. There is a small 3-5 second window of communication upon reconnect therefore this may take multiple attempts.

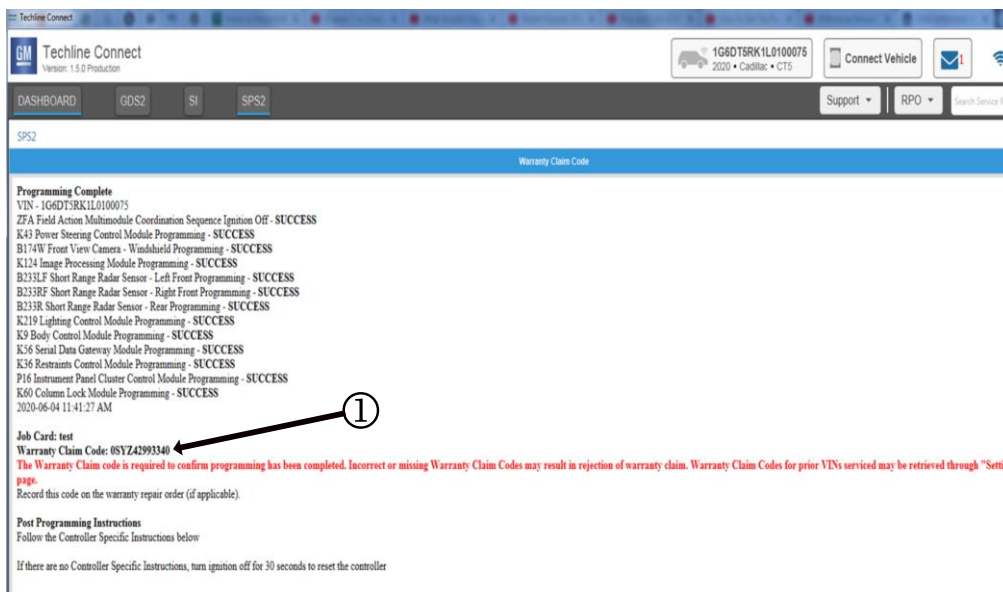
5618451

**Important:** SPS and Techline Connect screen shown.

**Important:** To avoid warranty transaction rejections, you MUST record the warranty claim code provided on the SPS and Techline Connect Warranty Claim Code (WCC) screen on the job card. Refer to callout (1) above for the location of the WCC on the SPS and Techline Connect screen.

4. Record SPS Warranty Claim Code on job card for warranty transaction submission.
