**SERVICE PROGRAM BULLETIN**

**APPLICABILITY:** 2015 MY Legacy and Outback

**NUMBERS:** WTG-67R

**SUBJECT:** Engine No-Start Condition in Cold Climates

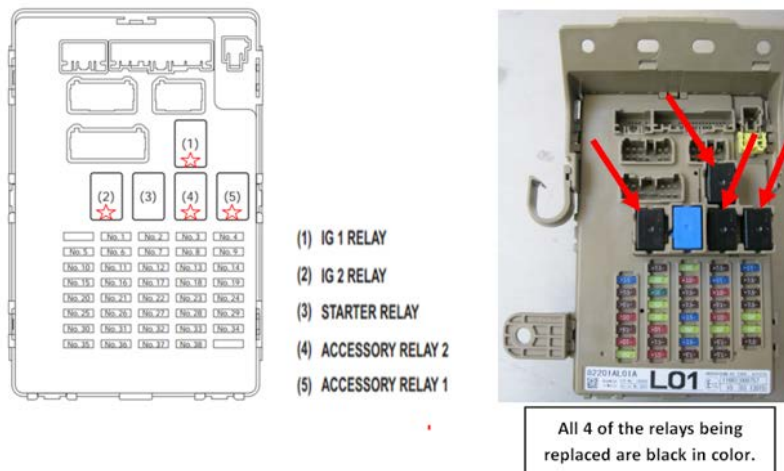
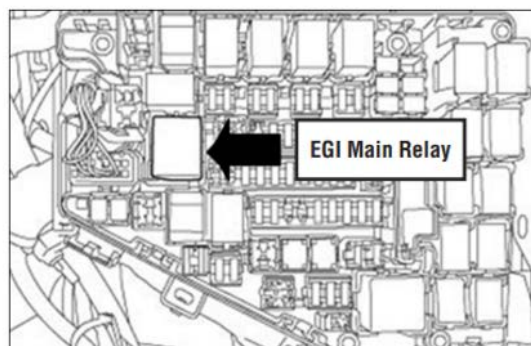
Under-hood Main Fuse Box (M/B)

The 4 IG1, IG2, ACC1, ACC2 relays are located in the vehicle's interior fuse box (F/B). The EGI Main Relay is located in the under-hood fuse box (M/B).

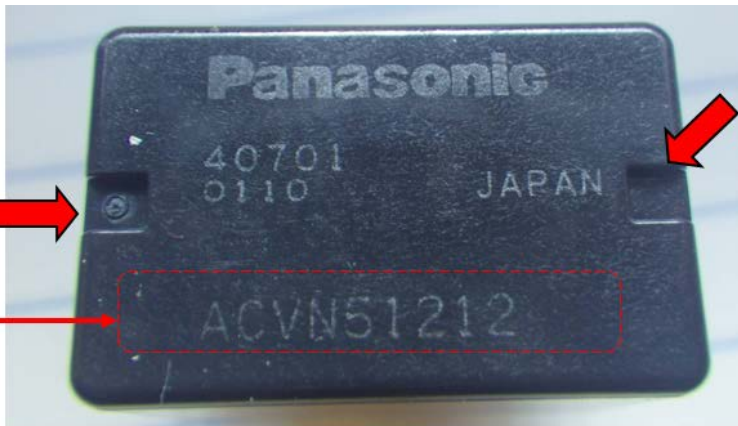
**NEW**  
**Revised Relays**

Identified by 2 small  
dents on the ends.

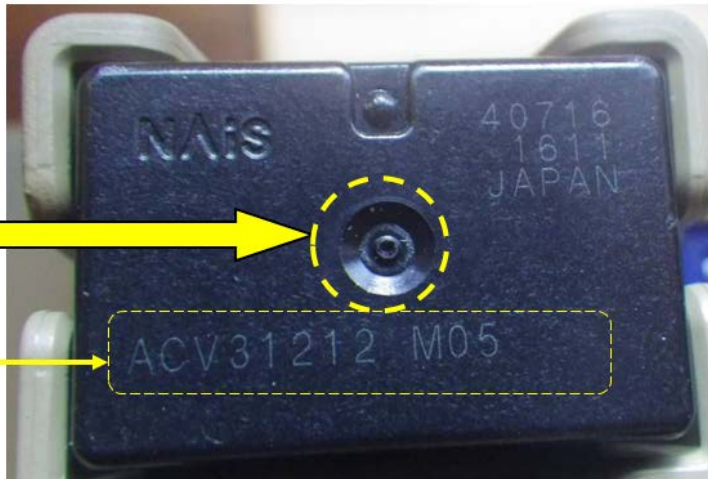
**Current Relays**

Identified by the 1  
dent in the center.
