GLOBAL SAFETY FIELD INVESTIGATIONS
DCS5549
URGENT - DISTRIBUTE IMMEDIATELY

Subject: N202316420 - Service Update
Liftgate Opening Metal Split

Models: 2020 Cadillac XT5

N202316420 Liftgate Opening Metal Split

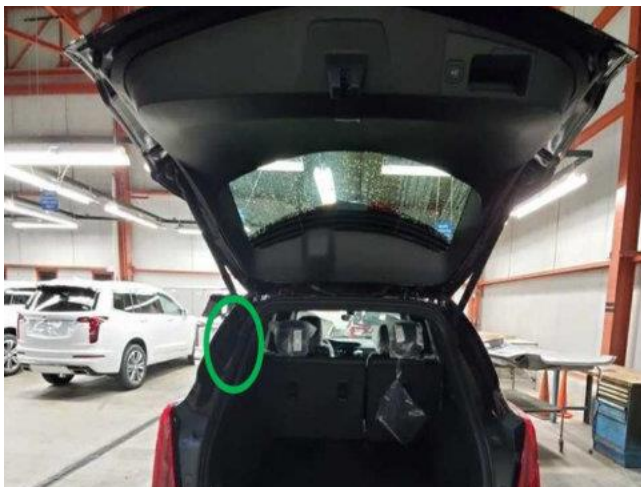
5660950

1. Open the liftgate and inspect the upper left area of the opening between the strut mount and the weatherstrip for a split condition.
