Subject: N202316150 - Service Update
Starter Nut Incorrect Torque Possible Arcing

Models: 2020 Cadillac CT5 equipped with 3.0 L Engine (RPO LGY)

Service Update

N202316150 Starter Nut Torqued Incorrectly – Potential for Arcing

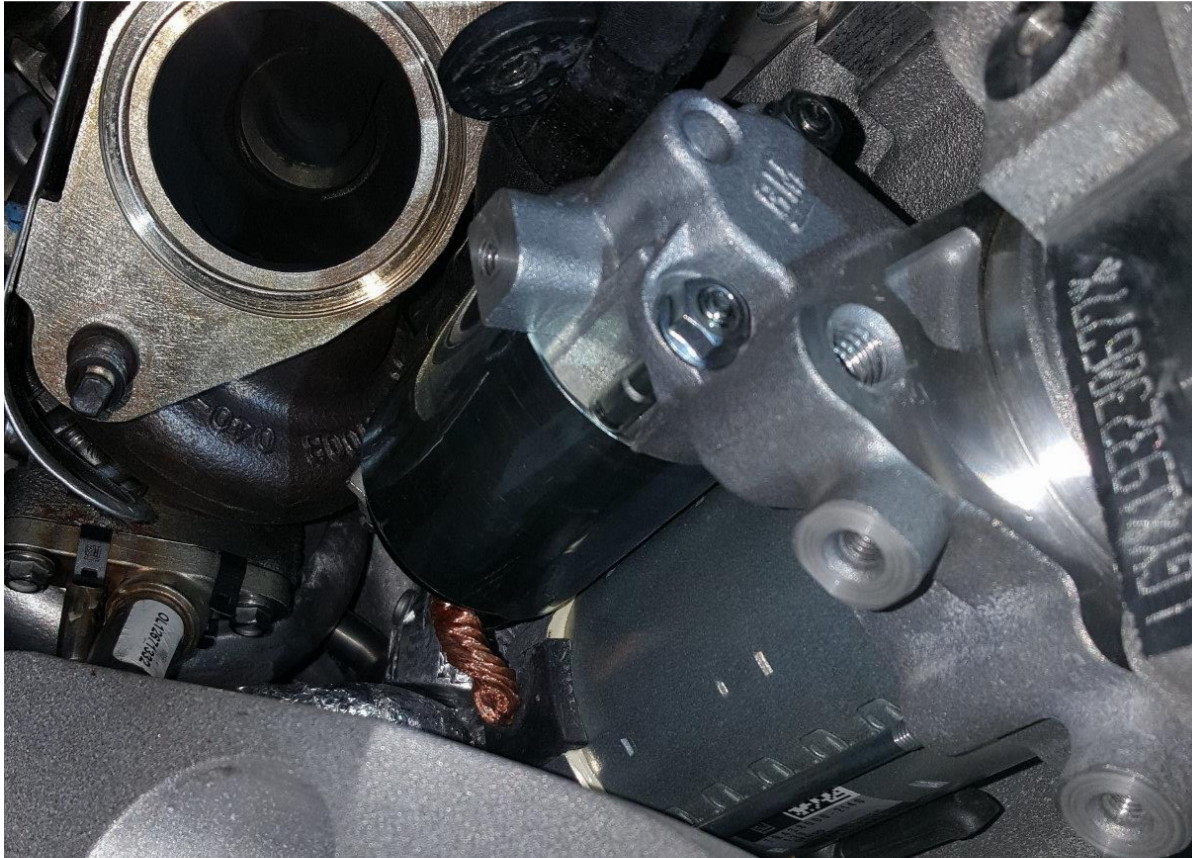
5654292

3. Rotate the starter approximately 90 degrees towards the driver's side of the car (as shown) to gain access to the starter B+ terminal.
4. Inspect the starter terminal for evidence of arcing (it may be helpful to use a mirror or borescope). If evidence of arcing is found on the nut or starter terminal, replace the starter.
 - If no evidence of arcing is found, torque the starter B+ terminal nut to 9 lb-ft (12 N-m).
 - If evidence of arcing is found on the nut or starter terminal, replace the starter. Refer to *Starter Replacement* in SI.
 - If evidence of arcing is found on the battery positive cable, replace it. Refer to *Auxiliary Generator Battery Jumper Cable Replacement* in SI.
5. Install the starter bolts and tighten to 43 lb-ft (58 N-m).
6. Replace the starter heat shield and all associated components. Refer to *Starter Heat Shield Replacement (LGY)* in SI.
