GLOBAL SAFETY FIELD INVESTIGATIONS
DCS5574
URGENT - DISTRIBUTE IMMEDIATELY

Subject: N202313960 - Customer Satisfaction Program
Daytime Running Lamp (DRL) Color Change

Models: 2021 Chevrolet Suburban
2021 Chevrolet Tahoe

N202313960 Daytime Running Lamp (DRL) Color Change

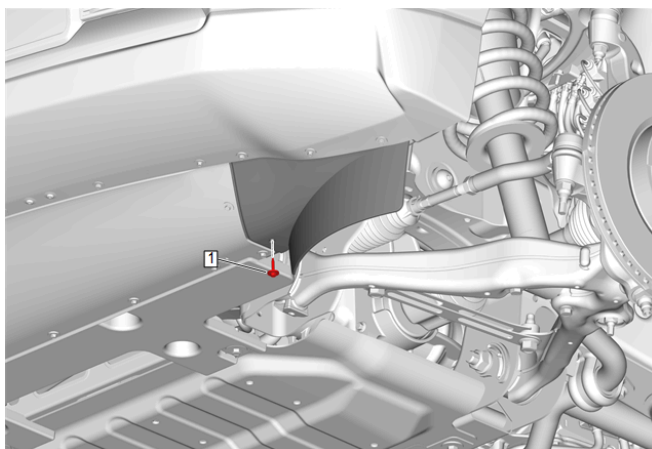
5522093

- Partially lift the vehicle to a level that provides access to the front inner wheelhouse liner assembly. Refer to *Lifting and Jacking* in SI.

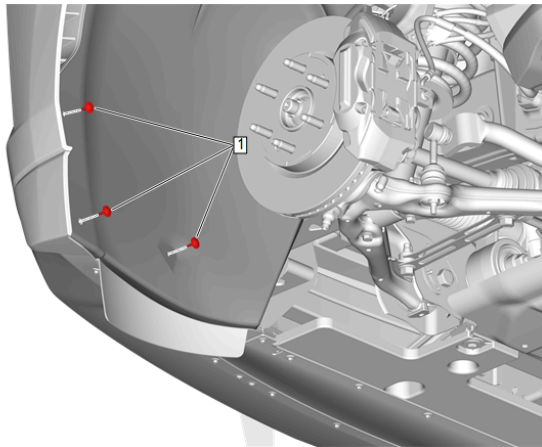
5513747

2. Partially remove the left front wheelhouse liner fasteners. Only remove the 8 fasteners forward of the suspension shock absorber/spring assembly (1-2).
3. Reposition the front section of the wheelhouse liner allowing access to the back of the headlamp assembly. Use care to not damage the suspension height sensor.

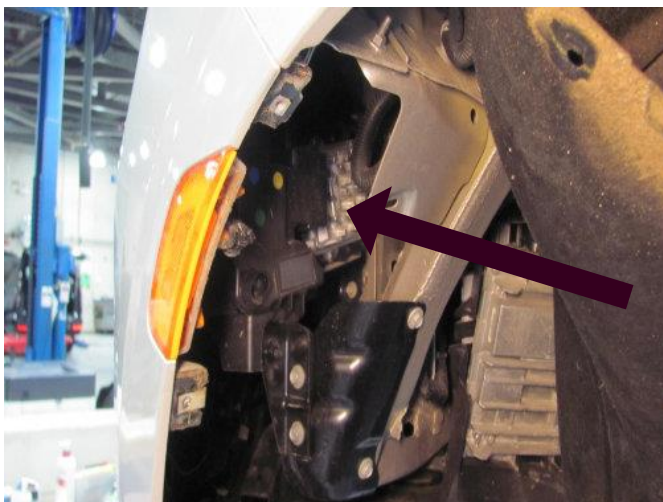
5646325

4. Locate the headlamp LED driver module located on the headlamp housing.

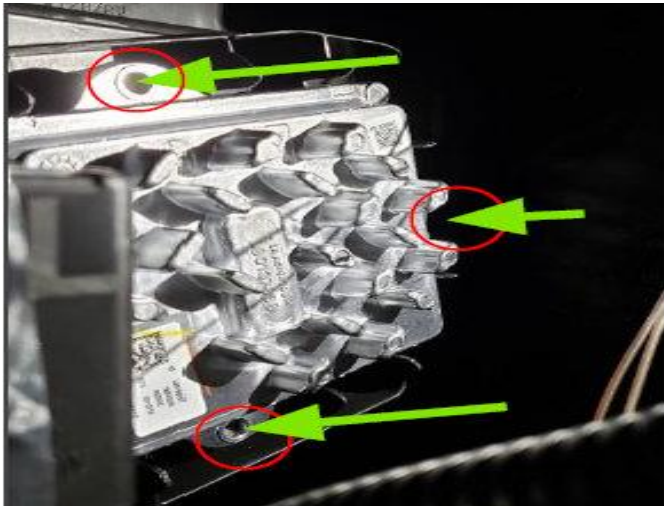
5646326

5. Remove the 3 module attachment fasteners, use care to not damage the threads on the headlamp housing.

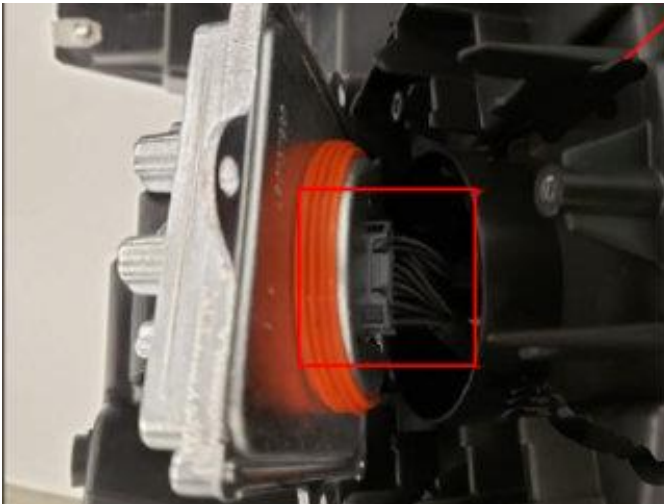
5646327

CAUTION: The headlamp LED driver module electrical connector is inside of the headlamp assembly. **Do not pull the driver module away from the headlamp assembly** without disengaging the connector, this may damage the headlamp. You may separate the driver unit up to 40mm (1.6 In.) away from the lamp.

6. Separate the headlamp LED driver module from the headlamp housing no more than 40mm (1.6 In.).

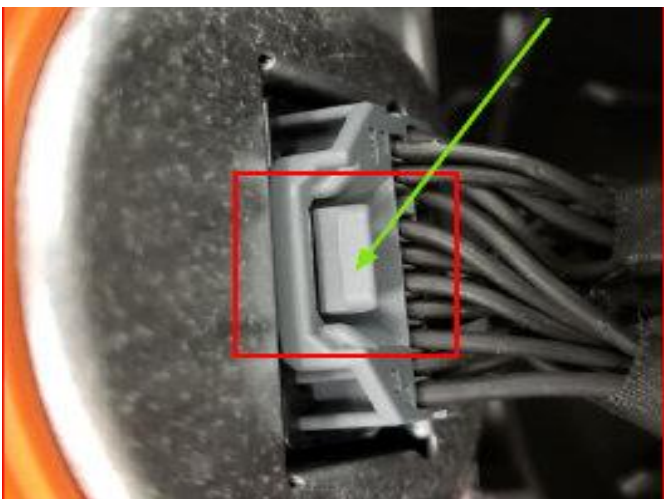
5646328

7. Locate the electrical connector tab and disengage the connector from the module. The tab will be on the inboard side of the headlamp LED driver module.
8. Move the headlamp LED driver module rearward in the vehicle and remove.
9. Connect the electrical connector to the new headlamp LED driver module, verify the connector is fully seated and the tab is engaged.
10. Place the new headlamp LED driver module into the headlamp housing.

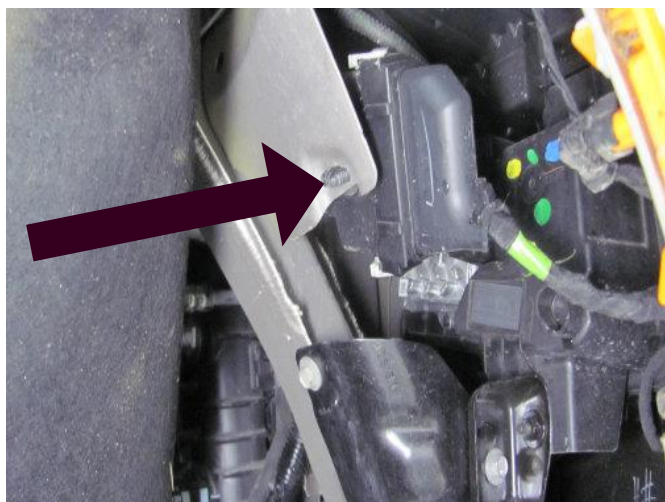
5646329

- There is a body harness connector blocking access to the repair area on the right front inner fender. Using a trim panel removal tool, separate the Christmas tree fastener from the body and reposition the harness out of the work path. Reinstall the harness to the body after the new headlamp LED driver module is installed.
