PRODUCT CAMPAIGN BULLETIN

APPLICABILITY: 2020MY Legacy and Outback **NUMBER:** WRH-20R
SUBJECT: Rear Visibility FMVSS 111 Non-Compliance **DATE:** 12/11/20
REVISED: 01/21/21
NHTSA ID: 20V-766

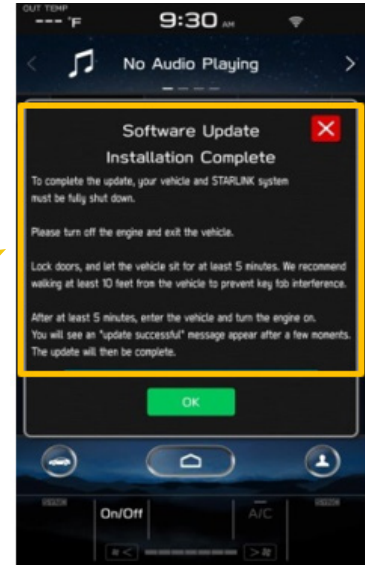
- Clarification of the post-FOTA procedure instructions required to complete the update. The screenshot below will appear and explain what must be done to complete the update installation.

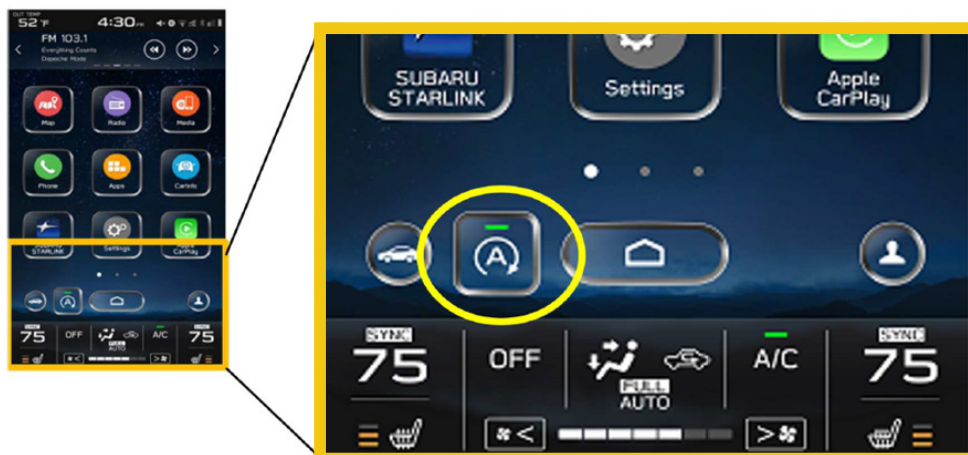
The Auto Stop-Start On/Off function button has been moved from the bottom to top layer of the system for easier use. A screenshot of how the button will appear is shown below.

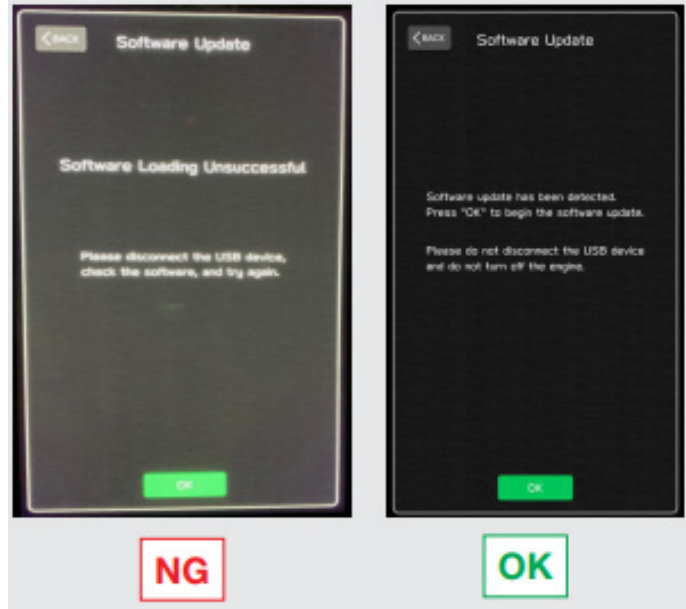
NOTE: If after plugging in the USB, the screen displays a Software Loading Unsuccessful message, confirm the USB device has been properly formatted and the software on the device matches the H/U being reprogrammed (example: **MID** software is being used to update a **MID** H/U).

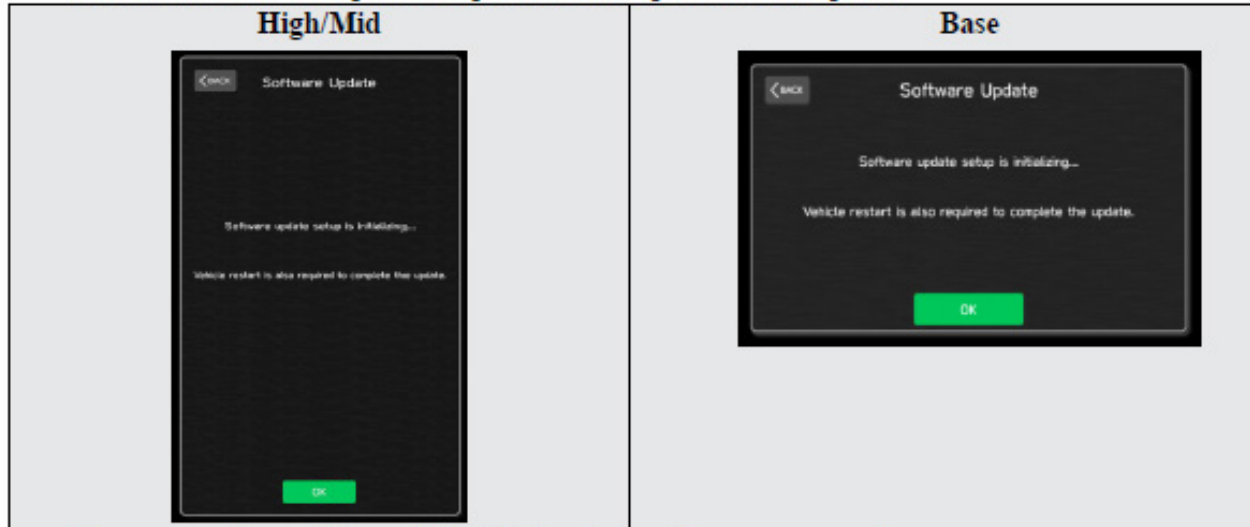
- If the screen shown below appears, **WAIT** for approximately 15 minutes or as long as necessary to allow the Software update setup initialization process to complete.

1. Turn the ignition OFF, open the driver's door, close the driver's door and **WAIT** for 3 or more minutes before proceeding further.
2. Open the driver's door again and either turn the ignition ON (if a charger is connected) or start the engine.
3. Go to Dealership Mode menu again (PRESS and HOLD the RIGHT-side temperature control buttons (both up and down) and press the Tune / Scroll knob 6 times then release all to display the Dealership Mode) and select Software Update as in STEP 3 beginning on pg. 8.
