SERVICE PROGRAM BULLETIN

APPLICABILITY: 2019MY Ascent NUMBER: WRK-20

SUBJECT: Air Conditioning Refrigerant Pipe Replacement DATE: 01/18/21

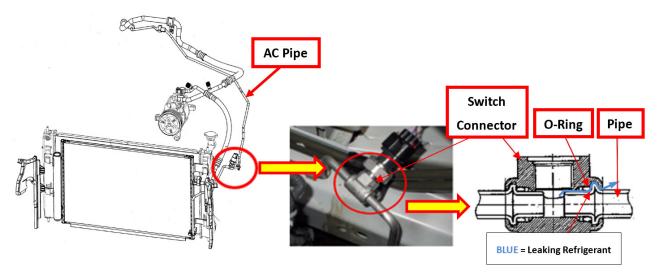
The sealing capability of the pressure switch connector on the metal high-pressure refrigerant pipe may have been compromised during manufacture resulting in a refrigerant leak and unsatisfactory cooling performance of the A/C system. The switch connector is a component of the high-pressure pipe assembly as shown in the illustrations below. This service program involves replacement of the pipe assembly.

Subaru retailers will replace the air conditioning pipe in affected vehicles at no charge to the customers.
