SERVICE PROGRAM BULLETIN

APPLICABILITY: 2020-2021MY Legacy and Outback **NUMBER:** WRI-20R
SUBJECT: Reprogramming of Denso CP1 Infotainment Units to Optimize System Performance **DATE:** 12/11/20
REVISED: 01/21/21

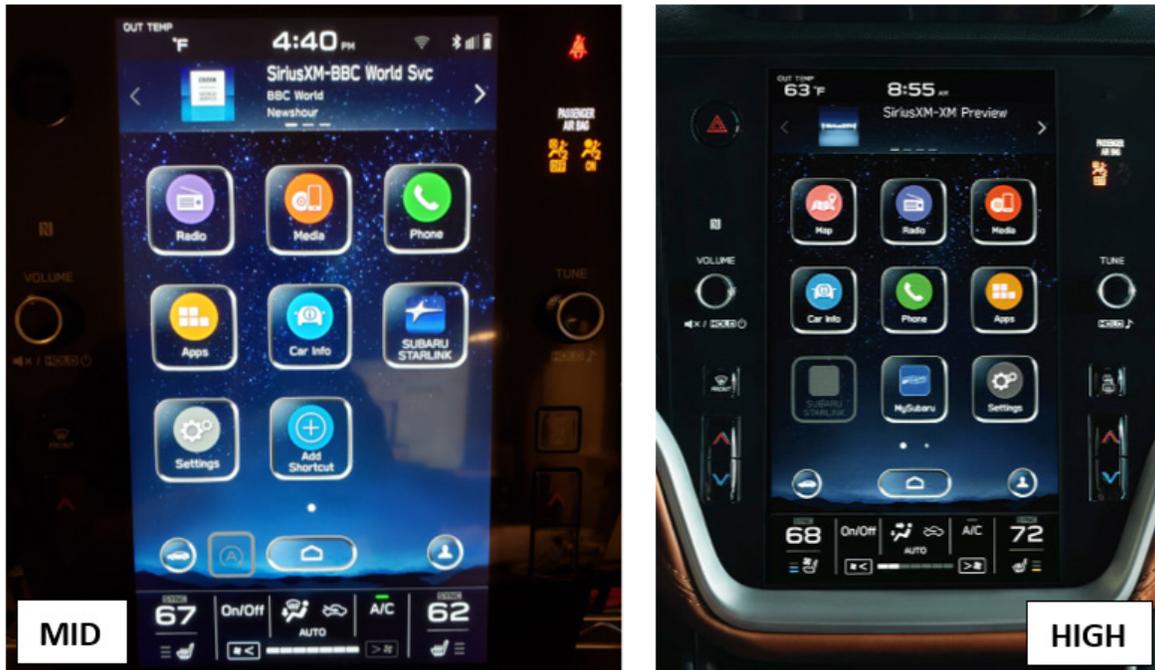
This Campaign affects certain “Mid” and “High” (w/ Navigation) -level CP1 Head Units with 11.6-inch display ONLY as pictured below. The “Base” model (2- 7.0-inch display screen unit) is NOT affected.

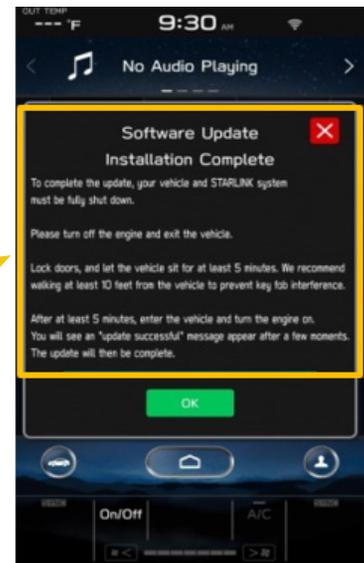
- Clarification of the post-FOTA procedure instructions required to complete the update. The screenshot below will appear and explain what must be done to complete the update installation.

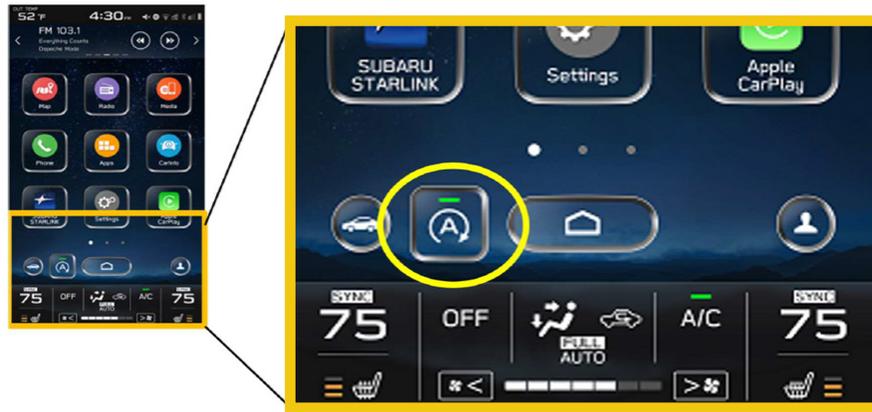
The Auto Stop-Start On/Off function button has been moved from the bottom to top layer of the system for easier use. A screenshot of how the button will appear is shown below.
