SERVICE PROGRAM BULLETIN

APPLICABILITY: 2015 MY WRX 2.0L DIT Models
 2014-2015 MY Forester 2.0L DIT Models
SUBJECT: Engine Control Module (ECM)
 Reprogramming

NUMBER: WQW-58R
DATE: February 10, 2016
REVISED: August 14, 2017

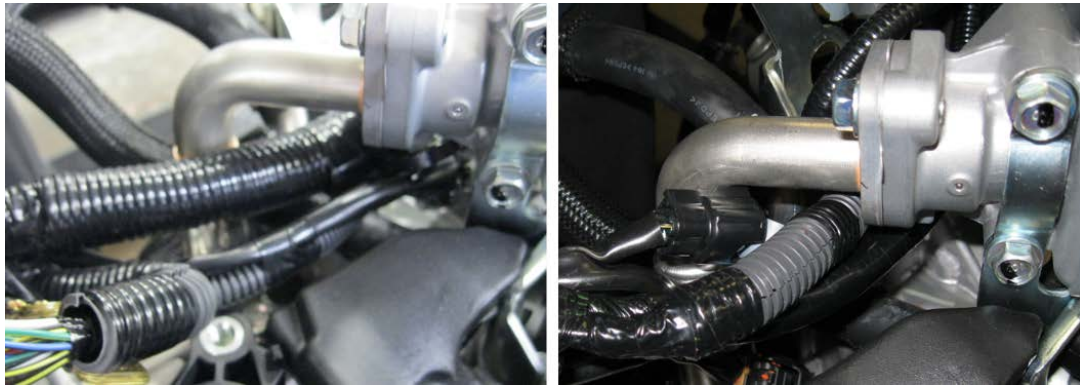
- When installing the new engine harness assembly:
 - o Use caution when removing the foam insulators from the high-pressure fuel piping.
 - o The EGR assembly does **not** have to be removed as the new harness can **CAREFULLY** be fed under the large EGR pipe as shown in the photos below.

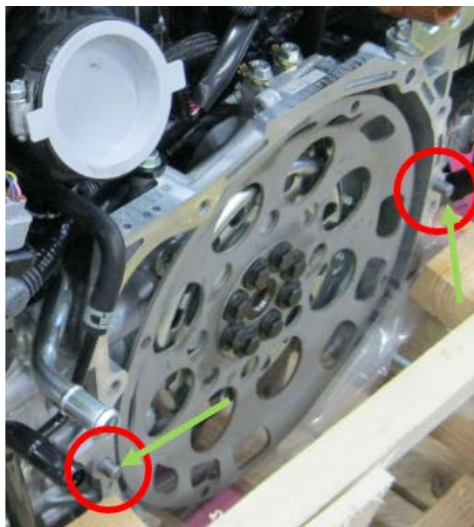
- After removing the “old” timing chain guide and sprockets, mark them accordingly so they do not get confused with the new replacement parts.
- Always confirm the reluctor between the flex plate and crankshaft flange on the new engine matches the original **BEFORE** reinstalling the assembly.
- Confirm the new engine assembly has both alignment dowels installed (and none in the transmission).
