SERVICE PROGRAM BULLETIN

APPLICABILITY: 2017 MY Forester (non-Turbo) with CVT
SUBJECT: Service Campaign – Forester CVT Low Fluid Level

NUMBERS: WTJ-70R
DATE: 10/03/16
REVISED: 08/03/17

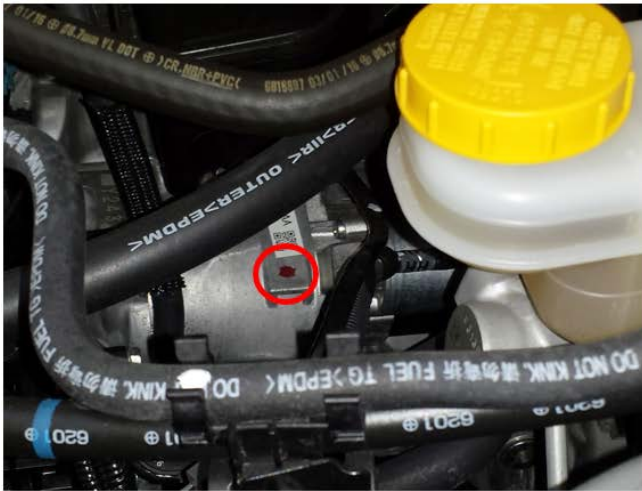
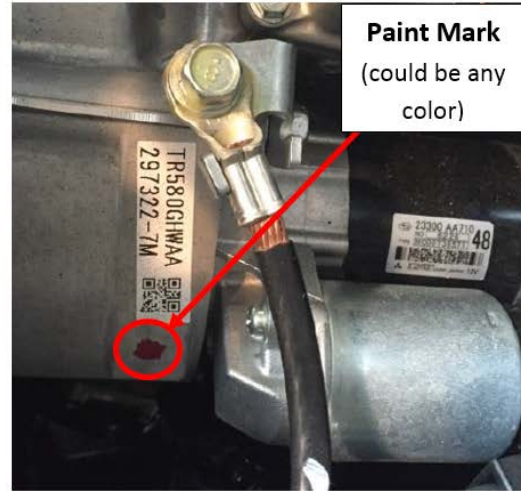
- Campaign applicability by performing a Vehicle Coverage Inquiry on subarunet.com.
- Inspect the vehicle transmission ID label area for a paint mark as shown in the photos below.
- If you find a paint mark in this area, this procedure has already been completed. **STOP**. No further action is required.
- If there is not a paint mark, proceed with the balance of this Service Procedure.

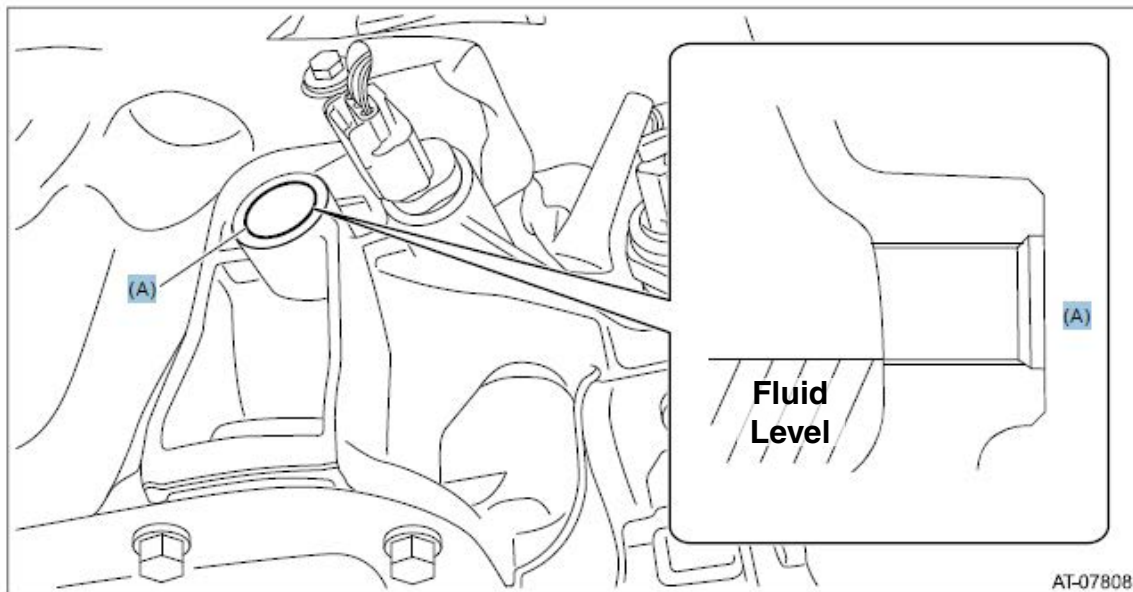
(A) Filler plug hole

If CVTFII is added up to the lower section of filler plug hole while the transmission is in cold condition, overfilling of CVTFII occurs, causing the oil to spill out.

7. Install the filler plug.
NOTE: Always use a new filler plug gasket, part number: 803918060.
Tightening torque:
50 N·m (36.9 ftlb)
8. Reinstall the under cover front - transmission.
Tightening torque:
18 N·m (13.3 ftlb)

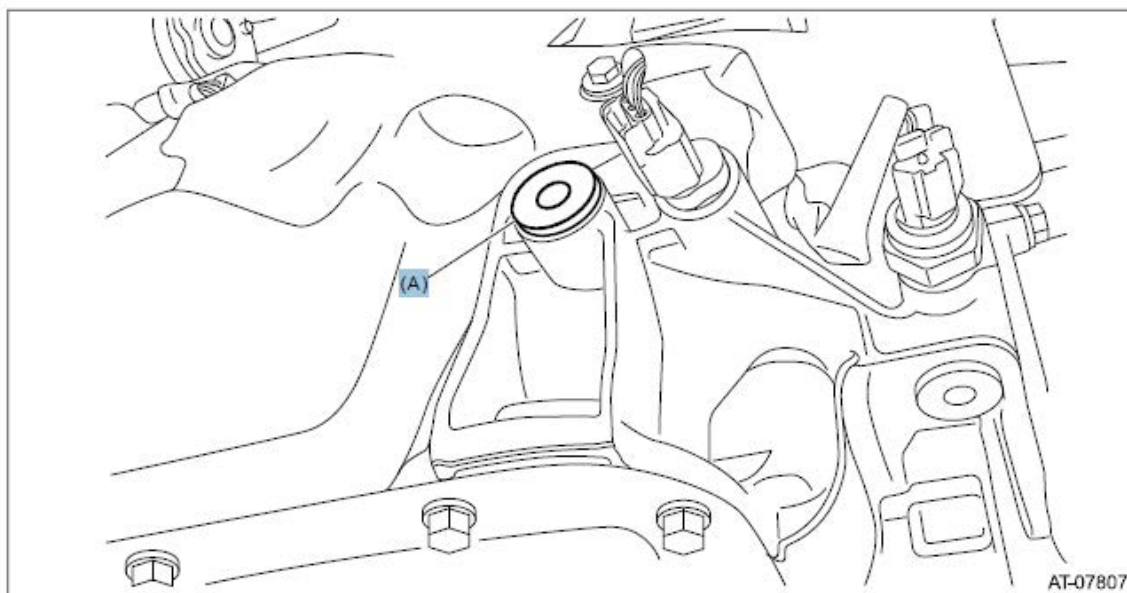
(A) Filler plug

NOTE: The CVT is full when the fluid level is at the bottom of the filler plug hole.

12. When there is no CVTFII leakage, add the specified fluid up to the filler plug hole lower section. A small amount of CVTFII may drain initially from the filler plug hole due to the presence of residual fluid in the access port. It is expected 700 ml of fluid will need to be added to achieve correct fill in all cases. If the CVT appears to need significantly more or less than 700ml, confirm the fluid temperature is still correct for inspection and that the engine is running.
