SUBJECT: **Customer Satisfaction Program 20N11 - Supplement #1**
Certain 2016 - 2019 Model Year Explorer Vehicles equipped with a Roof Rail
Roof Rail Cover Detachment

REF: **Technical Service Bulletins 19-2364 and 20-2154**
2016-2019 Explorer – Roof Rail Covers Loose

CERTAIN 2016-2019 MODEL YEAR EXPLORER VEHICLES — ROOF RACK REPAIR

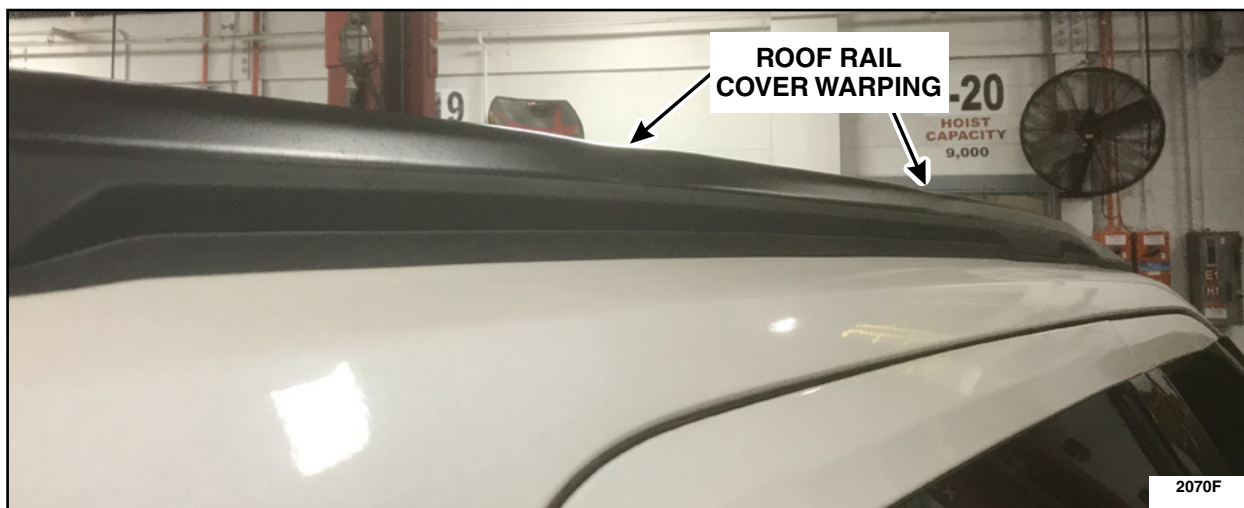
FIGURE 1

1. Inspect for roof rail covers that are missing, broken and or show signs of warping. See Figure 1. Are either one or both of the roof rack covers missing, broken and or show signs of warping?

If **YES** - Take a photo of the roof rail cover on the vehicle, remove and discard the roof rail cover as a *new* one will be installed. Proceed to Step 4.

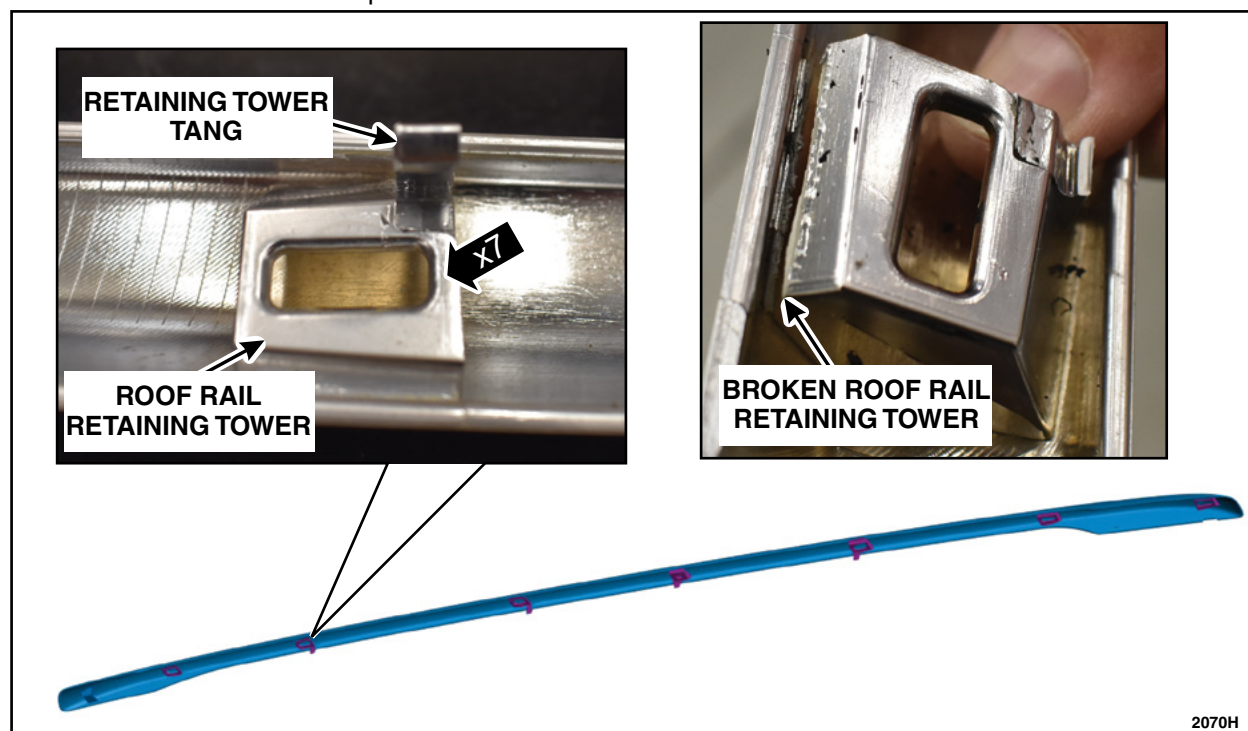
FIGURE 3

NOTE: The tangs on the retaining tower can be broken and do not qualify as a broken retaining tower.

3. Inspect the roof rail cover retaining towers and front tab. Are any of the seven retaining towers or front tab missing and or broken? See Figure 3.

If **YES** - Take a photo of the broken retaining towers, discard the roof rail cover and replace with a *new* one. Proceed to Step 4.

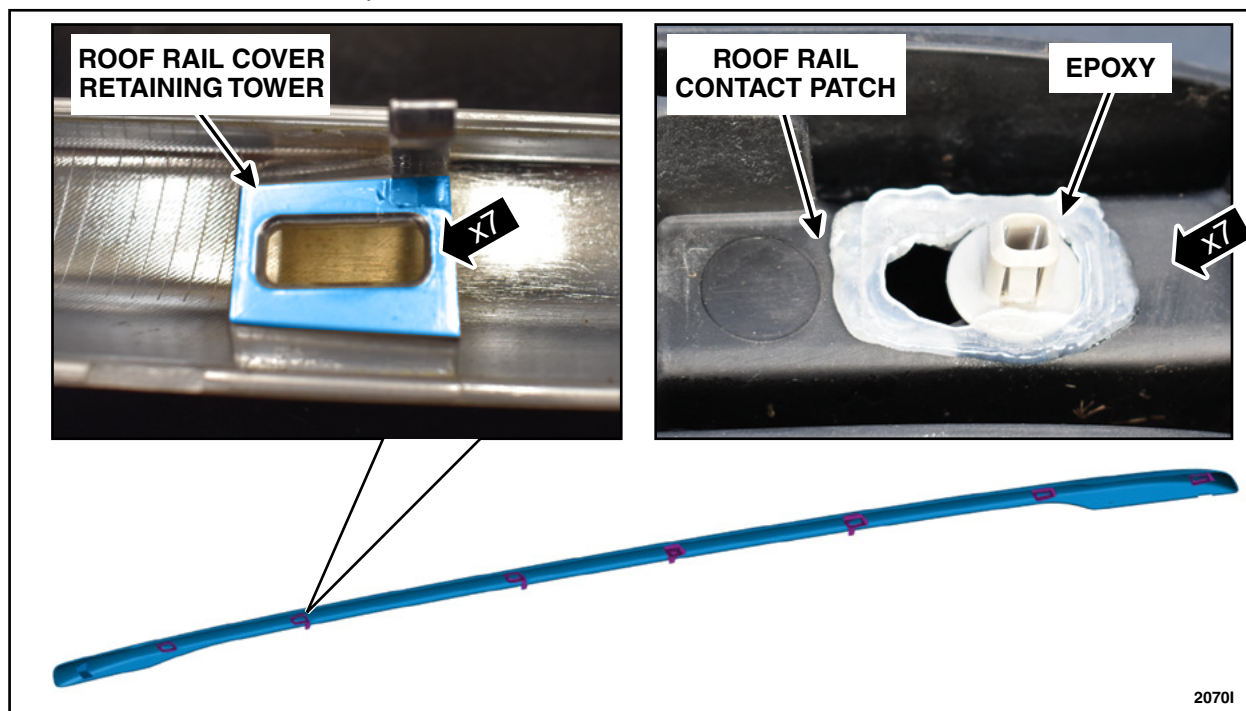
FIGURE 4

4. If Technical Service bulletin (TSB) 19-2364 or 20-2154 was performed, evidence of RTV or epoxy will be seen on the roof rack cover and or roof rail contact patch. Inspect the roof rack cover retaining tower and roof rail contact patch for signs of RTV or epoxy adhesive. See Figure 4. Was evidence of RTV or epoxy found?

5. Remove any adhesive on the roof rail cover retaining tower and roof rail contact pads. See Figure 5.

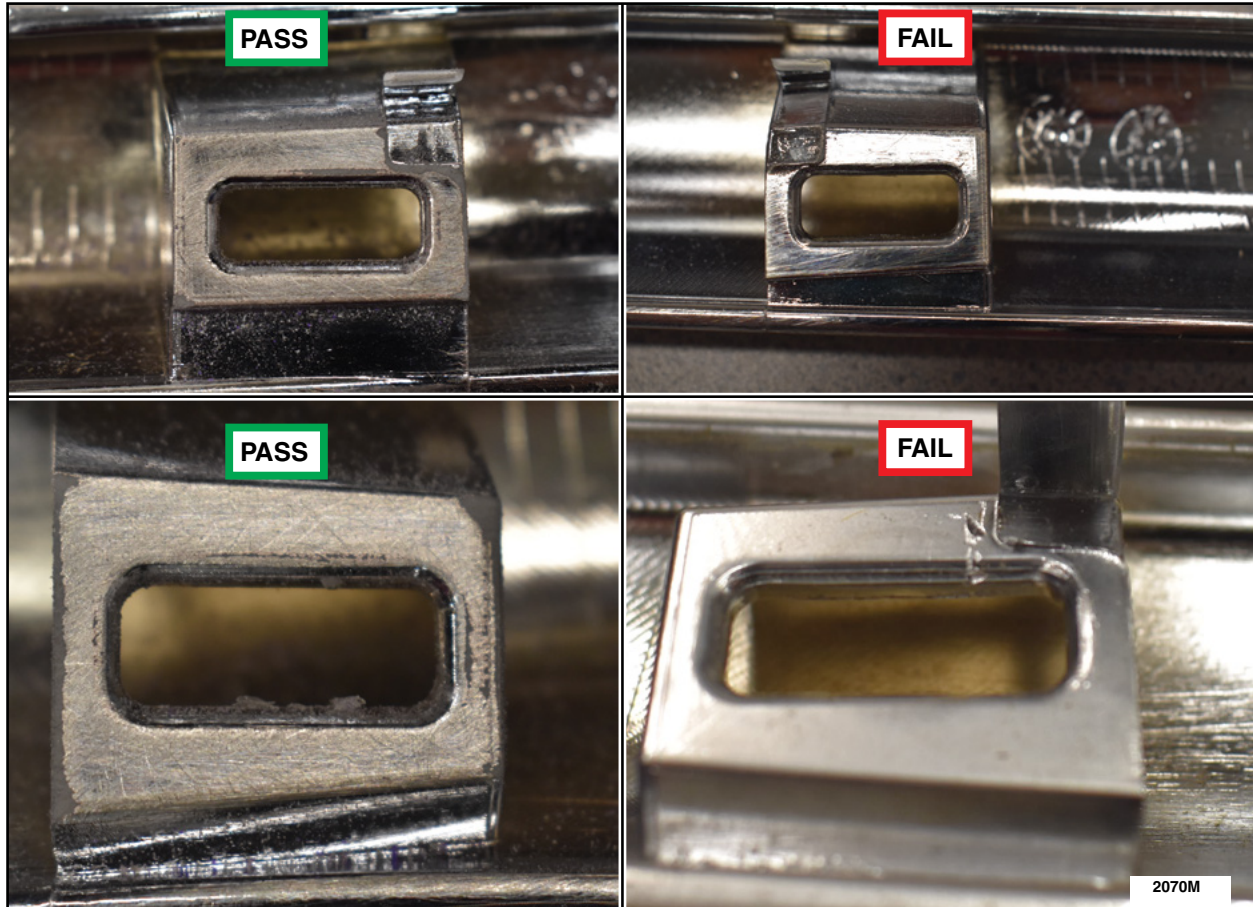
FIGURE 8

8. Without proper abrasion the adhesive will not hold. See Figure 8. Has proper abrasion been achieved?

If **FAIL**, requires more scuffing, go back to Step 7.
