PRODUCT CAMPAIGN BULLETIN

APPLICABILITY: 2021MY Outback 2.5L
 2021MY Impreza
SUBJECT: CVT Select Lever Cable Nut- Low Torque

NUMBER: WRA-21R
DATE: 01/21/21
REVISED: 02/01/21
NHTSA ID: 21V-024

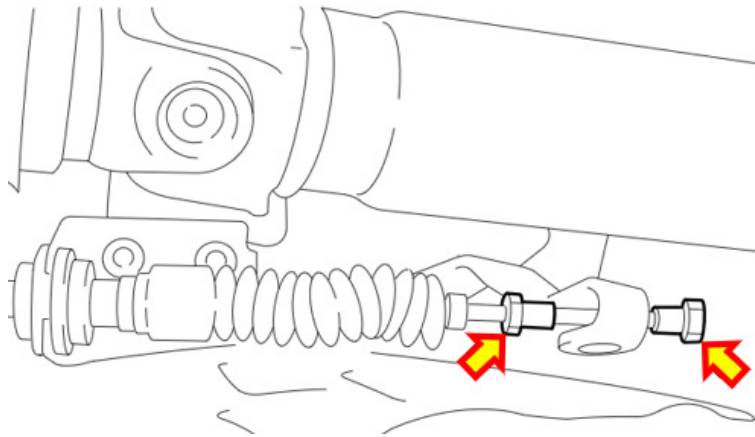
Step 4: With the center exhaust cover removed, locate the select cable adjusting nuts as shown below.
