SERVICE PROGRAM BULLETIN

APPLICABILITY: 2016 MY Forester, Impreza, Crosstrek, Legacy, and Outback

NUMBER: WQZ-61R

SUBJECT: Telematics System Data Communication Module (DCM) Reprogramming

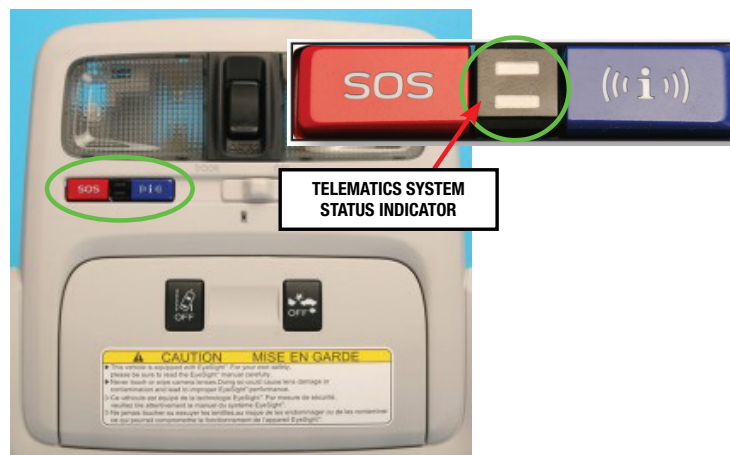
TELEMATICS SYSTEM STATUS CHECK PROCEDURE:

VERY IMPORTANT: Before attempting programming, the status of the Starlink Telematics system **MUST** be confirmed by observing the RED and GREEN indicator LEDs on the overhead console located between the Blue “i” and Red “SOS” buttons with the ignition ON.

There are four possible statuses: RED lamp ON, GREEN lamp ON, BOTH lamps ON, BOTH lamps OFF.

- If only the RED lamp is on, diagnose any DTCs found in the DCM using the applicable Service Manual. The concern(s) must be corrected before attempting any reprogramming.
- If only the GREEN lamp is on, proceed with programming. When programming is complete, confirm: (1), the GREEN light comes back on and (2), when pressing the RED SOS button, you are connected to Starlink Support.
- If BOTH lamps are OFF, proceed with programming. When programming is complete, confirm when after pressing the RED SOS button, you hear the “Not currently subscribed to STARLINK please visit mySubaru.com to upgrade your service” message.
- If BOTH lamps are ON, the Starlink Telematics system is having a communications concern. Please diagnose using the applicable Service Manual. The concern must be corrected before attempting programming.
